**COMANDO DA AERONÁUTICA**  
**CENTRO DE INVESTIGAÇÃO E PREVENÇÃO DE**  
**ACIDENTES AERONÁUTICOS**

**FINAL REPORT**  
**A-013/CENIPA/2017**

<b>OCCURRENCE:</b>	<b>ACCIDENT</b>
<b>AIRCRAFT:</b>	<b>PR-SOM</b>
<b>MODEL:</b>	<b>C90GT</b>
<b>DATE:</b>	<b>19JAN2017</b>

During the second approach attempt to land at the Paraty Aerodrome, RJ, the aircraft flew into a region under restricted visibility conditions, which caused the pilot to lose visual contact with the terrain references, leading to loss of control and the impact of the aircraft against water.

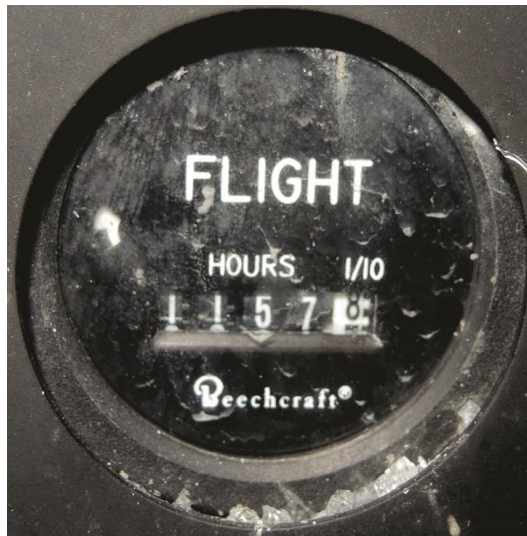
Figure 1 - "Hour meter" of the PR-SOM aircraft.

The aircraft had 1,157.8 total flight hours, according to the "hour meter" (Figure 6).

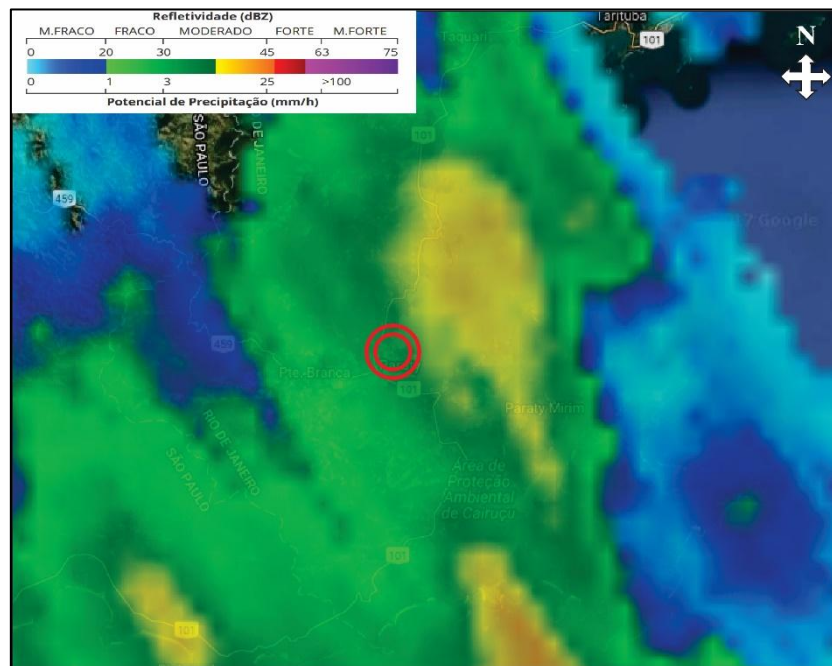
Figure 16 - Meteorological RADAR image of Pico do Couto at 15:46 (UTC).

It stands out the image generated at 15:46 (UTC), about two minutes after the impact of the aircraft, when it is observed a potential rainfall precipitation of 25 mm/h on the Paraty Bay.

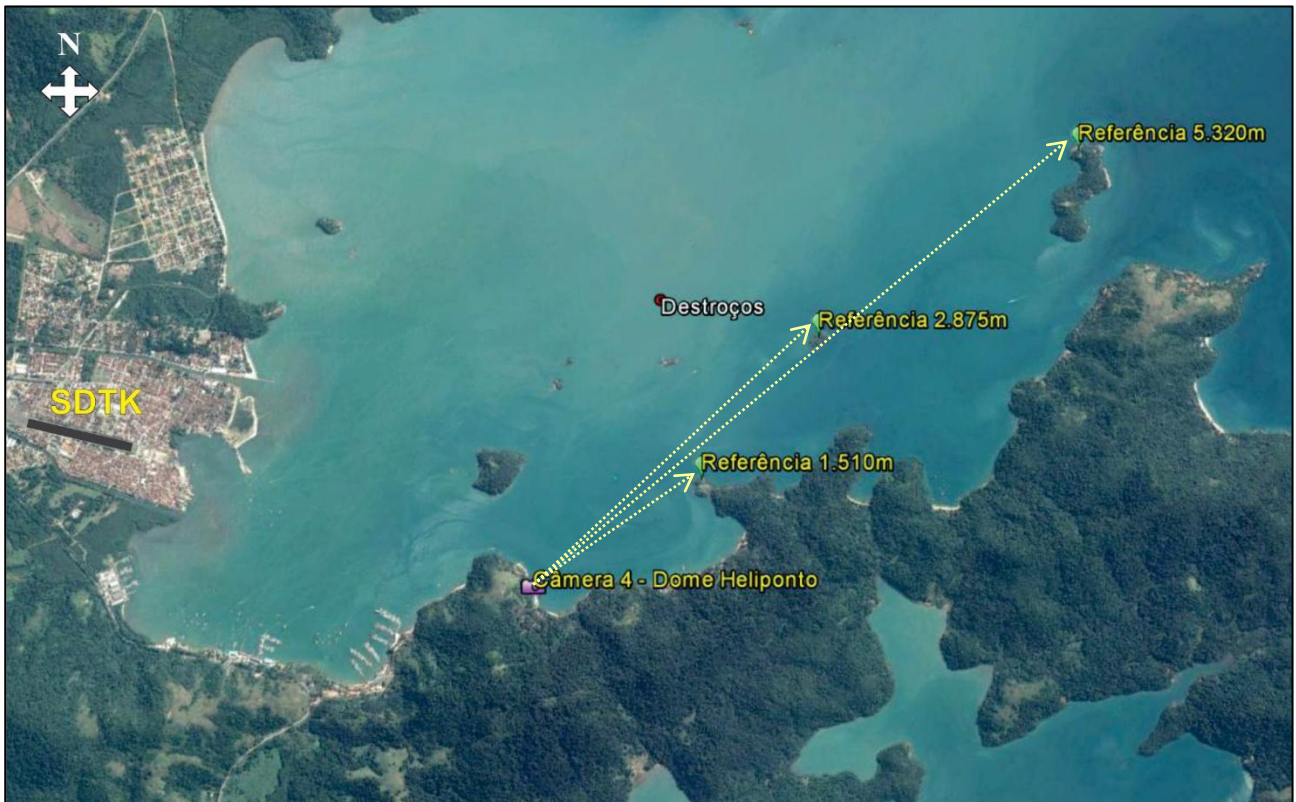
Figure 19 - Relative positions of the Aerodrome, of the camera and the distance references seen in the recorded images.

Aiming at an approximate measurement of the horizontal visibility present in the region, at the time of the accident, the Investigation Team used the images recorded by a security camera (Camera 4 Dome Heliponto). In addition were adopted some points on the ground (Referência 1,510m; Referência 2,875m; Referência 5,320m) which were used as reference distance for the determination of the visual range, according to Figure 19.

The figure also illustrates the position of the Paraty Aerodrome, RJ, and the position of the aircraft wreckage (red circle and white letters).

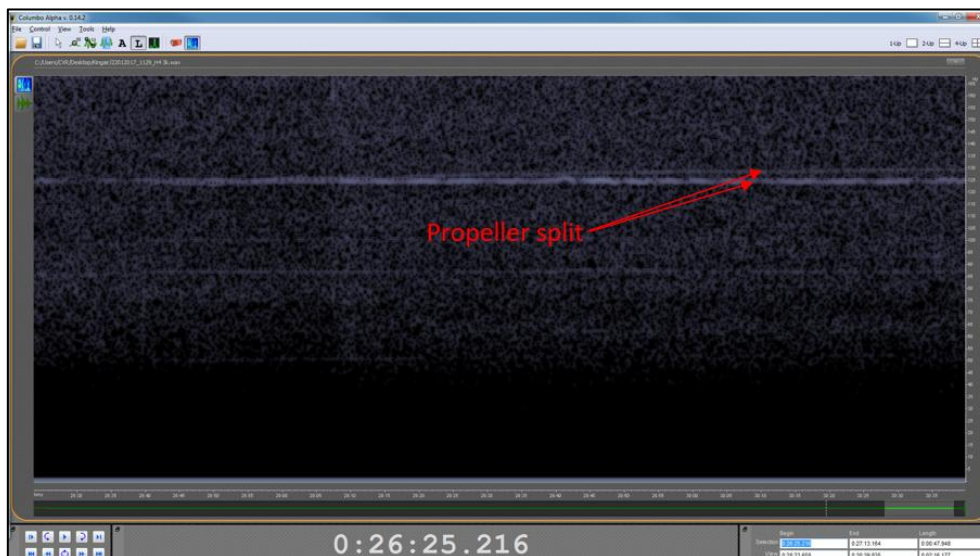
Figure 36 - Small detachment of the frequencies of the propellers rotation indicated in the spectrum.

At 15:42:41 (UTC) the beginning of a small speed differential between the propellers was observed. At the end of the recording, one of the propellers was at 1,875 RPM and the other at 1,950 RPM. The spectral analysis, however, did not allow defining to which engine each rotation was associated with (Figure 36).

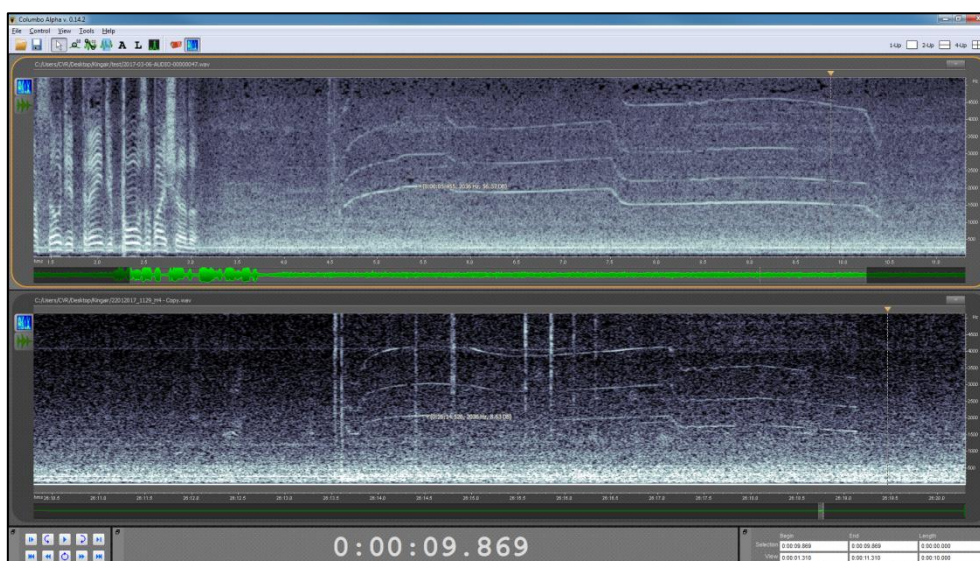
Figure 37 - Comparison between flight spectra with another C90GT aircraft (top image) and crash flight (bottom image).

When comparing the graphical information of the recording of another C90GT aircraft in relation to the information of the accident flight, the parameters of Figure 37 were obtained. Comparison of the data revealed lines that characterized the movement of the landing gear of the PR-SOM aircraft.

Thus, it was possible to identify the landing gear at retraction at 15:40:23 (UTC) and 15:44:12 (UTC).

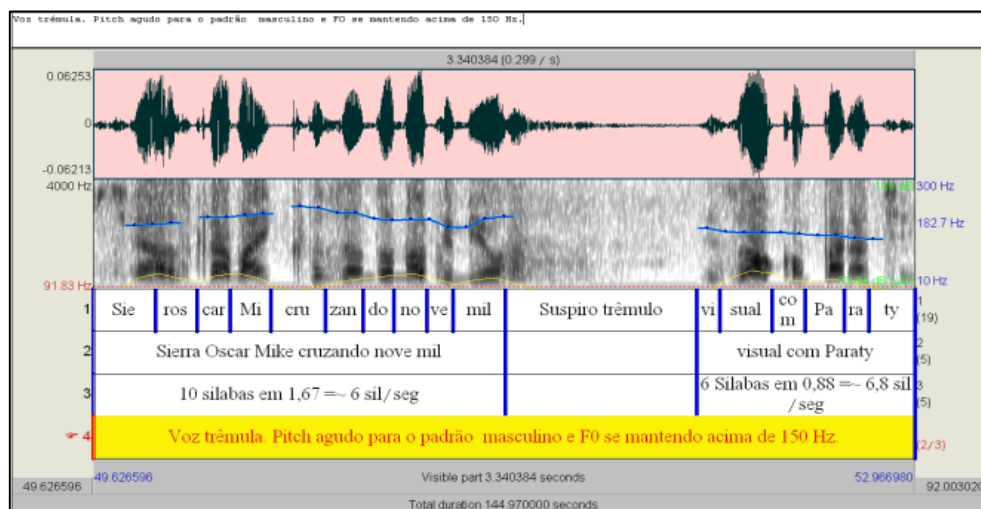
Figure 38 - Excerpt from the pilot's dialog with APP-SP at 15:32:18 (UTC).

In addition to these acoustic parameters, it was observed an acute pitch for the male pattern and in comparison with the pilot's own pattern, incoordination of the pneumophonoarticulatory (alteration in coordination between breathing and articulation). Likewise, vocal quality was tense throughout the flight, accentuating itself in the passage shown, and in this section, the voice was slightly shaky.

It is important to point out that the pilot presented himself breathless during the whole flight, and there was a moment of accentuation in the section of Figure 38

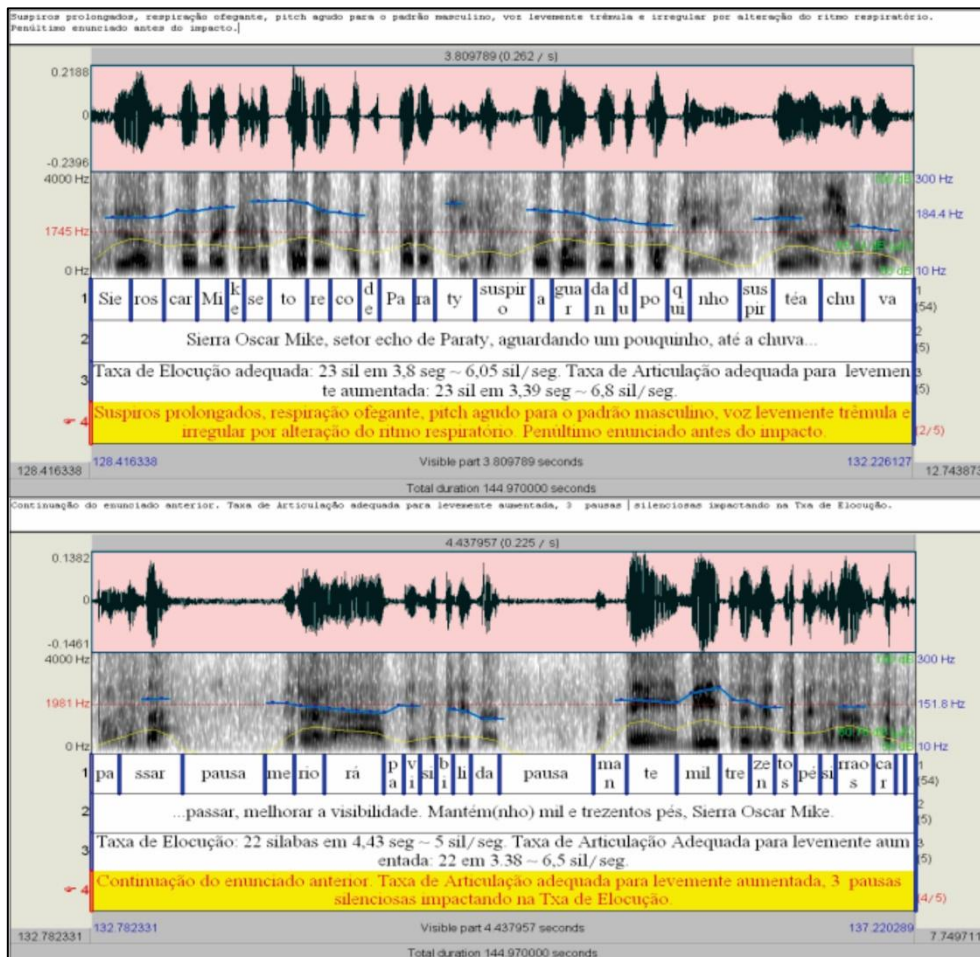
Figure 39 - Excerpt from the pilot's communication on the coordination frequency at 15:40:37 (UTC).

In the penultimate verbalization recorded before impact, it was reported in the phonics that the pilot would wait for the rain to stop, keeping 1,300ft (Figure 39).

At that moment, the pilot presented normal elocution rate, normal articulation rate for slightly increased, high F0, acute pitch, pneumophonoarticulatory incoordination, tense vocal quality, breathless speech, and voice trembling. In this section, these characteristics were more accentuated than previously demonstrated.

Thus, considering the scientific studies on the methodology of acoustic and clinical parameters to evaluate the expression of emotions, it was possible to infer that the pilot had traces of apprehension/worry and anxiety, ranging to fear, especially in the instant immediately before impact.

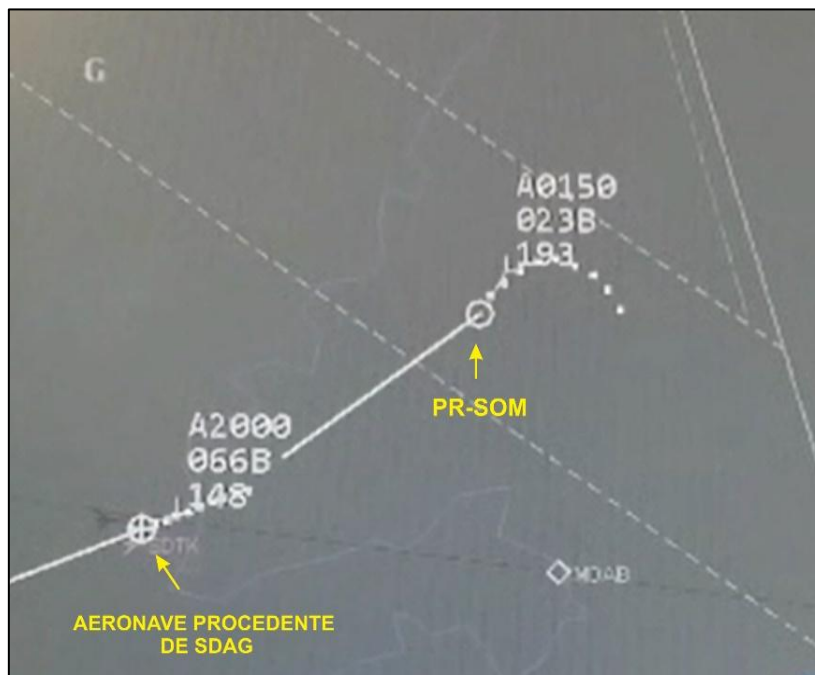
Figure 47 - RADAR image of APP-SP registered at 15:38:44s (UTC).

When it reached 3,200ft, it made a left turn, still descending, reaching 2,300ft (Figure 47).

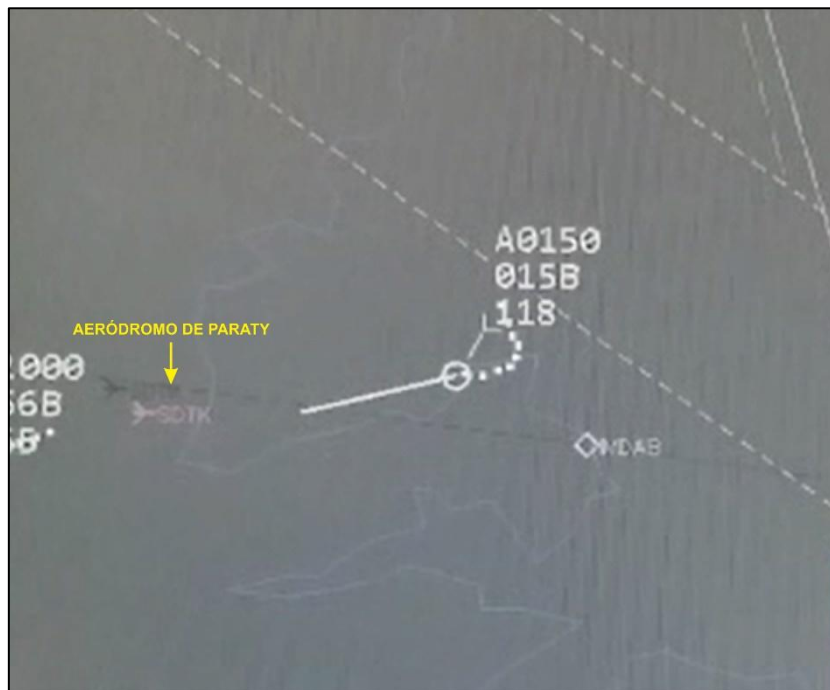
Figure 48 - APP-SP RADAR image recorded at 15:39:52 (UTC).

The aircraft then proceeded South and, as it approached the coast, made a right turn until it reached the SDTK Aerodrome, reporting that it was entering the approach to runway 28, crossing 1,500ft (Figure 48).

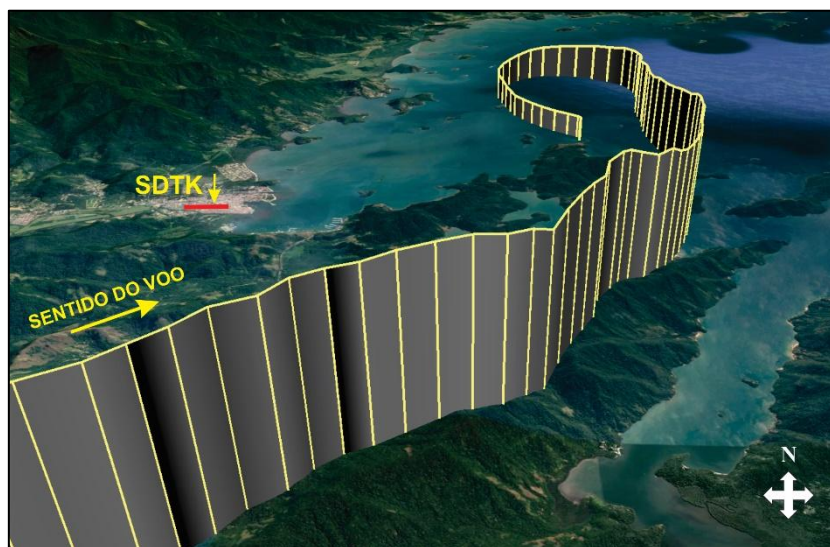
Figure 49 - Reconstruction of the descent profile of the aircraft, according to the RADAR air traffic control data.

When synchronizing the data provided by APP-SP RADAR with the terrain information of the Paraty Aerodrome region, it was verified that the aircraft followed a descent profile according to the reconstruction shown in Figure 49.

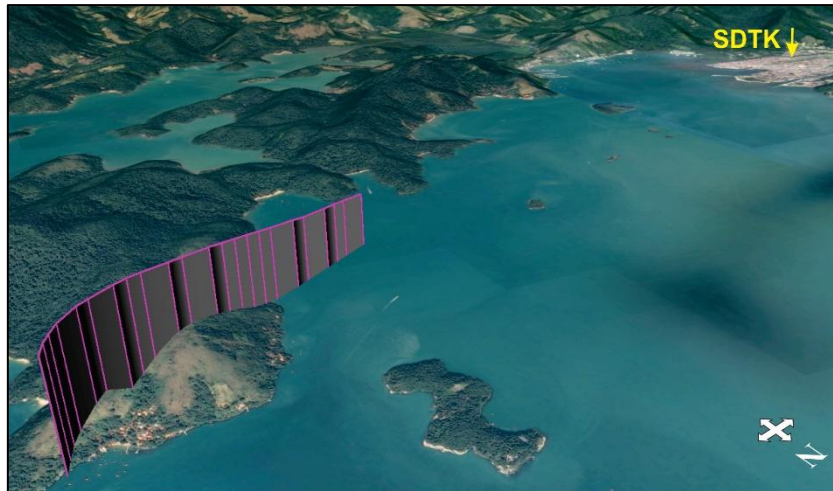
Figure 50 - Aircraft trajectory profile during the first approach attempt, according to aircraft EGPWS data.

The landing gear was lowered when the aircraft was at 1,570ft altitude. Subsequently, there was a significant increase in the rate of descent (2,000ft/min), resulting in a Sink Rate alert which was inhibited by the pilot in the EGPWS equipment.

At 15:39:45 (UTC), at the end of the first trajectory recorded by the EGPWS, the aircraft was at 890ft altitude, with 161kt of ground speed and bow 234°

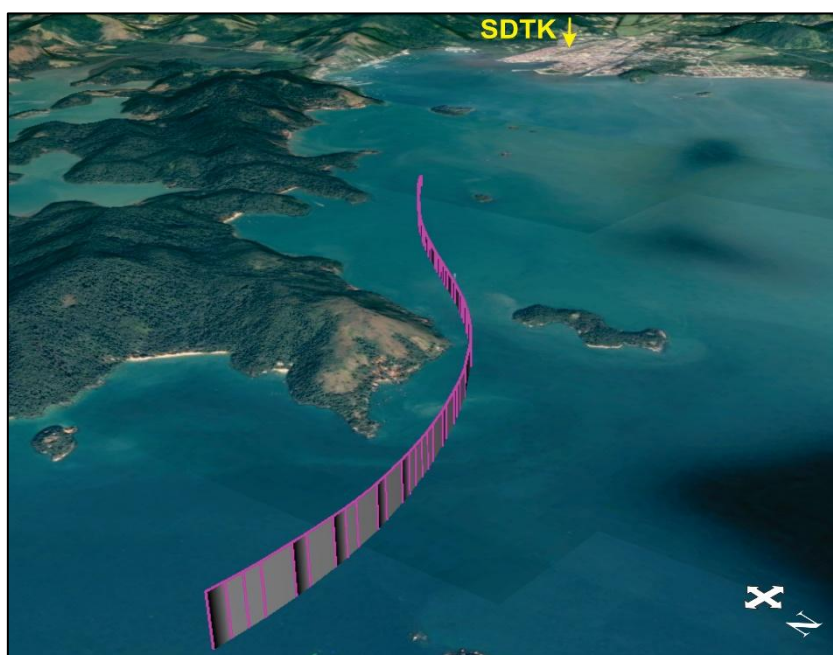
Figure 51 - Aircraft trajectory profile during the second approach attempt, according to the EGPWS data of the aircraft.

At 15:43:56 (UTC), at the end of the second trajectory recorded by EGPWS, the aircraft was at 270ft height, with 121kt ground speed and 236° bow.

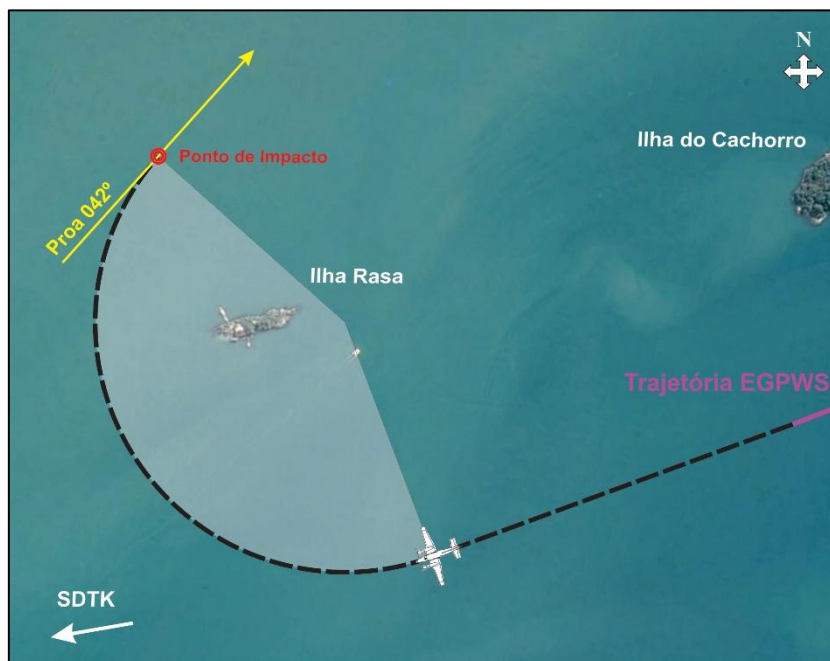
Figure 52 - Estimated aircraft trajectory between the last position recorded in the EGPWS and the point of impact.

By combining the data from the last position recorded by the EGPWS, with the bow of the aircraft at the time of impact, with the recorded audio in the CVR and with the reports of observers, the Investigation Team has elaborated a mathematical model that describes an estimated trajectory of the aircraft. In this estimated flight path, it was possible to infer flight parameters and the sequence of events until the moment of the impact (Figure 52).

The mathematical model adopted assumes a constant curve at the moment of impact, and the flight time of 31s from the last point recorded in the EGPWS. Thus, it is estimated that the aircraft started the curve at approximately 15:44:06 (UTC).

According to the Investigation Team's calculations, the curve started at approximately 15:44:06 (UTC), and the landing gear was retracted at 15:44:12 (UTC), suggesting that the go-around cockpit procedures were carried out simultaneously with the run of the curve.

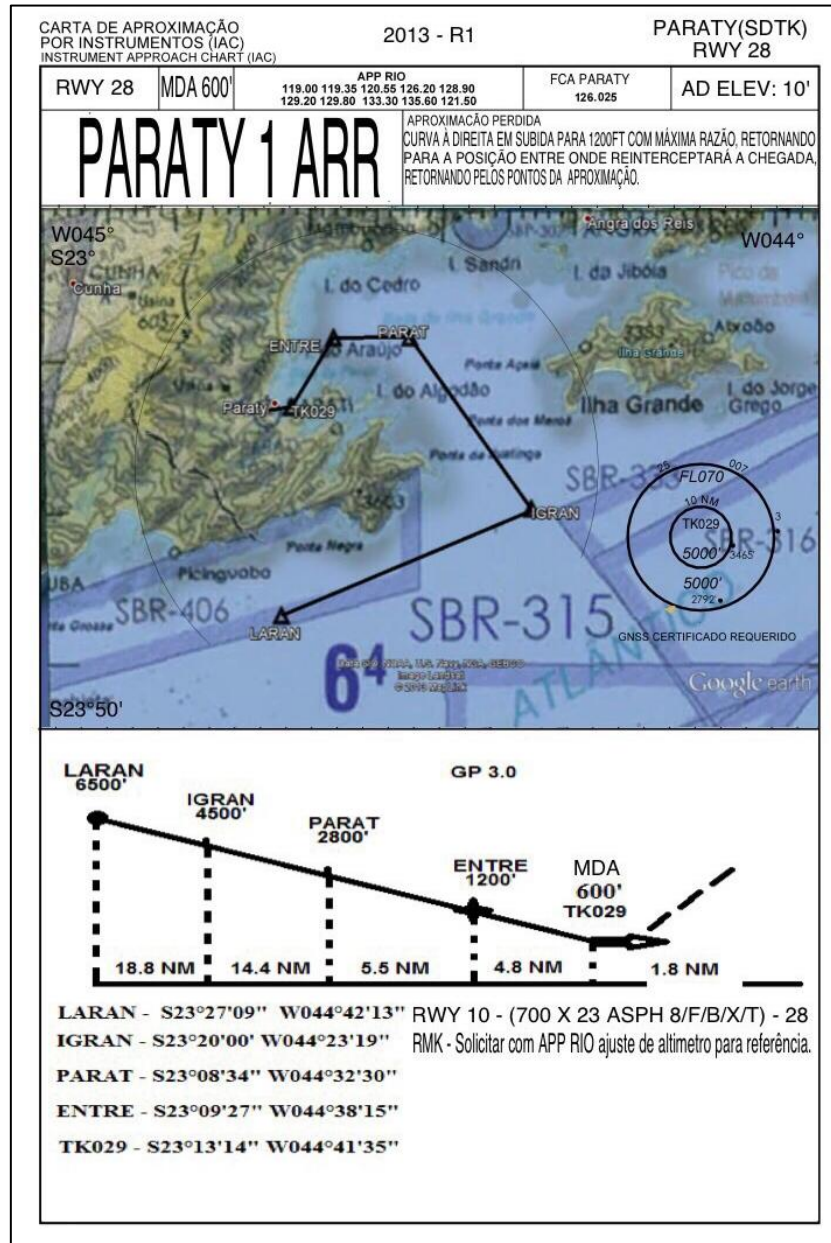
Figure 54 - Unofficial procedure "Paraty 1 ARR".

During the investigation, it was found that there was an unofficial instrument approach procedure, called "Paraty 1 ARR", which was used by pilots to perform descents under reduced visibility conditions at the SDTK Aerodrome (Figure 54):

Despite the fact that the pilot did not carry out the "Paraty 1 ARR" procedure, it should be pointed out that this type of procedure must be prepared by specialized technicians and in accordance with international safety standards.

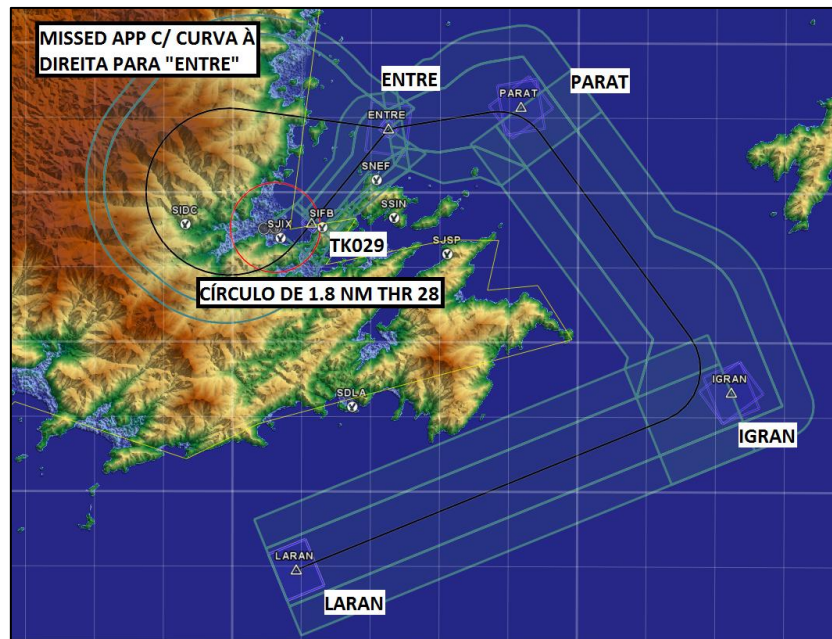
Figure 55 - Analysis of the unofficial procedure "Paraty 1 ARR" with the use of the FPDAM tool.

The evaluation pointed out that the procedure "Paraty 1 ARR" had several deficiencies, highlighting the most critical parameters, as follows:

- the change of direction between two initial approach trajectories was higher than the 90° limit (found 105°);
- the intermediate approach segment intercepted the final approach segment, through a fly-by curve, at an angle above the 30° limit (found 41.43°);

- the angle formed between the final approach segment and the runway alignment exceeded the limits for direct approach by 15° for aircraft categories A and B, and by 30° for aircraft categories C, D and E (found 45, 83°);

- the gradient of climb in the missed approach, based on the altitude values in the chart and the lack of indication of minimum value to be used by the crews, was lower than the minimum of 2.0% (found value of 0.65%), ;

- the Minimum Descent Altitude (MDA) value of 600ft displayed on the chart was less than the value found by analyzing obstacles in the final approach segment (1,010ft);

- the evaluation of the missed approach segment resulted in several terrain violations, suggesting MDA of 5,920ft, in disagreement with the MDA indicated in the chart (600ft); and

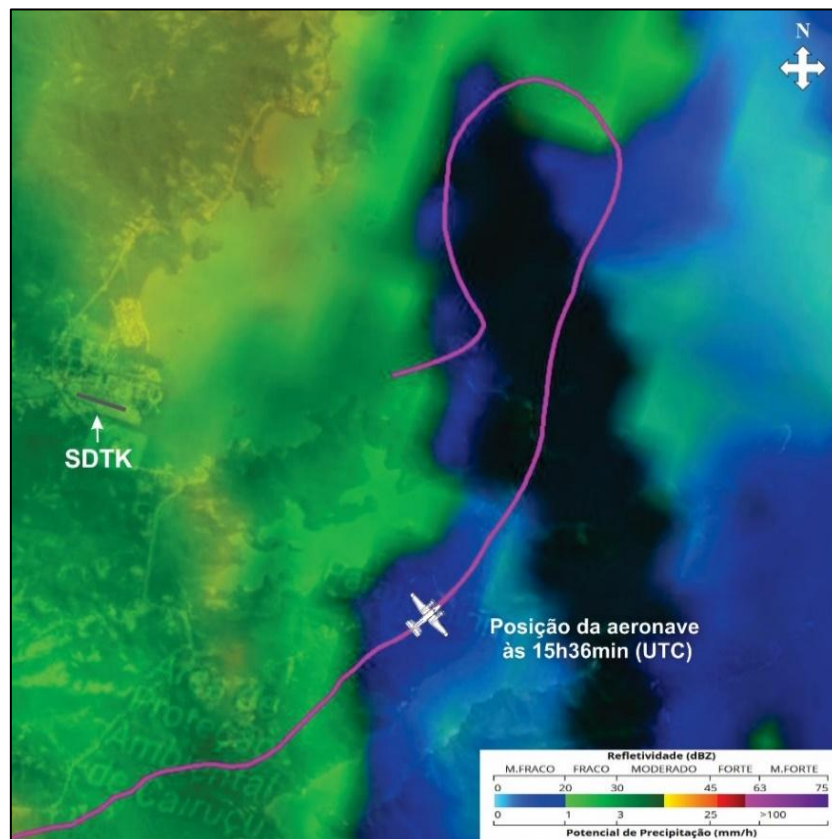
Figure 56 - PR-SOM descent trajectory in relation to meteorological formations recorded at 1536 (UTC) by Meteorological RADAR.

When synchronizing the air traffic control RADAR data with the Meteorological RADAR images from Pico do Couto, it was verified that, at 15:36 (UTC), the aircraft was descending, crossing 6,600ft (Figure 56), and performed a trajectory consistent with deviations from an area of rain located on the Paraty Bay.

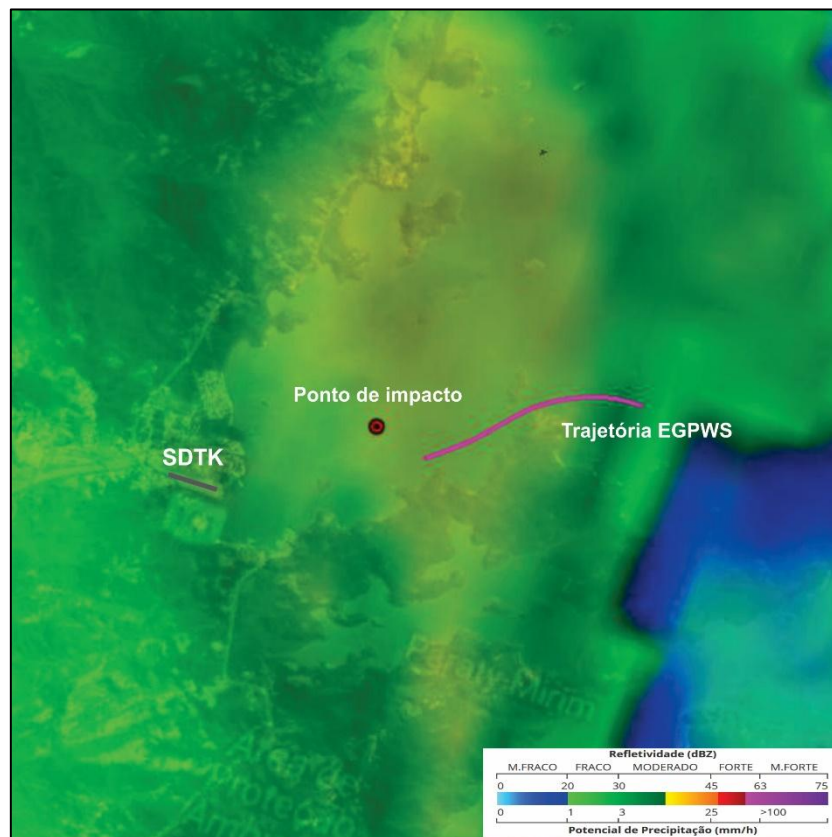
Figure 57 - Trajectory of the second attempt of landing of the aircraft, in relation to the meteorological formations registered at 1546 (UTC) by Meteorological RADAR.

When synchronizing the EGPWS data with the Meteorological RADAR images from Pico do Couto at 15:46 (UTC), recorded about one minute and thirty-four seconds after the impact time, there was rain with rainfall potential 25mm/h, covering the region of the trajectory recorded in the EGPWS and the location of the impact of the aircraft (Figure 57).

The analysis performed on the images of a security camera, positioned in the region where the impact of the aircraft occurred, estimated that the horizontal visibility, recorded at 15:46 (UTC), was 1,500m.

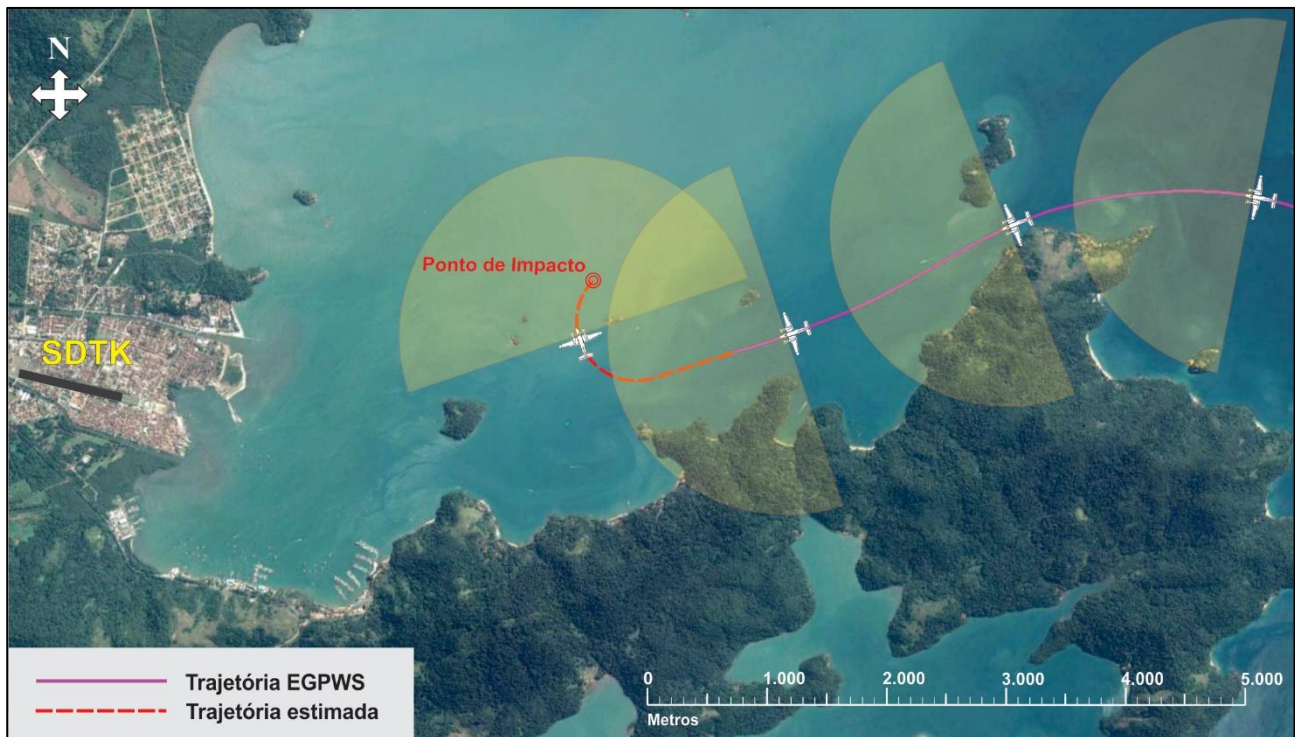
Figure 58 - Illustration of the pilot's visual range (estimated at 1,500m), in relation to the aircraft's trajectory (the aircraft is off-scale).

By associating visibility information of the region with the trajectory of the second attempt to approach and land the aircraft, it was verified that the visual field of the pilot was restricted and with few visual references of the ground that could allow his orientation.

This condition worsened, even more, in the final part of the EGPWS trajectory, when the pilot's visual range did not allow the identification of references at the front and he decided to make a right turn (Figure 58).
