FINAL REPORT ON INCIDENT TO M/S INDIGO AIRLINES AIRBUS A320
AIRCRAFT VT-ITF AT Mumbai ON 21/01/2017

| 14. Type of incident | : #1 Engine stall during take-off run |

M/s IndiGo Airlines A320 NEO aircraft VT-ITF (MSN 6860) operating the scheduled flight 6E-248 (Mumbai to Delhi) was involved in an incident at Mumbai (VABB/BOM) on 21st January 2017. There were 165 passengers including six crew members on board the aircraft.

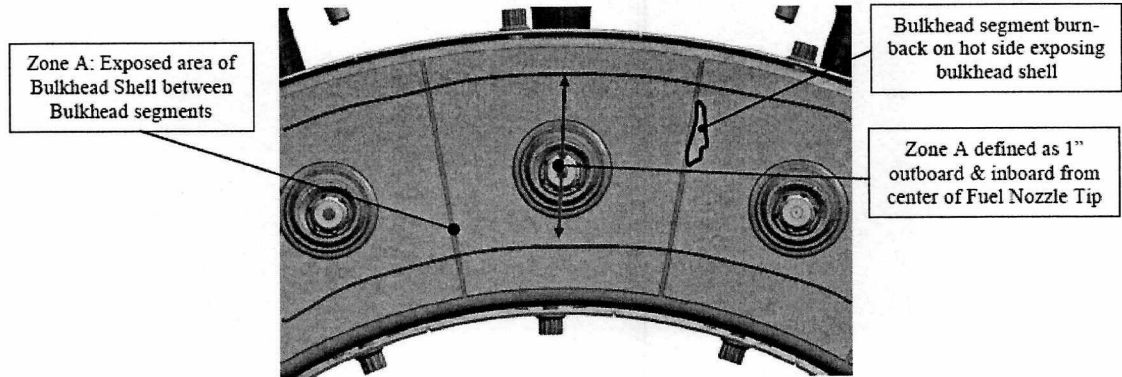
Figure 12: Bulkhead Shell Area Definition, Combustor Hood Removed for Reference - (Applies to cold side of part and hot side of part (shown))

1. Crack <0.750" within zone A (Bulkhead segment)

P&W Disposition: Any crack between 0.000 – 0.750 inch length maximum.

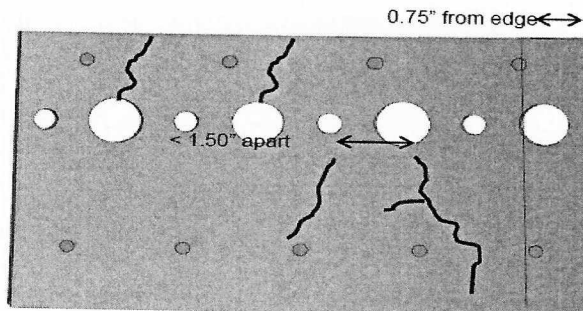
Figure 28: Rear Liner Panel – 750 EFH Interval

2. Crack is greater than 0.750" in rear Inner segment.

P&W Disposition: Cracks with a length of less than 2000 inches, separated by less than 1500 inches and more than 0.750 inches from the circumferential edge. Permitted for inspection interval of 750 hours.

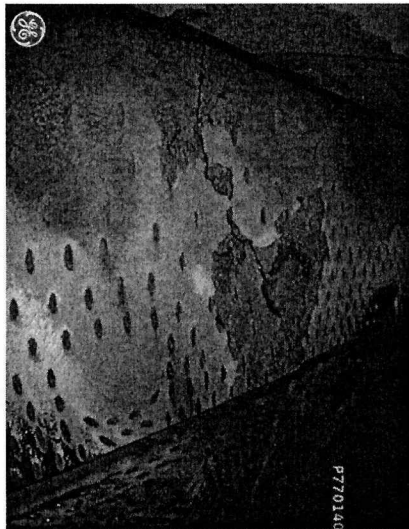
1. Observed crack greater than 0.750" in Outer Forward Segment & burnback less than 0.500" on Outer Forward segment.

P&W Disposition: Crack greater than 0.750 inch length maximum. Permitted for inspection interval of 350 hours. Also requires boroscope inspection of 1st HPT blades. Any burnback or burn – through less than 0.500 inch length maximum. Permitted for inspection interval of 1350 hours.

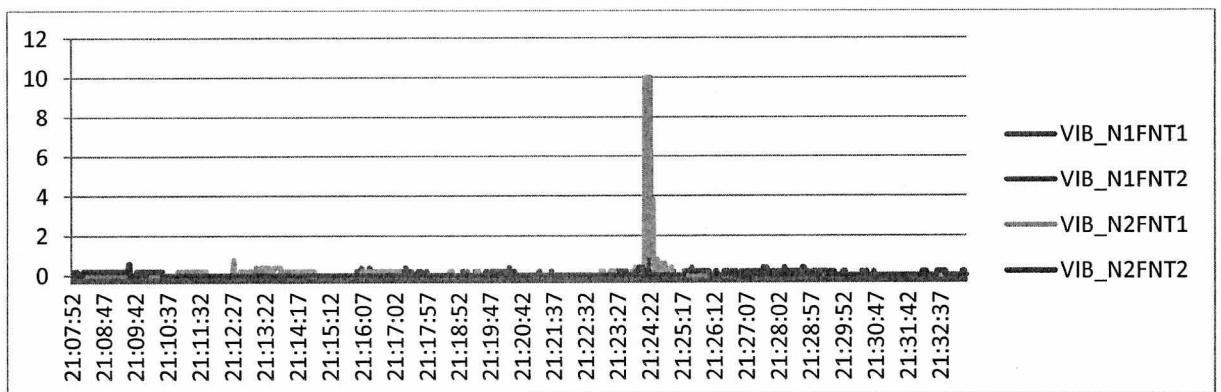
7. Maximum Vibration was recorded was 10, 1.2, 10, and 0.6 units on Eng1 N1, Eng2 N1, Eng1 N2 and Eng2 N2 respectively.
8. Maximum EGT 2 recorded was 851 degree C.

9. Maximum EGT 1 recorded was 998 degree C.
10. Aircraft vacated via E and returned back to bay.
