INVESTIGATION
REPORT
ON INCIDENT TO M/s GO AIRLINES
A320N AIRCRAFT VT-WGB

DUE
IN-FLIGHT SHUT DOWN AT DELHI ON
08TH FEB 2017.

**REPORT ON INCIDENT TO M/s GO AIRLINES (INDIA) LTD AIRBUS A320N AIRCRAFT VT-WGB AT
DELHI ON 08TH FEB 2017.**

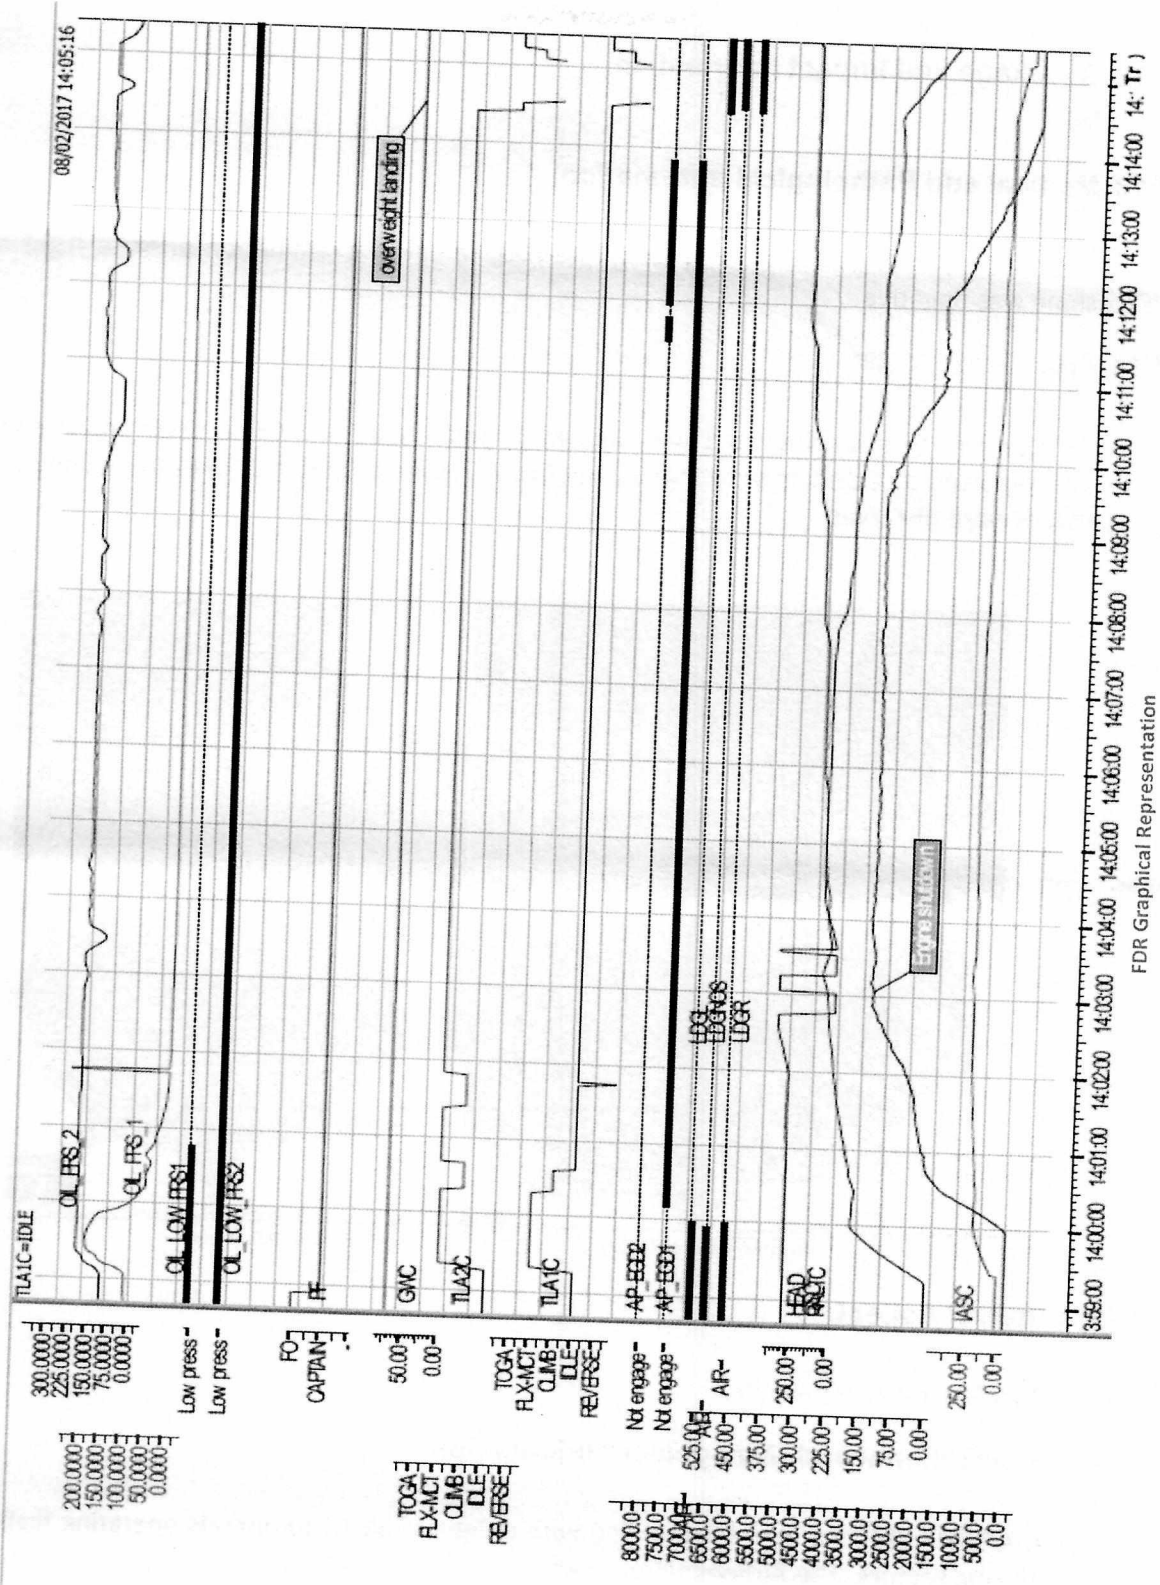
TIME (UTC)	EVENT
14:01:44	Take off Initiated; Oil Pressure E1/E2 – 163 psi/ 166 psi
14:02:05	Oil Pressure E1 starts to reduce; IAS – 108Knots
14:02:24	Lift off; IAS – 169 Knots; Oil Pressure E1/E2 – 97 psi/ 186 psi
14:02:26	Master Warning Triggered; Rad Alt 37 ft
14:03:03	Throttle E1 brought to Idle; E1N1/ E2N2 – 84%/85%; Rad Alt 1633 ft
14:03:11	Lo Oil Pressure (E1) triggered; Rad Alt 1787 ft
14:03:20	Eng#1 Shut Down; Eng#1 Master – ON; Rad Alt 1838 ft
14:03:35	Eng#1 Master – OFF; Rad Alt 1946 ft

The graphical representation of the flight is attached in the next page.
