AIRCRAFT ACCIDENT REPORT AND EXECUTIVE SUMMARY

Reference:	CA18/2/3/9615	
Aircraft registration	ZS-VDM	Date of accident	22 April 2017		Time of accident	0810Z
Type of aircraft	Bell 430 (Helicopter)		Type of operation	Private (Part 91)		
Pilot-in-command licence type	Commercial		Age	30	Licence valid	Yes
Pilot-in-command flying experience	Total flying hours		1 480.0		Hours on type	91.3
Last point of departure	Grand Central Aerodrome (FAGC), Gauteng Province					
Next point of intended landing	Spartan Helistop, Kempton Park, Gauteng Province					
Location of the accident site with reference to easily defined geographical points (GPS readings if possible)						
Spartan Helistop (GPS position; 26°07'20.0" South 028°13'02.0" East), elevation of 5516 feet AMSL						
Meteorological information	Surface wind; 360°/6kt, Temperature; 20°C, Dew point; 5°C, CAVOK					
Number of people on board	1 + 1	No. of people injured	0	No. of people killed	0	
Synopsis

AIRCRAFT ACCIDENT REPORT

Name of Owner : Quantum Leap Investment 572 (Pty) Ltd
Name of Operator : National Airways Corporation
Manufacturer : Bell Helicopter Textron
Model : 430
Nationality : South African
Registration markings : ZS-VDM
Place

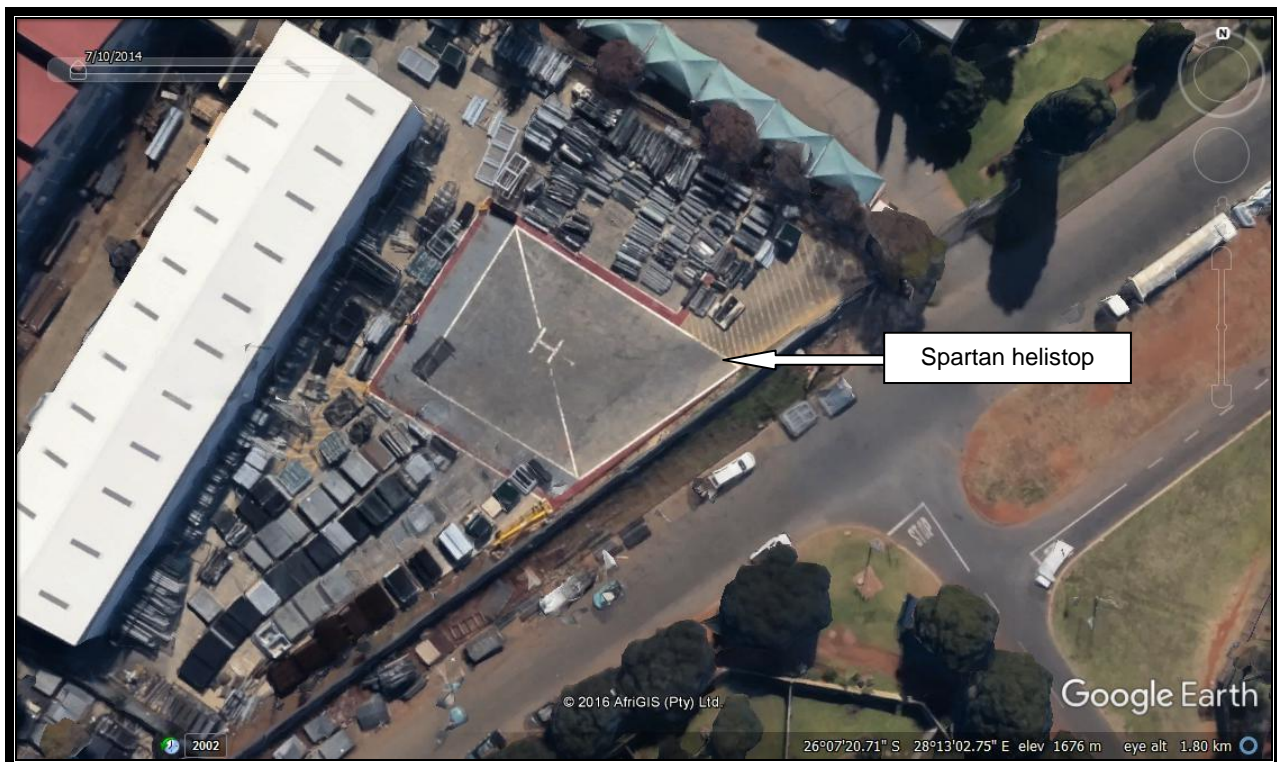
Figure 3: Google Earth overlay depicting the Spartan helistop.

This was an approved facility and the helistop directory (see Figure 6 on page 12 of this report) was published on the regulating authority's website. The helistop dimensions were 20 m in width and 25 m in length. The helicopter main rotor diameter was 12.80 m and its overall length 15.80 m. The helistop was surrounded by staggered steel products as well as a roadway on the one side. The surface had a slope to the one side to assist with water drainage, this information was not contained in the helistop directory, nor was the pilot made aware of such a slope by the passenger/pilot that flew with her. Even though the pilot made use of all the

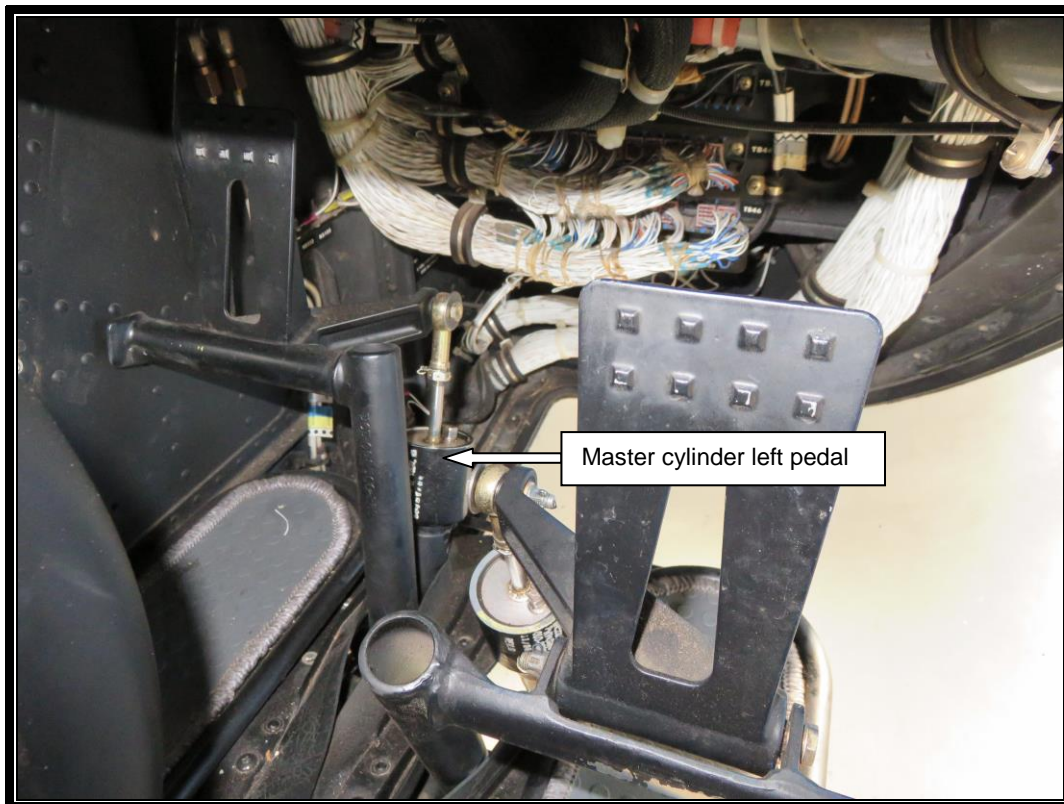
Figure 13: The anti-torque rudder pedals with toe brakes attached to the master cylinders

The pilot stated that although she had applied toe brakes, it had no effect in stopping the helicopter. She never asked the pilot that was seated next to her to apply toe brakes on his side, as these were two independent braking systems. Due to the damage suffered by the helicopter, this system could not be tested for functionality.

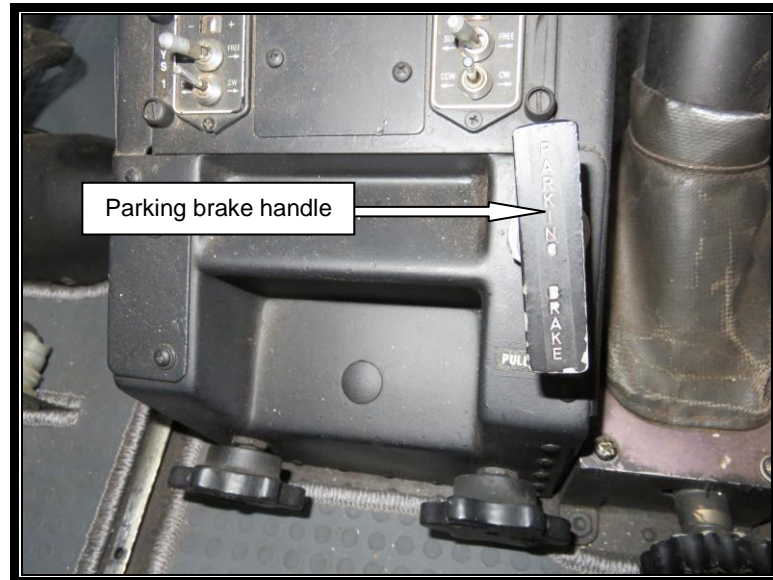
Figure 14: The parking brake handle

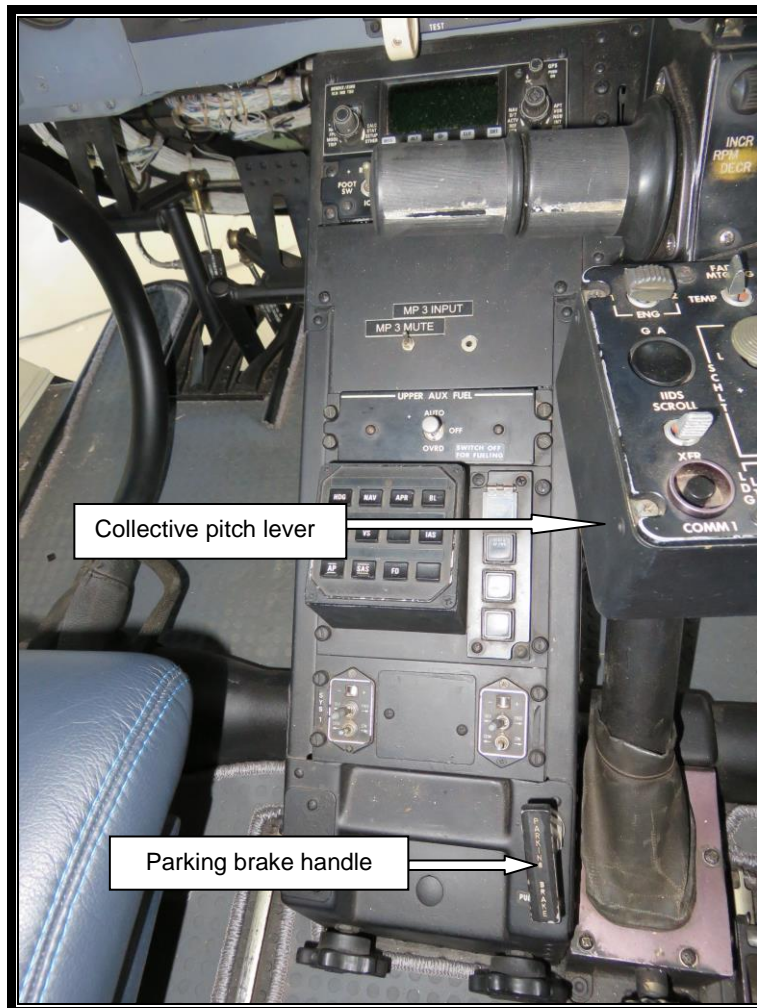
Figure 15: The parking brake handle next to the collective pitch lever
