**FINAL REPORT ON ACCIDENT**

**DIAMOND DA-42 AIRCRAFT VT-NFM**

**NATIONAL FLYING TRAINING INSTITUTE**

**ON 26/04/2017 AT GONDIA**

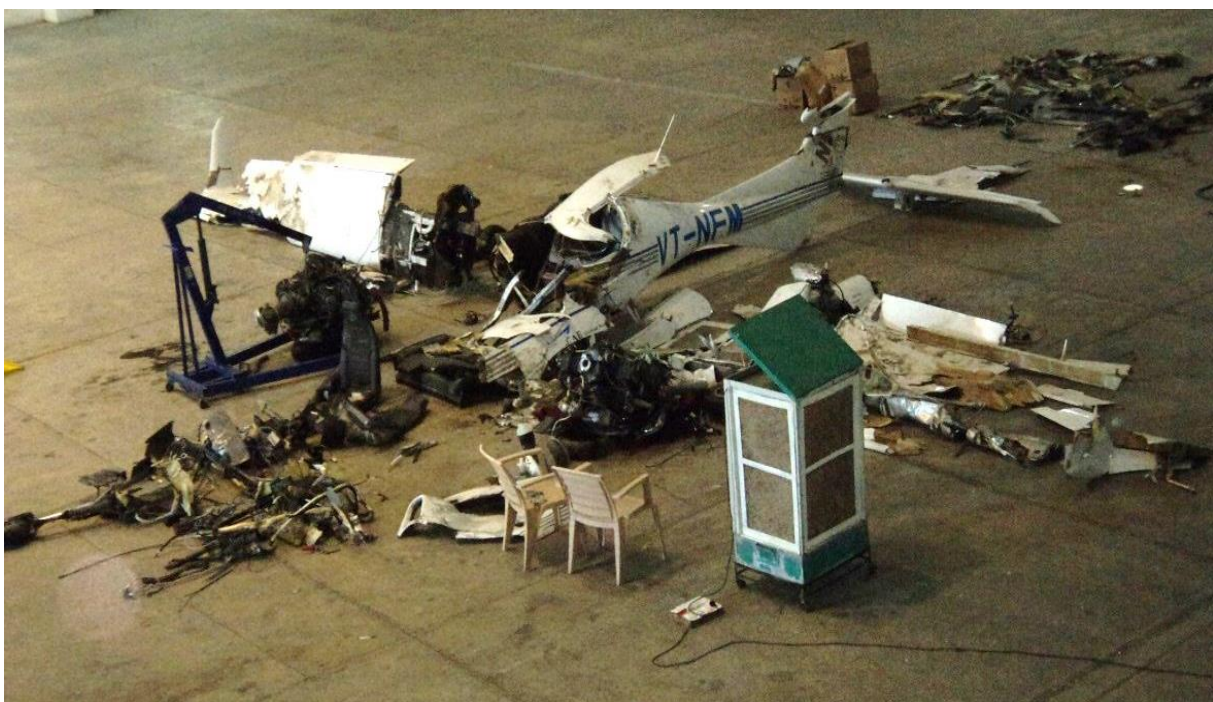
**Fig 7: Wreckage Layout at Gondia airport Hangar**

After impact the aircraft had disintegrated and scattered into mainly three major sections which were composed of main fuselage, engines and wings. The left wing was completely damaged and only fuel filler section along with fuel tank was recovered.

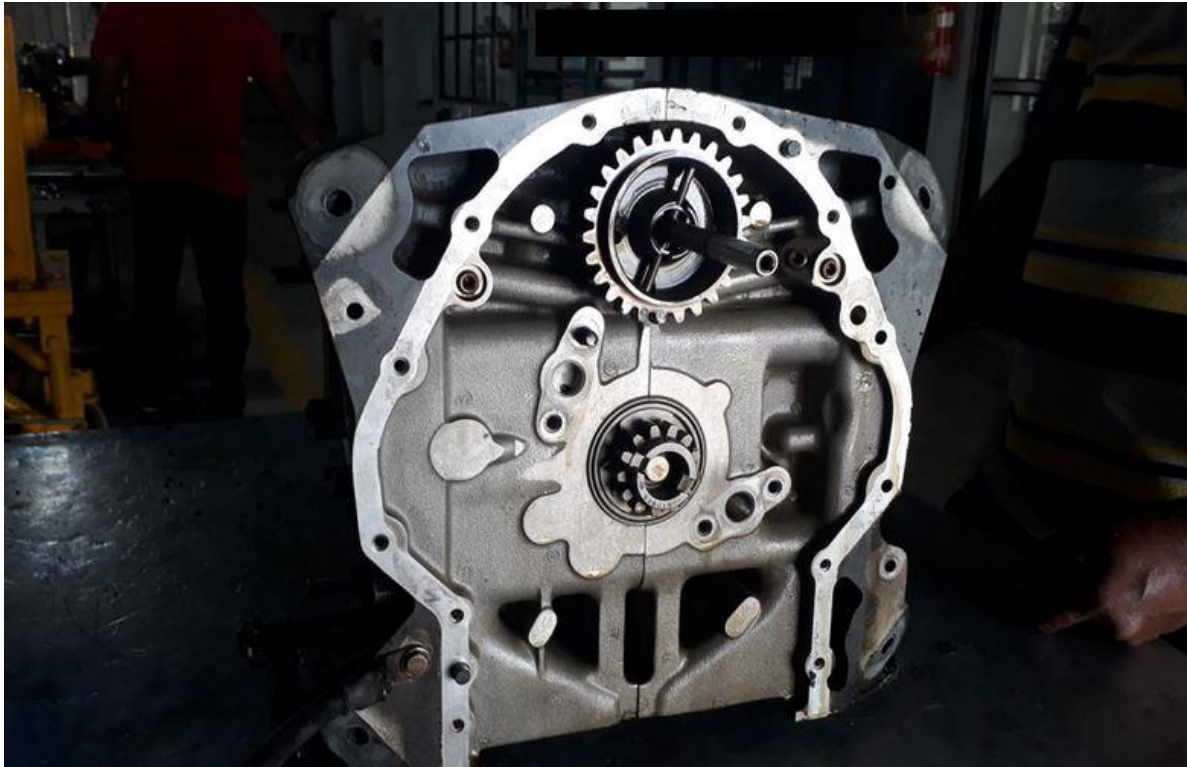
There was no visible sign of damage on the gears.

**Fig: 34: Gears**
