**FINAL INVESTIGATION REPORT**

**GROUND INCIDENT INVOLING M/S ETHIOPIAN AIRLINES  
AIRCRAFT ET-AMG AND M/S AIR INDIA AIRCRFT VT-EXD AT DELHI  
ON 08.08.2017**

**FINAL INVESTIGATION**  
**REPORT ON GROUND INCIDENT INVOLVING M/S ETHIOPIAN AIRLINES**  
**AIRCRAFT ET-AMG AND M/S AIR INDIA AIRCRAFT VT-EXD AT DELHI**  
**ON 08.08.2017**

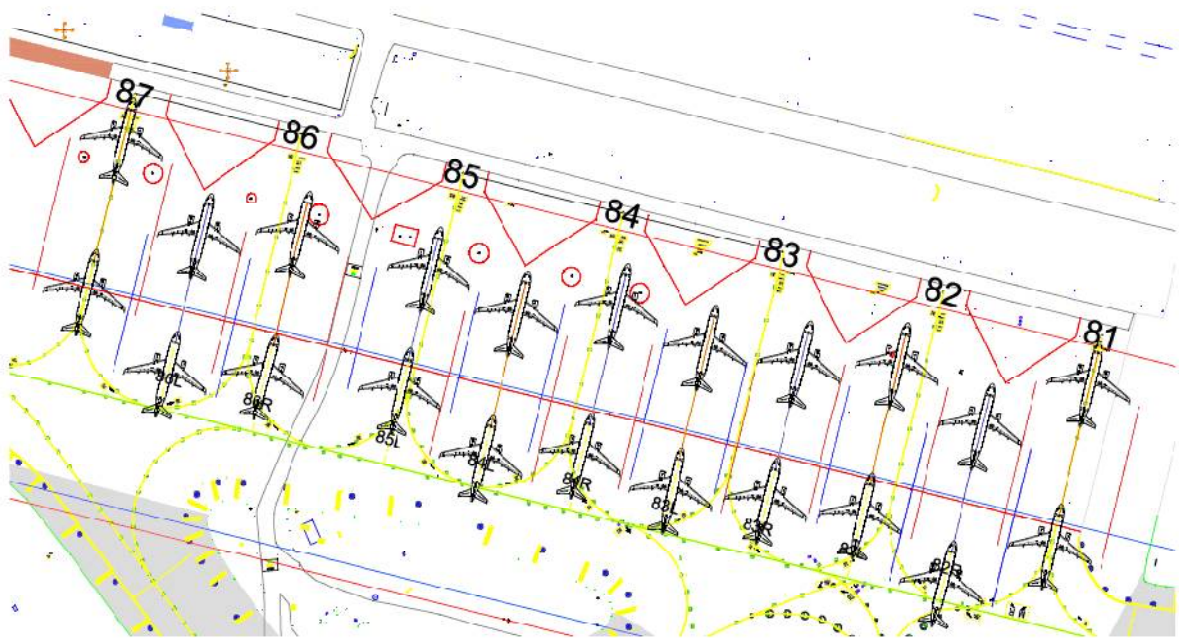
The Air India aircraft was parked on stand 86L. However after the occurrence, the Air India aircraft got displaced towards the port side. At the displaced position, the nose wheel found approx. 3'4" ahead of nose wheel marking and 5'1" towards portside from the lead line.

<b>Stand Occupied</b>	<b>Stand(s) Blocked</b>
82L	82
82R	81 and 82
83L	83 and 84
83R	82 and 83
84L	84 and 85
84R	84
85L	85
86L	86 and 87
86R	86

<b>Stand Occupied</b>	<b>Stand(s) Blocked</b>
81	82R
82	82R,82L,83R
83	83L,83R
84	83L,84R,84L
85	84L,85L
86	86L,86R
87	86L

T2 Remote stand layout (not to scale).
