# Air Accident Investigation Sector

- Final Report -

AAIS Case N°: AIFN/0010/2017

## Descent below Cleared Altitude during Approach and FMS not reconfigured following a reset during the Second Approach

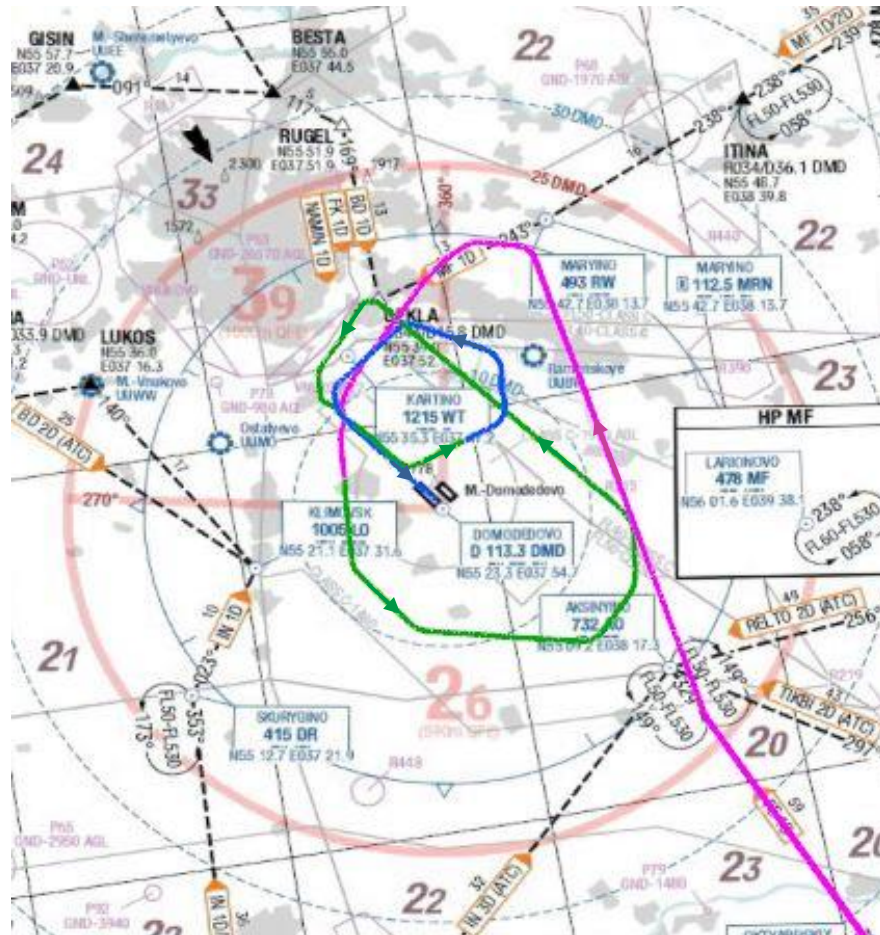
Figure 2 – Approaches and Landing attempts - UDD Runway 14R STAR Transitions Chart

The flight crew flew one go-around and one discontinued approach and landed on runway 14R from the third approach. The go-around, discontinued and landing are shown in figure 2. The trajectory in magenta depicts the first approach and go-around, the green line illustrates the second approach and discontinued approach, and the third approach and landing is shown by the blue line.

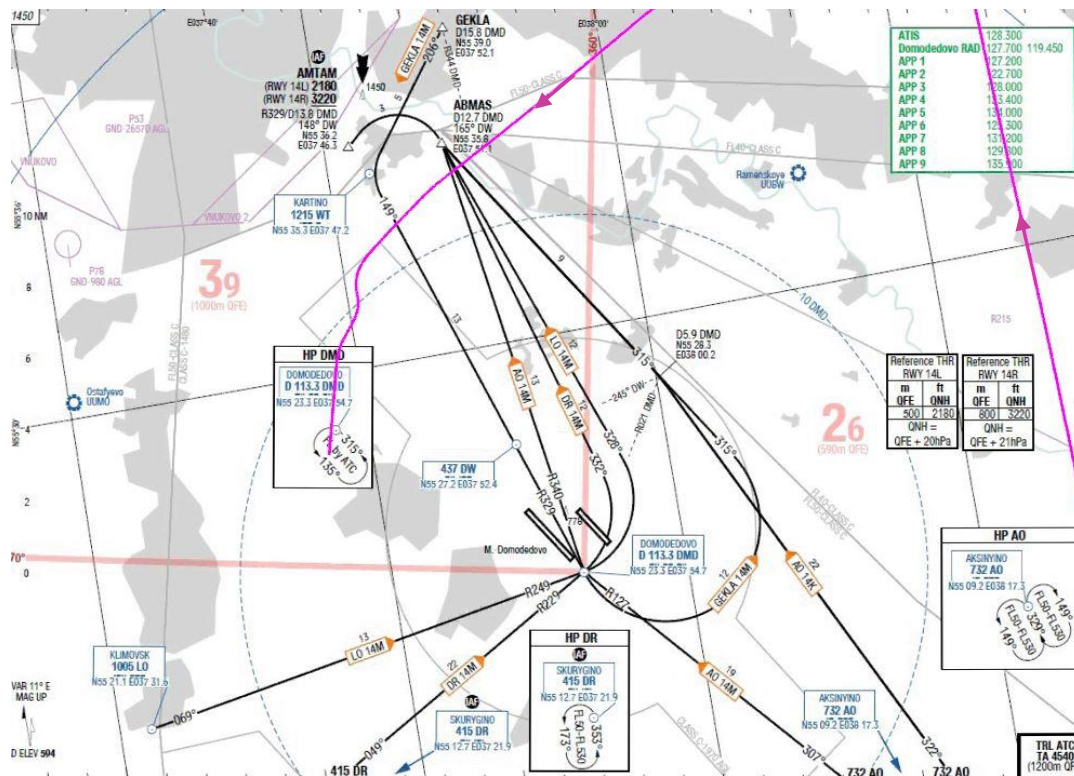
Figure 3 – First Approach and Go-around (magenta line) - UUDD STAR Runways 14L/R Chart

During the descent, the Radar Controller provided vectoring, which resulted in a wider compared to the standard arrival through the AO14K route due to traffic in the vicinity of UUDD (see figure 3). The Aircraft started to slow before the AO NDB waypoint. The selected airspeed was reduced gradually from 315 to 180 knots, as instructed by ATC.

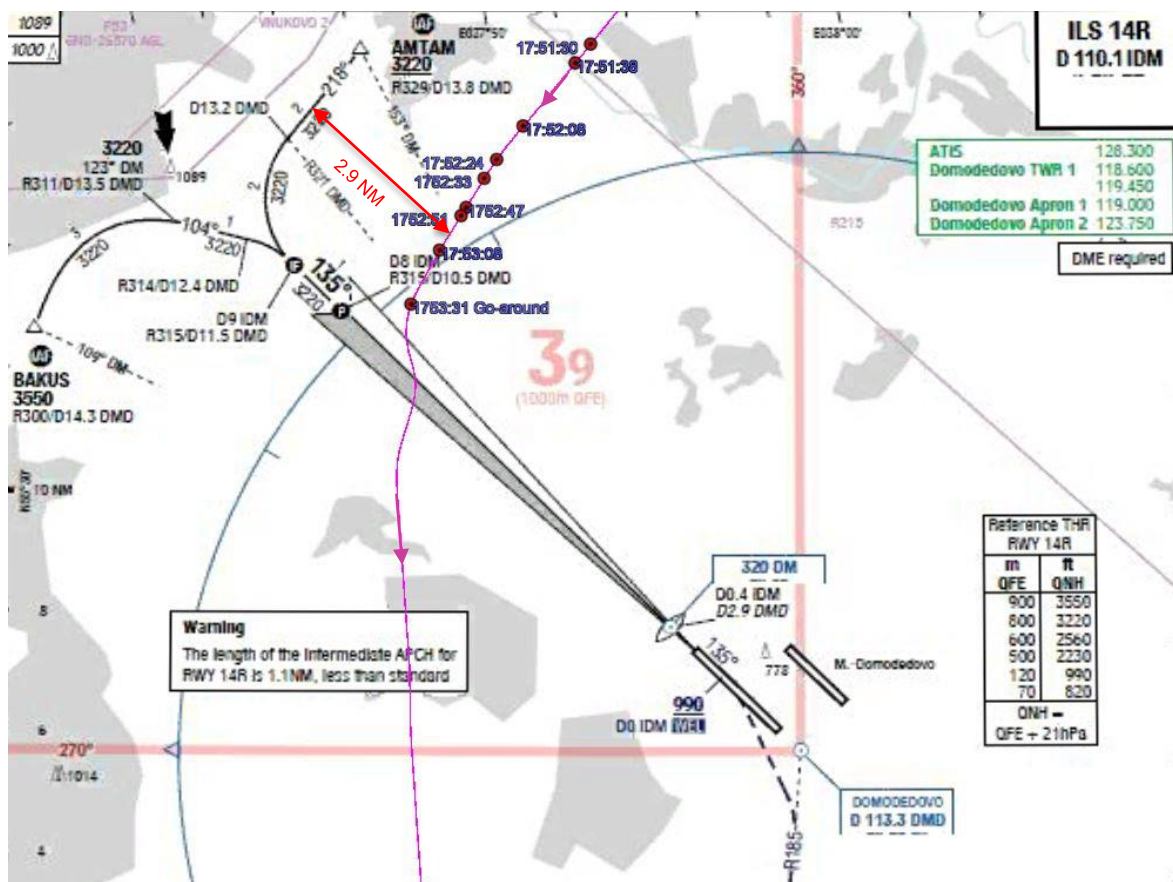
Figure 4 – First Approach and Go-around Flight Path on Instrument Approach Chart (IAC) for ILS 14R

The EGPWS alerts began with a two second “glideslope” caution, followed by a terrain awareness and display (TAD) “Terrain ahead-pull up” warning which lasted for six seconds and ended with a further EGPWS “glideslope” alert lasting one second. The minimum radio altitude reached was 395 feet above ground level, while the EGPWS alerts were active.

The vectoring for the approach resulted in a 2.9 nautical mile shorter flight track to the runway, compared to the track of the runway 14R ILS through the AMTAM waypoint (as shown in figure 4).

Before selecting the airspeed to 170 knots, the flight crew were concerned that they were being vectored inside the final approach point (FAP/ P). The vectoring brought the Aircraft 2.9 nautical miles closer to the runway threshold, compared to the ILS 14R approach chart (figure 4) distance.

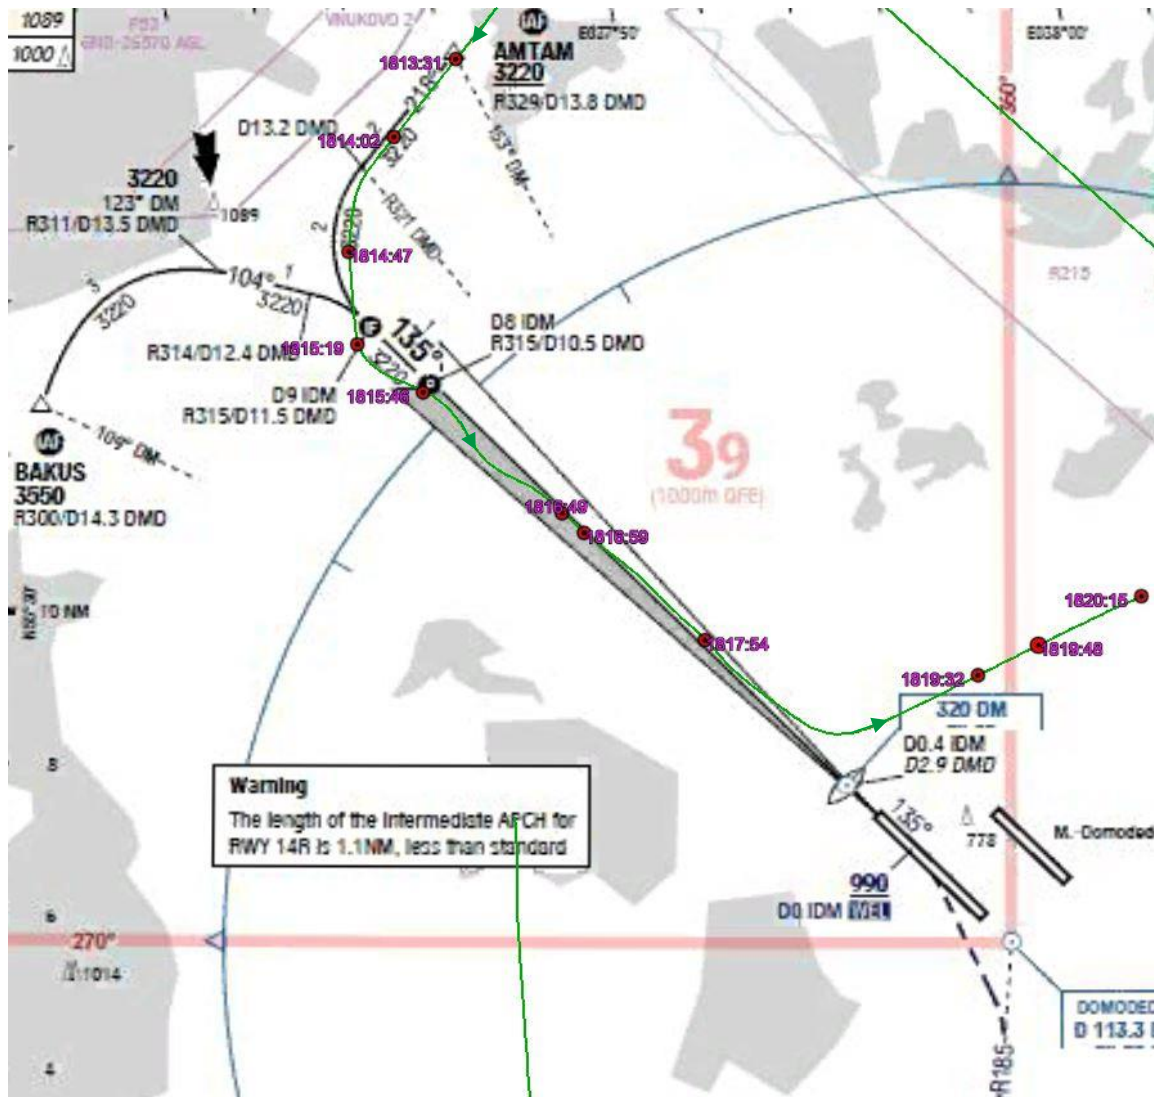
Figure 5 – Second Approach and Discontinued Approach Flight Path on the IAC Chart for ILS 14R

The radar vectoring for the second approach was such that the flight path passed approximately over position AMTAM, the IAF waypoint for the runway 14R ILS approach (figure 5). The Aircraft then flew through the IF and P<sup>9</sup> points before entering the final approach segment for the precision approach.

The lateral vectoring provided for the approach was almost the same track as the published instrument approach chart for the runway 14R ILS via the AMTAM waypoint (figure 5).

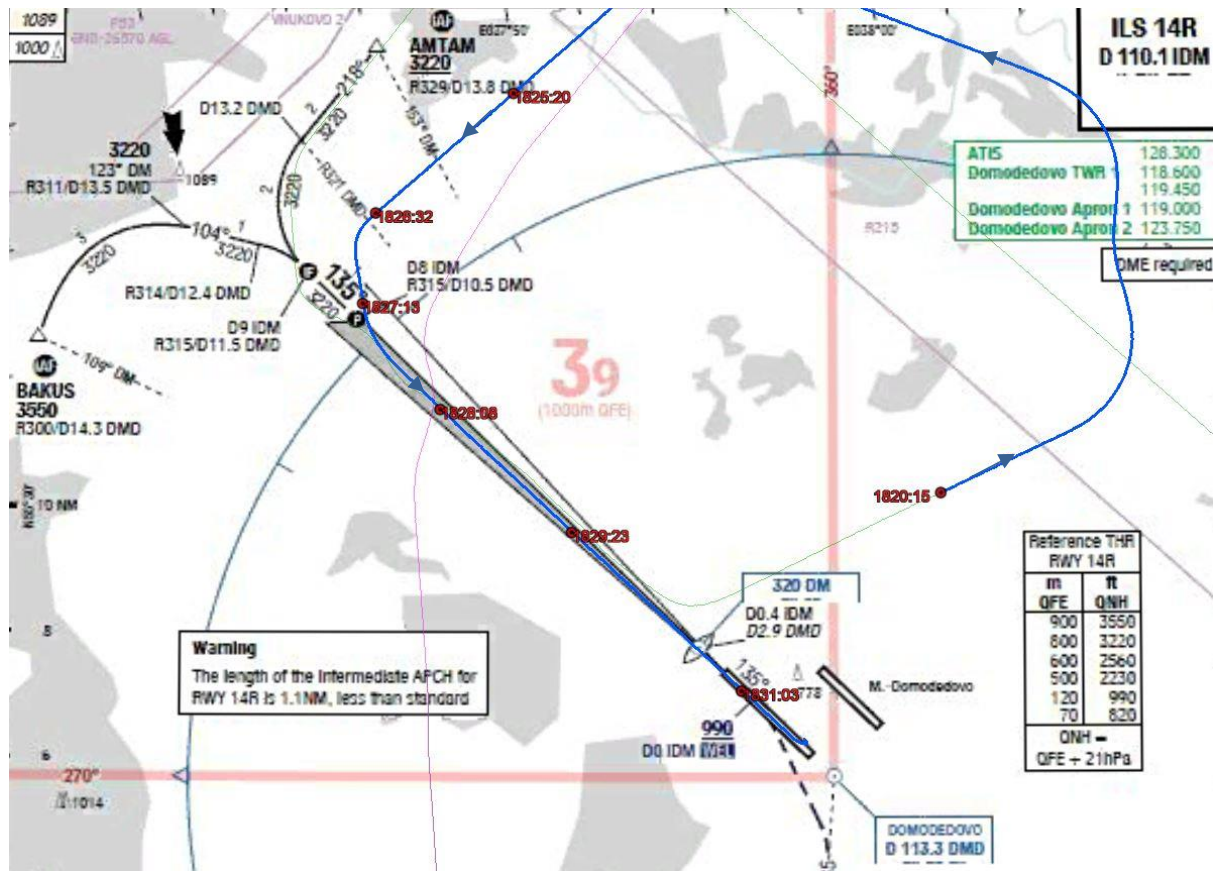
Figure 6 – Third Approach and Landing Path on IAC Chart of ILS 14R

The radar vectors provided for the third approach were such that the Aircraft flight path was as shown in figures 2 and 6. The Aircraft did not fly through the IAF point on the path given in the instrument approach chart (IAC) for the runway 14R ILS. Instead, the Aircraft flew closer to the runway on the base leg, on almost the same flight path as on the first attempted approach, but slightly further from the runway.

After switching the communication to Radar Control, the Radar Controller queried the flight crew as to the reason for the go-around. The Commander replied that the go-around was necessary, as the Aircraft was not stable on the approach. The Commander also requested radar vectors for the third approach, which were subsequently provided by the Radar Controller, as shown in figure 6.

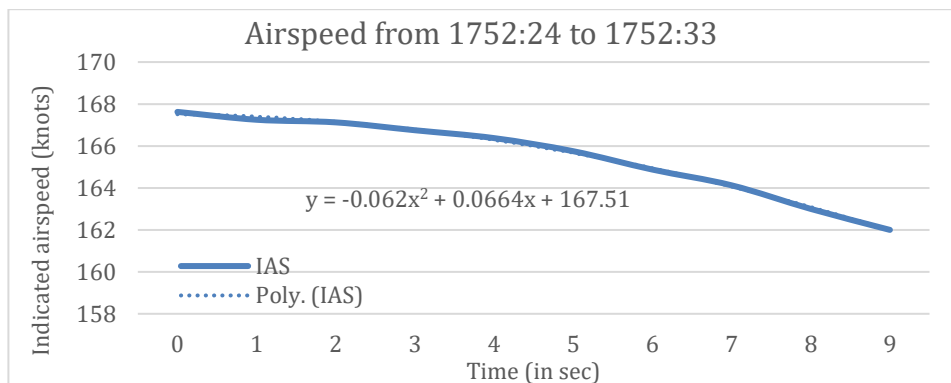
Figure 30. Second order polynomial of IAS

Figure 30 shows the equation for the indicated airspeed for the stated period as:

$$y = -0.062x^2 + 0.0664x + 167.51 \dots\dots\dots \text{(Equation 1)}$$

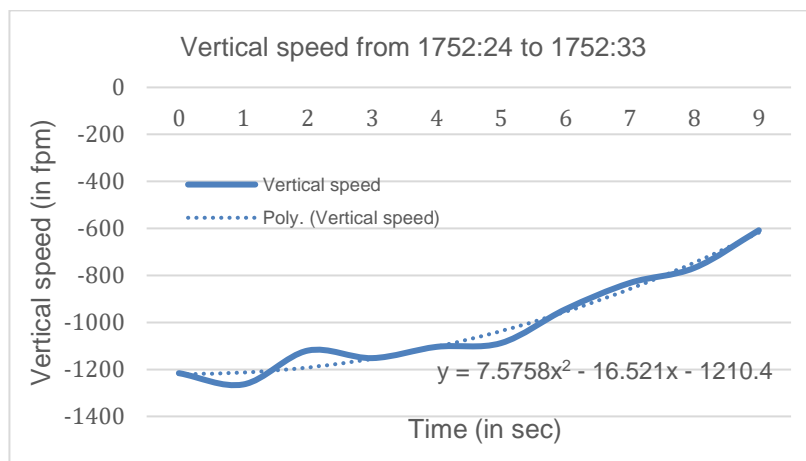
Figure 31. Second order polynomial of V/S

Figure 31 shows the equation for the vertical speed for the stated period as:

$$y = 7.5758x^2 - 16.521x - 1210.4 \dots\dots\dots \text{(Equation 2)}$$

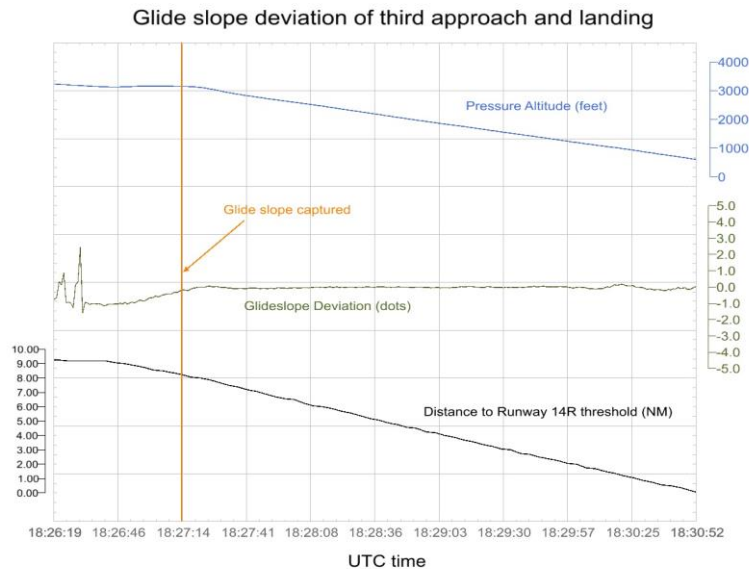
Figure 39. Glideslope deviation for the third approach and the landing

Figure 39 shows the proper glideslope deviation indication for the third approach.

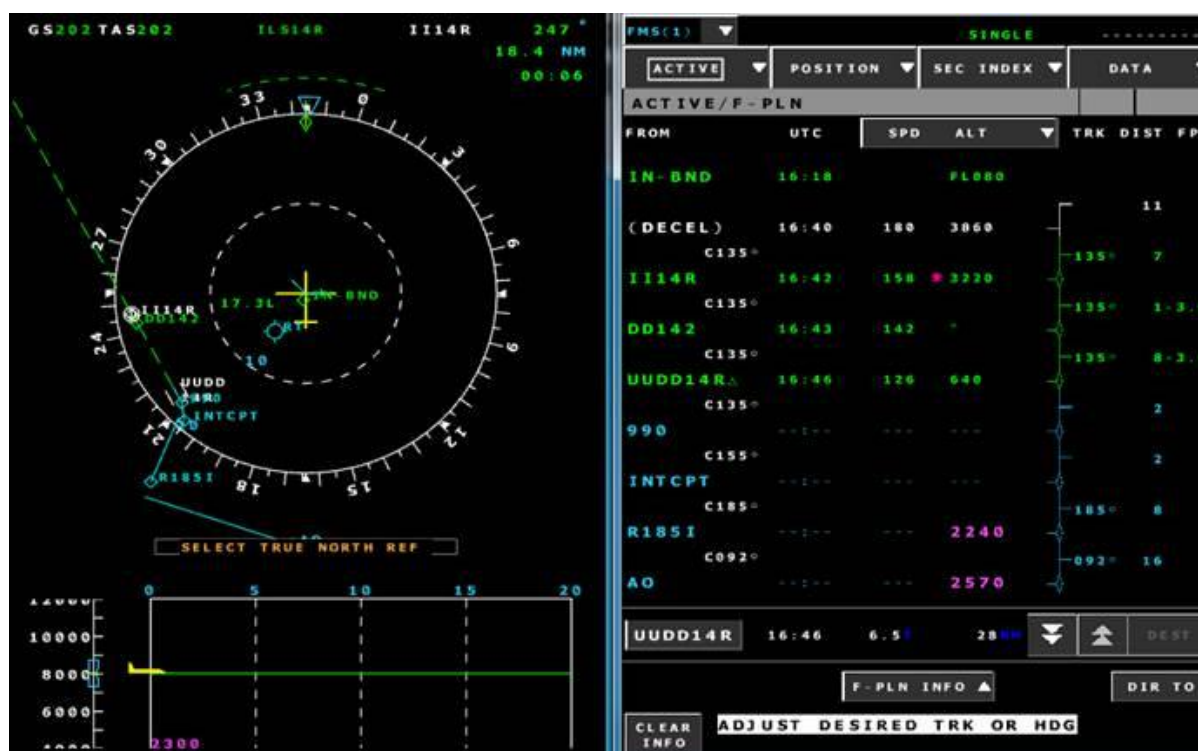
Figure A1.1 – Illustration of FMS flight plan displays on MFD and ND after selection of I114R waypoint using DIR TO CRS IN

At 1746:20, a lateral revision of the flight plan was performed by inserting I114R (IF) waypoint using the DIR TO CRS IN function from Commander side. The pressure altitude was 8,080 feet, and the airspeed just reached 180 knots. The FMS flight plan displays on the MFD and ND were as given in figure A1.1 below. The DIR TO CRS IN is a FM function used to help capturing the LOC (localizer).

The DIR TO CRS IN function was used to create a direct leg from the Aircraft present position to intercept an inbound course of I114R (IF) waypoint.

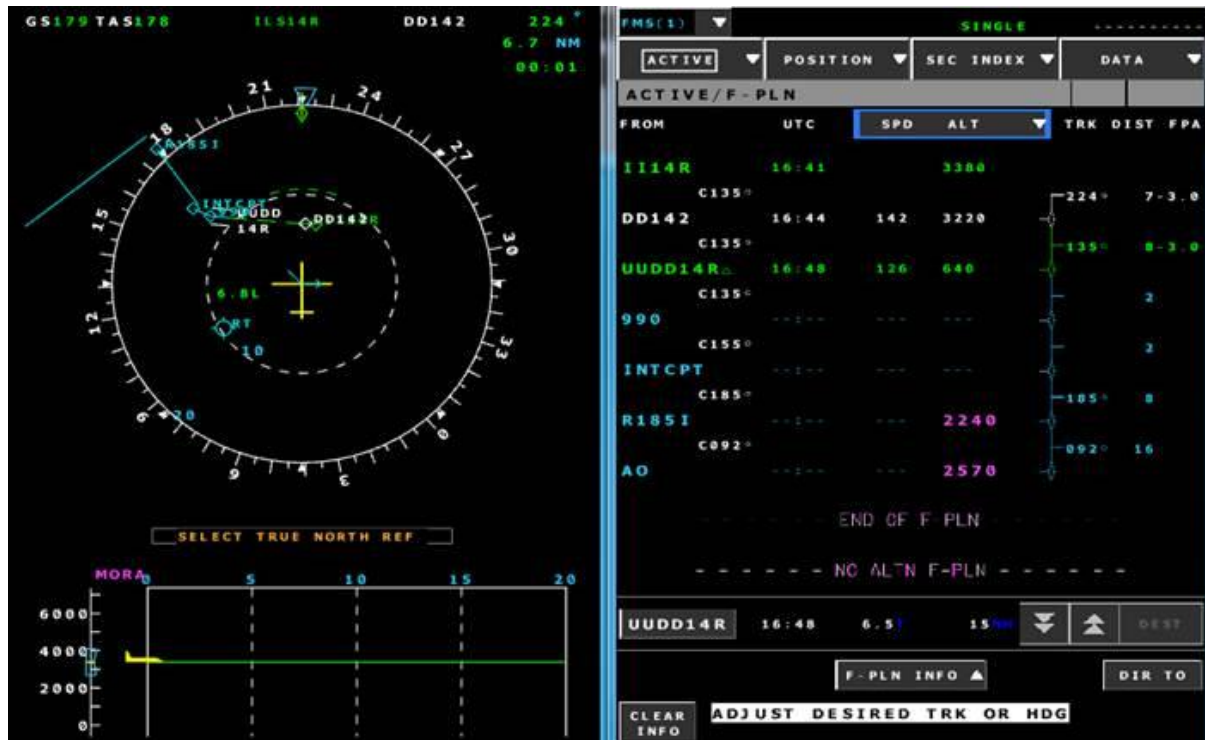
Figure A1.2 – Illustration of FMS flight plan displays on MFD and ND after II14R waypoint was sequenced

17:51:11 II14R (IF) waypoint was sequenced by the FMS. The Aircraft pressure altitude was 3,388 feet, and the airspeed was 170 knots. The Aircraft was at a distance of about 6.8 nautical miles from the extended runway 14R centreline.

At 1751:15, the indicated active waypoints were DD142 on the FMS flight plan as displayed on the MFD and ND (figure A1.2 below).

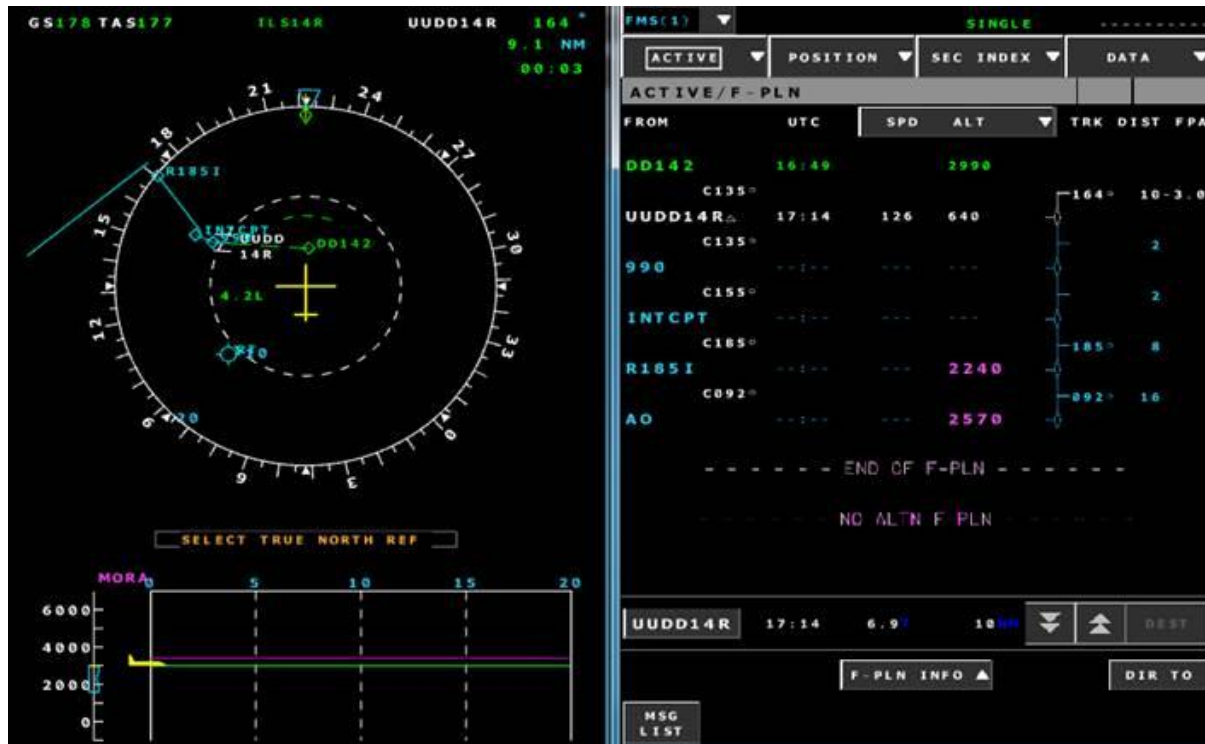
Figure A1.3 – Illustration of FMS flight plan displays on MFD and ND after DD142 waypoint was sequenced

At 1752:15, the indicated active waypoints were UUDD14R as displayed on the FMS (figure A1.3).

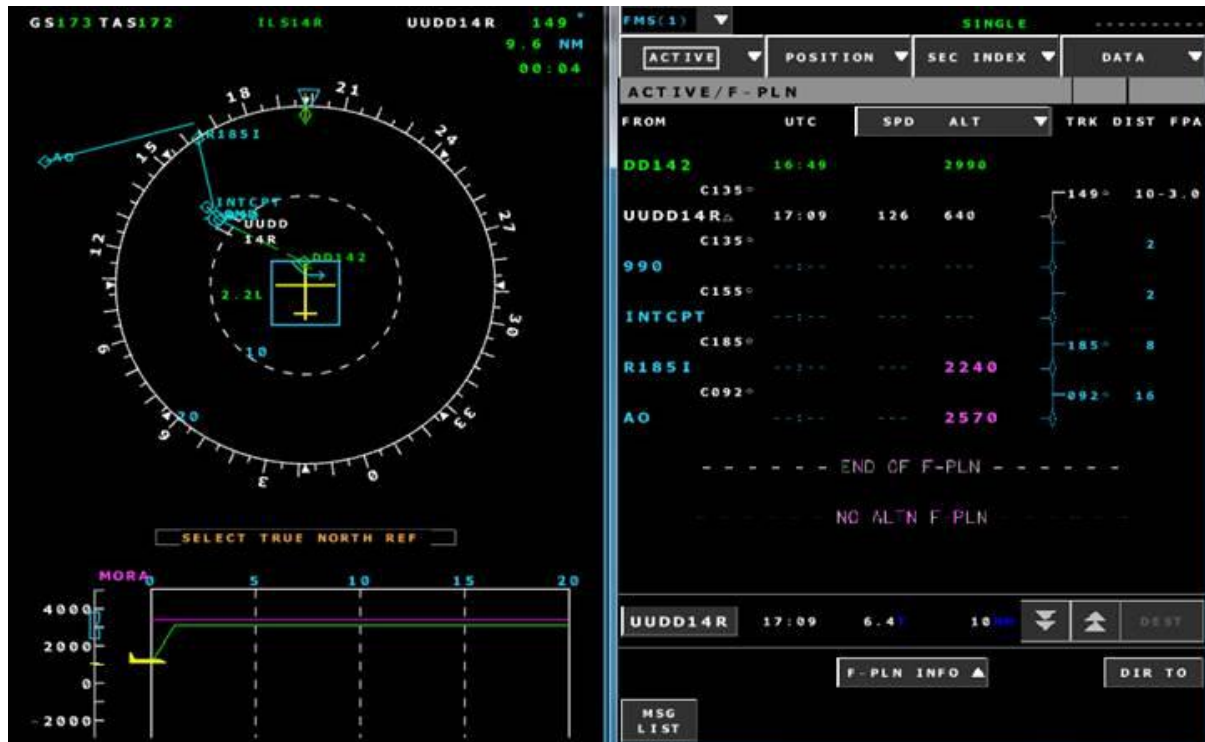
Figure A1.4 – Illustration of FMS flight plan displays on MFD and ND at the time of go-around activation

The figure A1.4 below illustrates the Aircraft position versus approach path at the time of go-around activation.

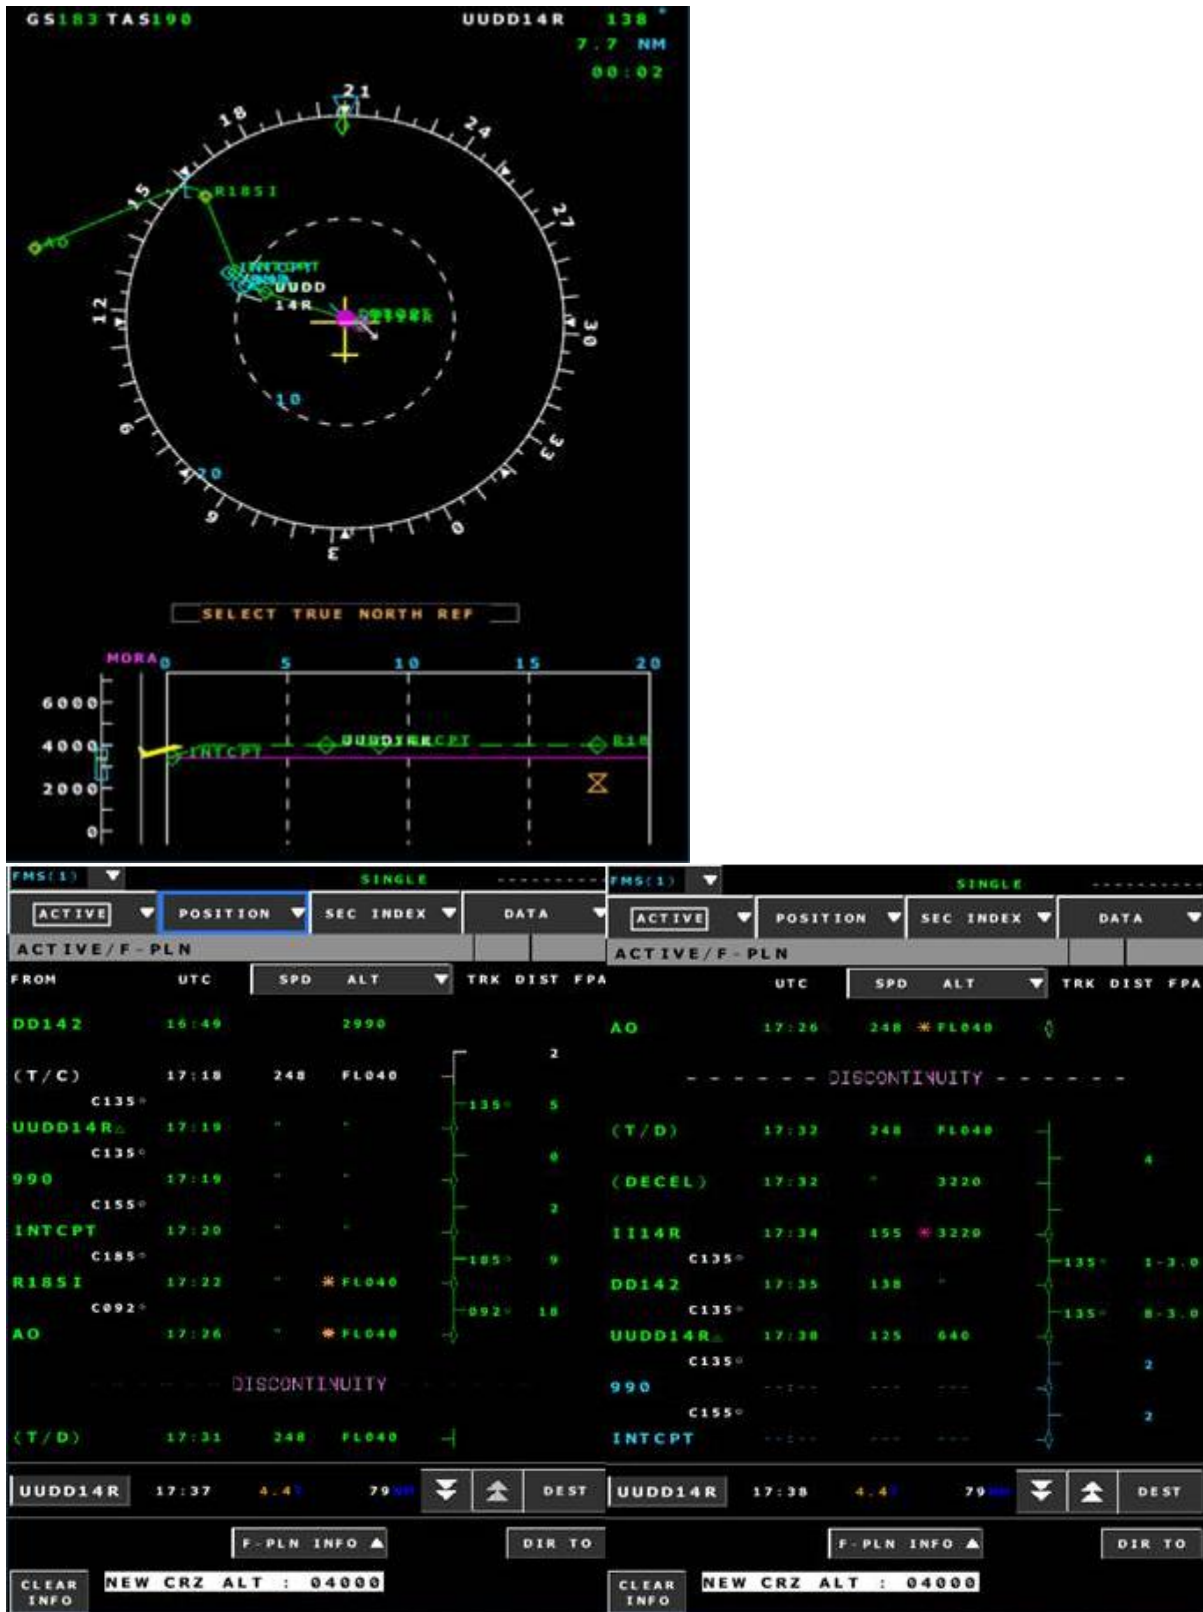
Figure A1.5 – Illustration of FMS flight plan displays on MFD and ND when previous ILS 14R approach was automatically re-strung into the FMS flight plan on go-around flight phase

The previous ILS 14R approach was automatically re-strung into the FMS flight plan on the go-around flight phase as shown in figure A1.5 below).

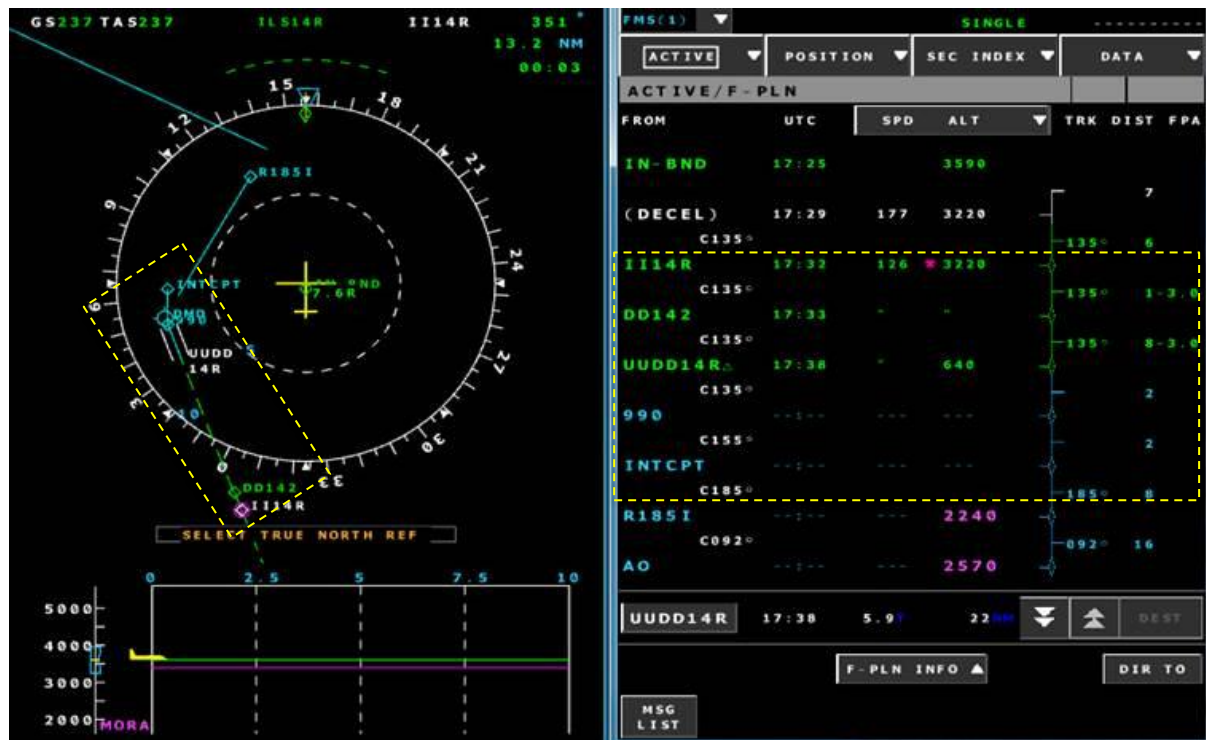
Figure A1.6 – Illustration of FMS flight plan displays on MFD and ND after selection of II14R waypoint using DIR TO CRS IN

According to the report from the Aircraft manufacturer and the FMS manufacturer/supplier, the supplier performed a desktop simulation. From the simulation, a partial reconstruction of the ND and the MFD flight plan pages based on the recorded data of FMS1 BITE was provided as shown in the figure A1.6.

The figure A1.6 below illustrates the displayed FMS on the ND and MFD of both side (Commander and Co-pilot side), after selection of II14R waypoint using DIR TO CRS IN.

At the time of DIR TO CRS IN function was performed, the Aircraft cross track position was more than seven nautical miles.
