DANSK UL-FLYVER UNION  
DANISH ULTRALIGHT FLYING ASSOCIATION

# ACCIDENT WITH OY- 9479 VL-3 EVOLUTION

16.October.2017

Location: AUDEBO, NORTH OF EKHK (HOLBÆK), DENMARK

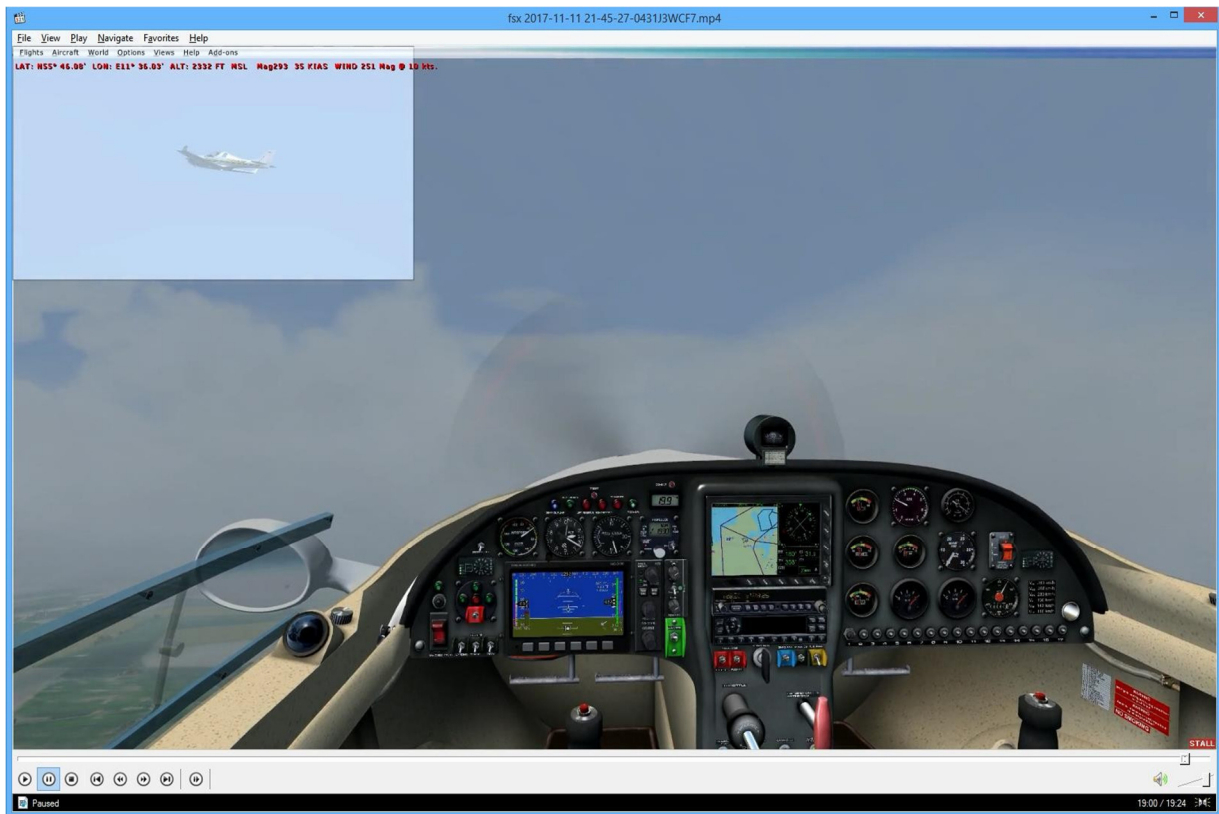
On the footage one can see that the aircraft performs a stall and that it in the stall drops a wing but is immediately corrected and brought back to normal flight.

The exercise is repeated and shows that the left wing drops. In this exercise it seems like the correction is rather abrupt, resulting in a right wing down condition.

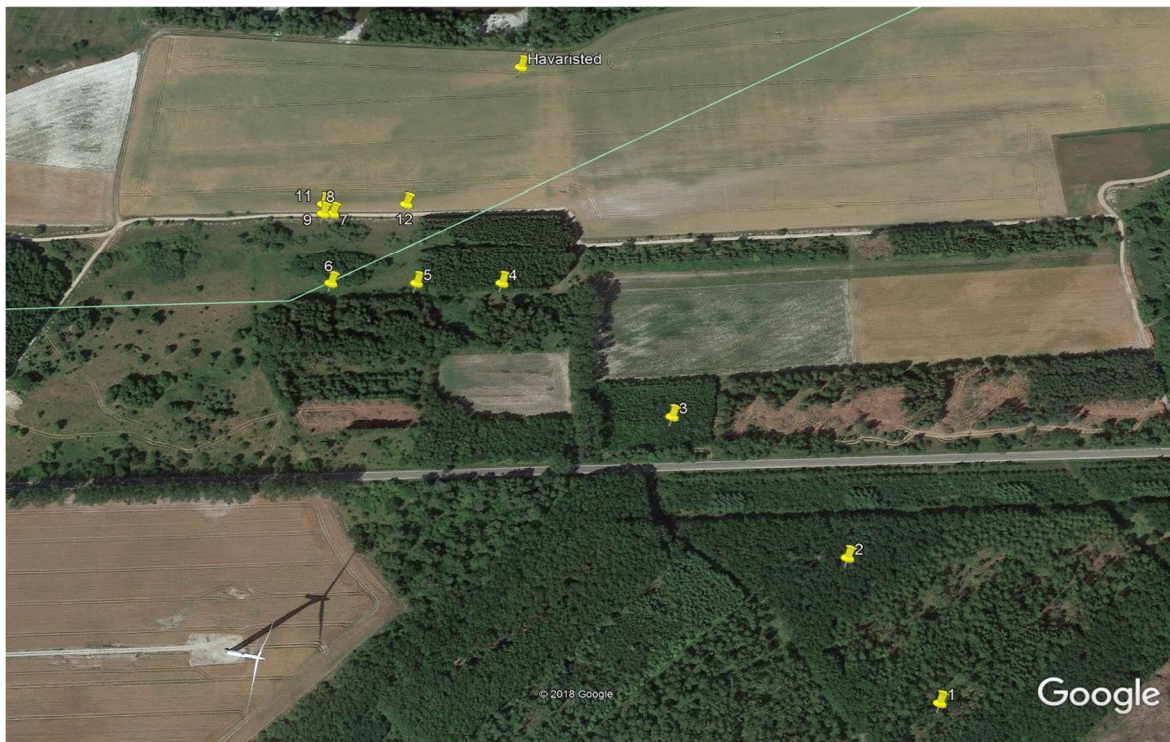
Location of the Impact Site with recorded GPS Coordinates
