AIRCRAFT ACCIDENT INVESTIGATION

FINAL ACCIDENT REPORT

HELICOPTER AS350 B3

REGISTRATION 5Y-NMJ

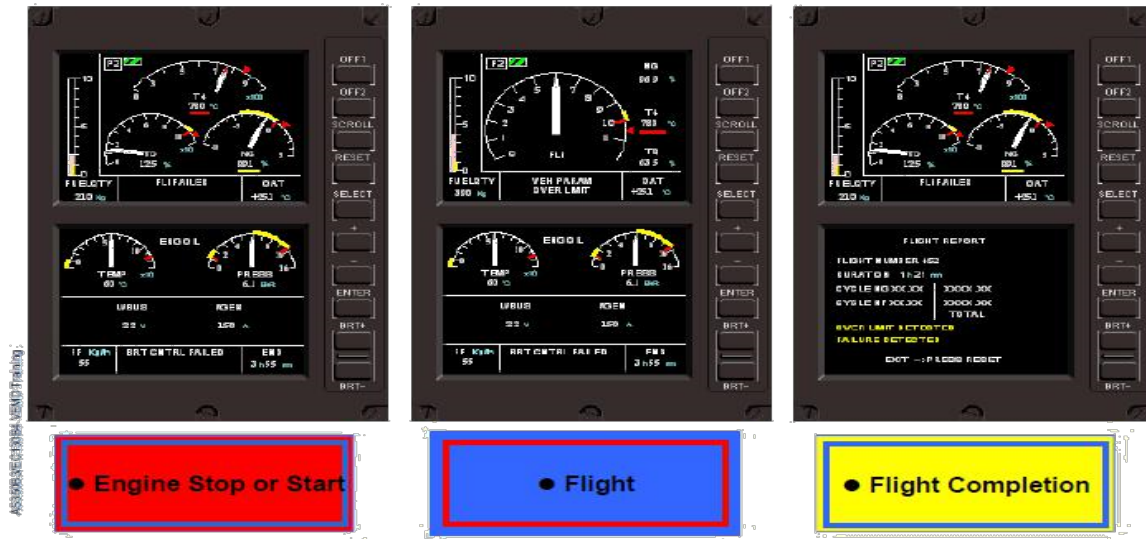
Figure 6; Graphs showing Central Panel Display System (CPDS) phases of operation.

The distinction between flight and end of flight status is determined by the following parameters.

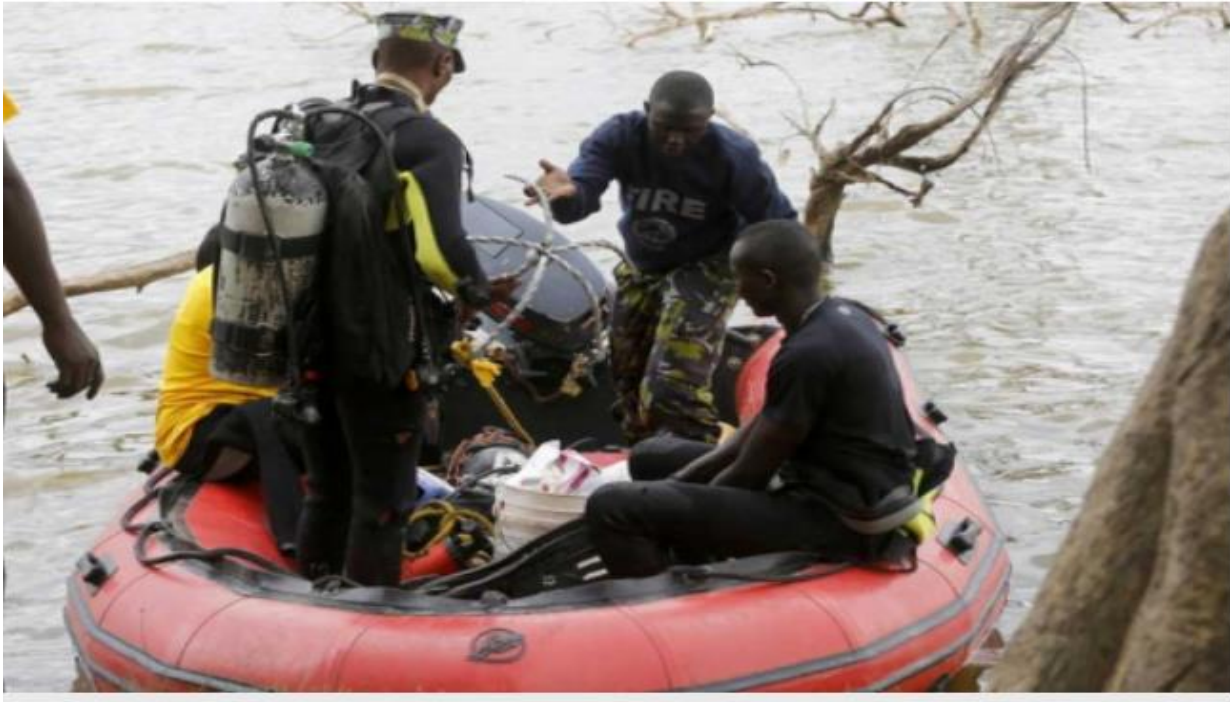
Figure 14: A photograph showing search and rescue team in the lake

1.15.1. Search and Rescue
