AIRCRAFT ACCIDENT REPORT AND EXECUTIVE SUMMARY

Reference:	CA18/2/3/9665	
Aircraft Registration	ZU-CIU	Date of Accident	18/11/2017		Time of Accident	1530Z
Type of Aircraft	Windlass Aquila		Type of Operation	Private (Part 94)		
Pilot-in-command Licence Type	National Pilot Licence (NPL)	Age	37		Licence Valid	Yes
Pilot-in-command Flying Experience	Total Flying Hours	108,2		Hours on Type	108,2	
Last point of departure	Potgietersrus Airport (FAQR), Limpopo Province					
Next point of intended landing	Microland airport, Gauteng Province					
Location of the accident site with reference to easily defined geographical points (GPS readings if possible)						
On the Mokopane mountains 7,8 nm from Mokopane town at the following GPS co-ordinates: S 24° 08' 31.3" E028° 52' 42.9" elevation 5655 ft						
Meteorological Information	Wind direction: 320°, wind speed: 05 kts, temperature 27,6 °C, dew point: 5.5 °C, visibility: 10 km					
Number of people on board	1+1	No. of people injured	1	No. of people killed	1

Name of Owner /Operator : Daniels N.R.J.
Manufacturer : Solo Wings CC
Model : Windlass Aquilla
Nationality : South African
Registration Marks : ZU-CIU
Place : Mokopane, Limpopo Province
Dat

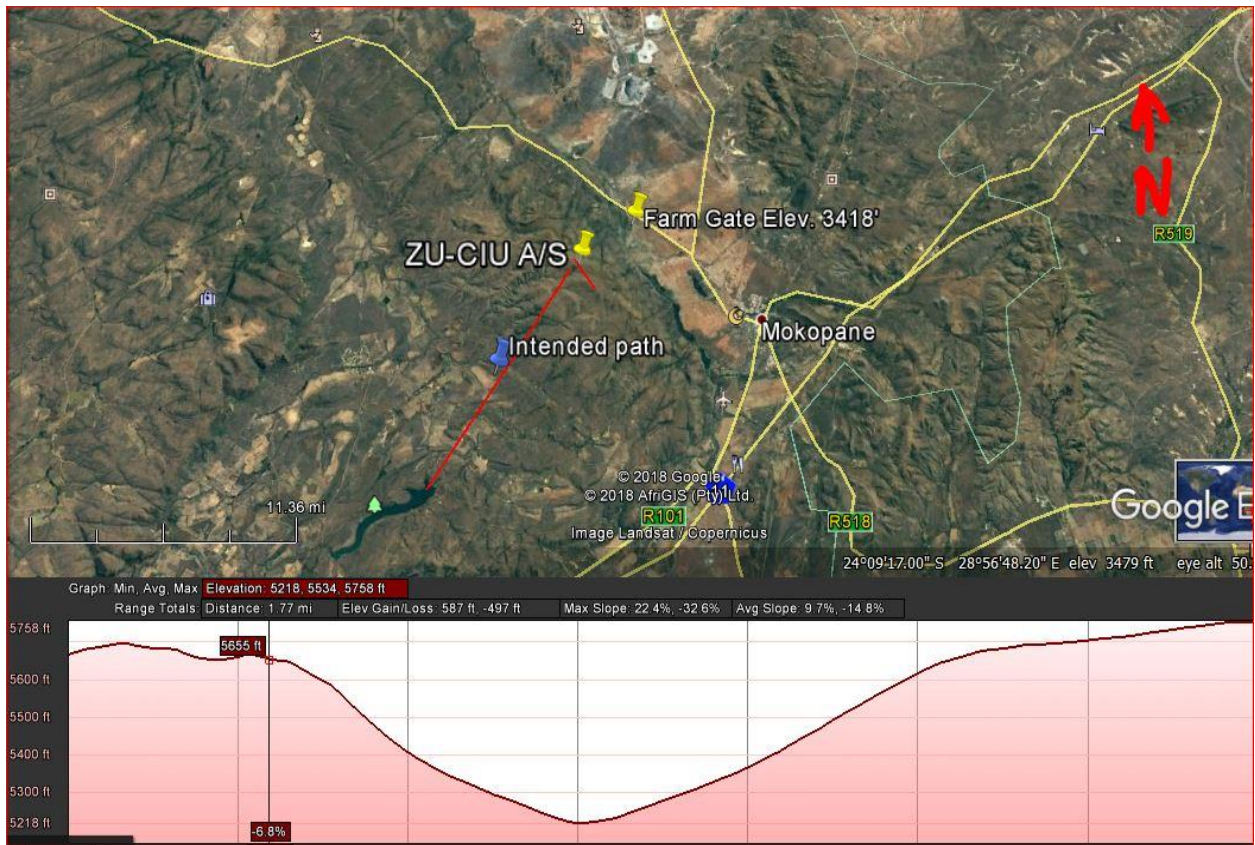
- 1.1.6 The SANDF was not available for the Investigator and therefore could not reach the accident site. It happened on a mountain in Mokopane with the following coordinates: GPS S 24° 08' 31.3" E028° 52' 42.9", elevation 5655 ft. It was a clear day without clouds at the site.

Figure 1: Cross section of valley's elevation profile where the accident happened.
