Safety Investigation Report

Ref.:
AAIU-2017-11-19-01

**ACCIDENT
ULTRALIGHT ESQUAL VM 1C
AT LANDEGEM
ON 19 NOVEMBER 2017**

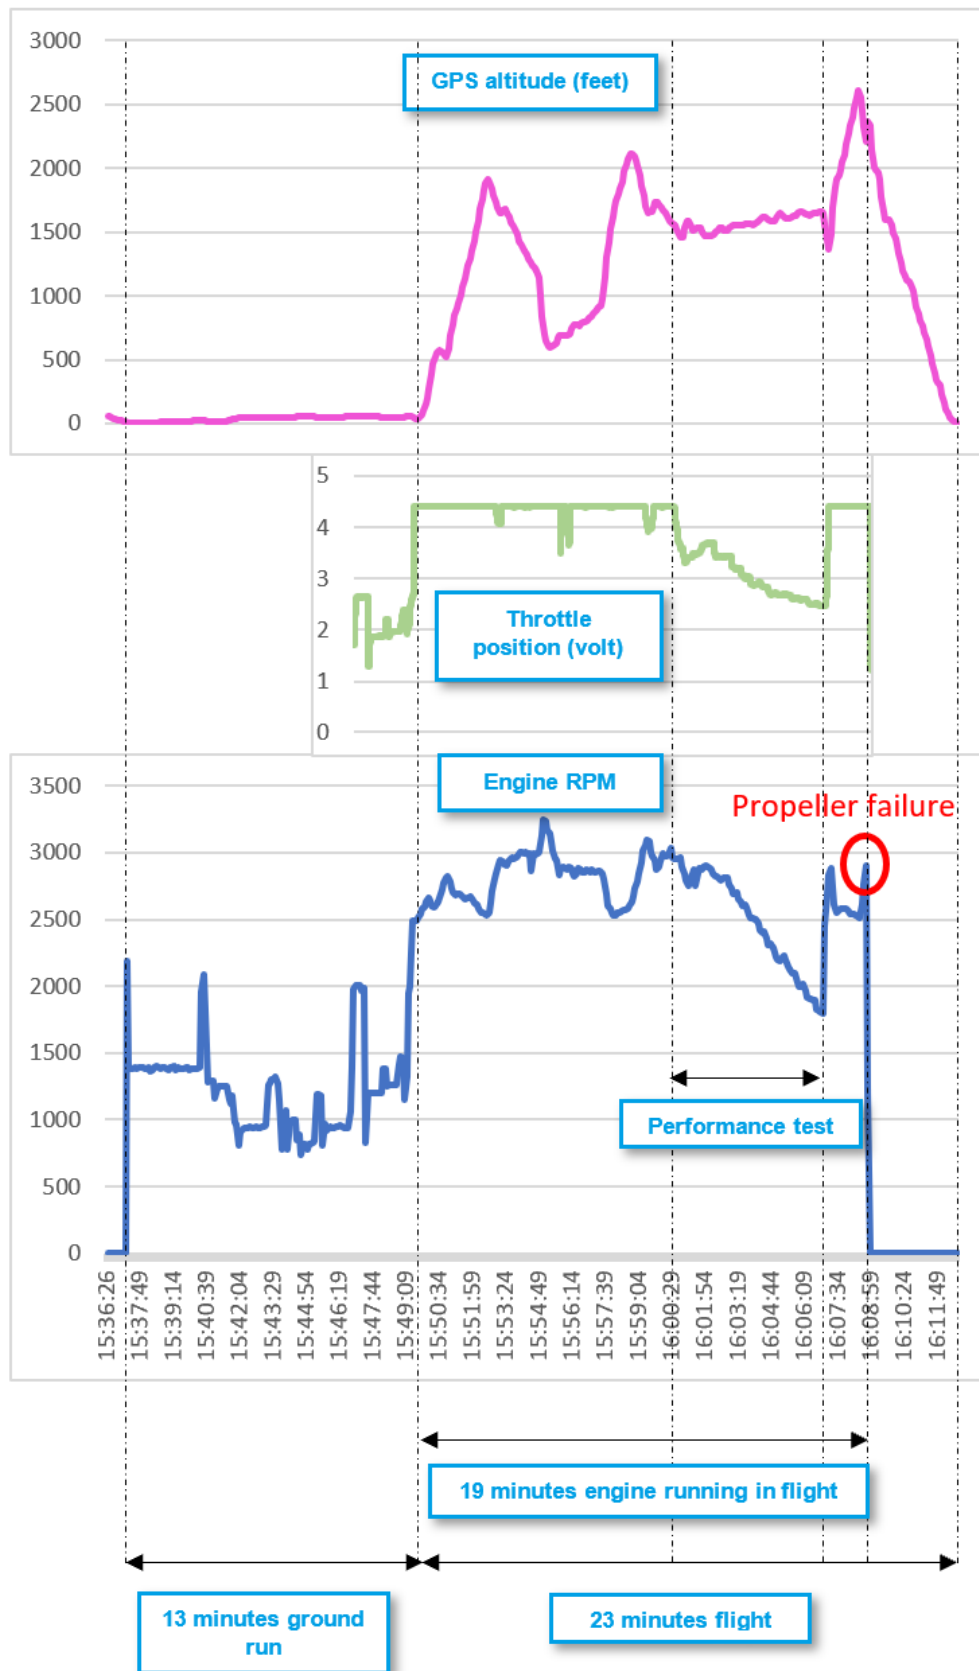
The propeller failure causes the immediate shut-down of the engine, identified on the graph on Figure 16.

Figure 16 : overview of the parameters during the different phases of flight

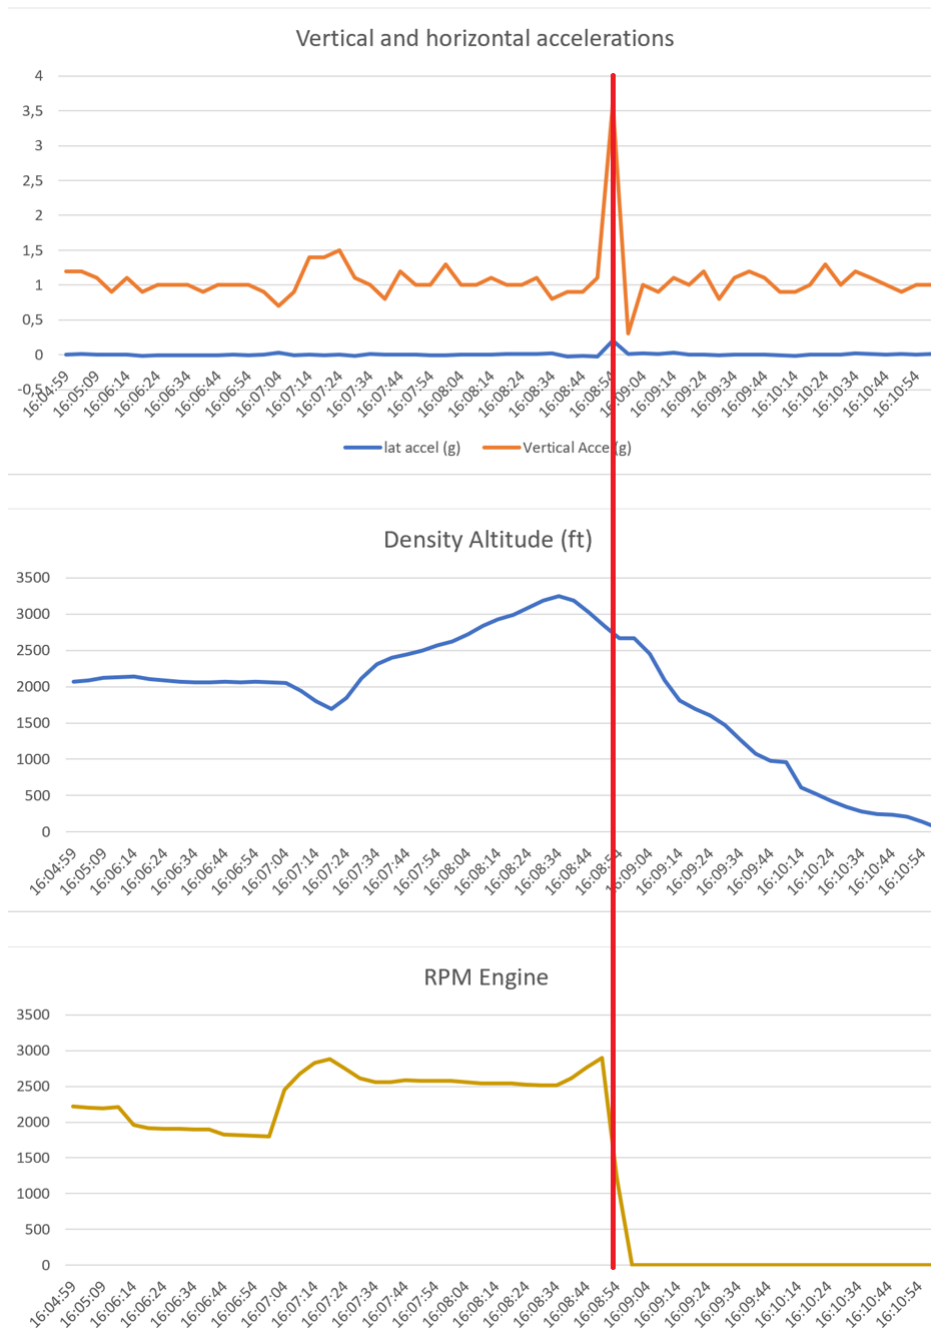
Few seconds later, just after flying above the east side of the city of Gent, when the aeroplane was descending, the pilot reported a light vibration, that disappeared when he reduced RPM. This vibration is not visible in the parameter records. At 16:08:54 UTC, the record shows a peak in vertical and horizontal acceleration – corresponding to the loud bang and heavy vibration felt by the pilot – and the engine RPM drops to zero. This moment corresponds to the propeller blade failure and departure from the aircraft.

Figure 17 : zoom on the parameters during the propeller loss

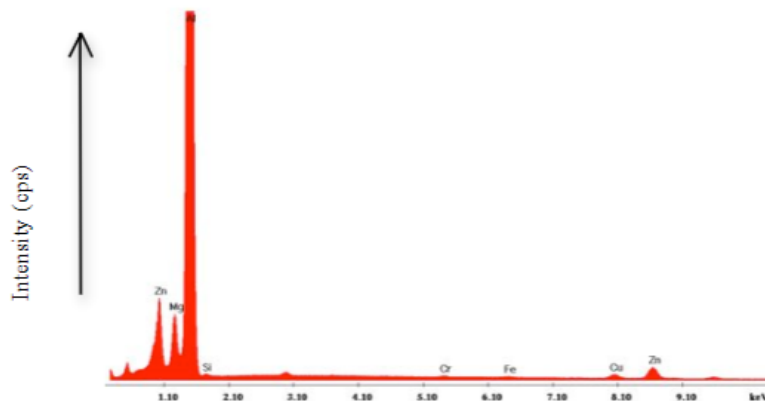
The propeller fixation ring is made from an 7000 aluminium alloy with composition given in table 1 (see figure 2 for the EDX spectrum).

Figure 2: EDX energy spectrum of the propeller fixation ring

Element	Al	Zn	Mg	Cu	Si	Cr	Fe
Weight%	86,9	7,1	3,2	2,1	0,2	0,2	0,3

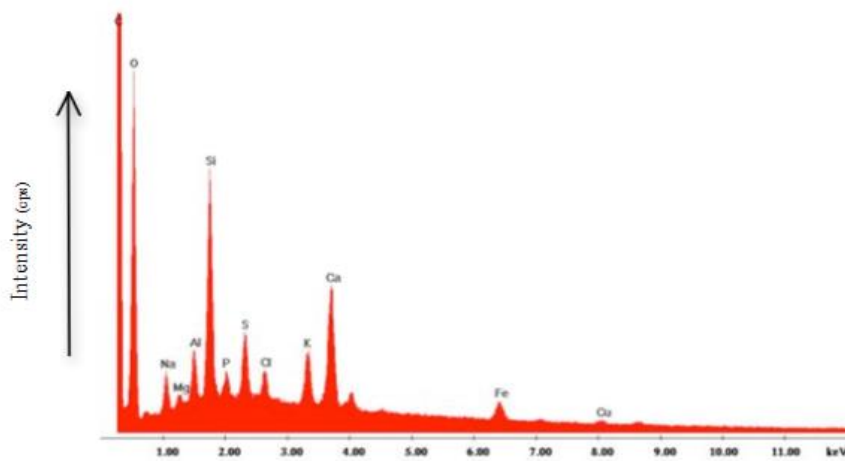
Figure 17 shows the trailing edge of the extremity of blade 2; two particles have been found (see figure 18(a) and (b)). Both particles have a brownish colour and a fibrous texture. The EDX spectrum of particle 1 (see figure 19) reveals carbon and oxygen (hydrogen is not visible using EDX) and a variety of elements between Na and Cu. Particle 2 has a similar spectrum. Both particles are organic, probably wood, with small contaminations of other elements.

Figure 19: EDX spectrum of particle 1 found on the extremity of propeller blade 2
