AIRCRAFT ACCIDENT REPORT AND EXECUTIVE SUMMARY

Reference:	CA18/2/3/9723	
Aircraft Registration	N53757	Date of Accident	16 July 2018		Time of Accident	1216Z
Type of Aircraft	Super Decathlon 8KCAB BL30		Type of Operation	Private (Part 91)		
Pilot-in-command Licence Type	PPL		Age	51	Licence Valid	Yes
Pilot-in-command Flying Experience	Total Flying Hours		1442.25		Hours on Type	133.50
Last point of departure	Mwana Private Airstrip, Limpopo Province					
Next point of intended landing	Brits Airfield (FABS), North West Province					
Location of the accident site with reference to easily defined geographical points (GPS readings if possible)						
Roodekopies Dam with GPS coordinates S25°24'57.66" E027°34'59.36" and a field elevation of 3345ft						
Meteorological Information	Wind Direction: North; Wind Speed: 5-10kt; Air Temperature: 18; Visibility: Good					
Number of People On-board	1 + 0	No. of People Injured	0	No. of People Killed	0	
Synopsis	<p>Two aircrafts with registrations N53757 and ZS-AXX, both with sole occupants, took off from Mwana Game Lodge in Limpopo Province, heading to Brits Airfield (FABS) with the intention to uplift fuel for the intended tour around the North West

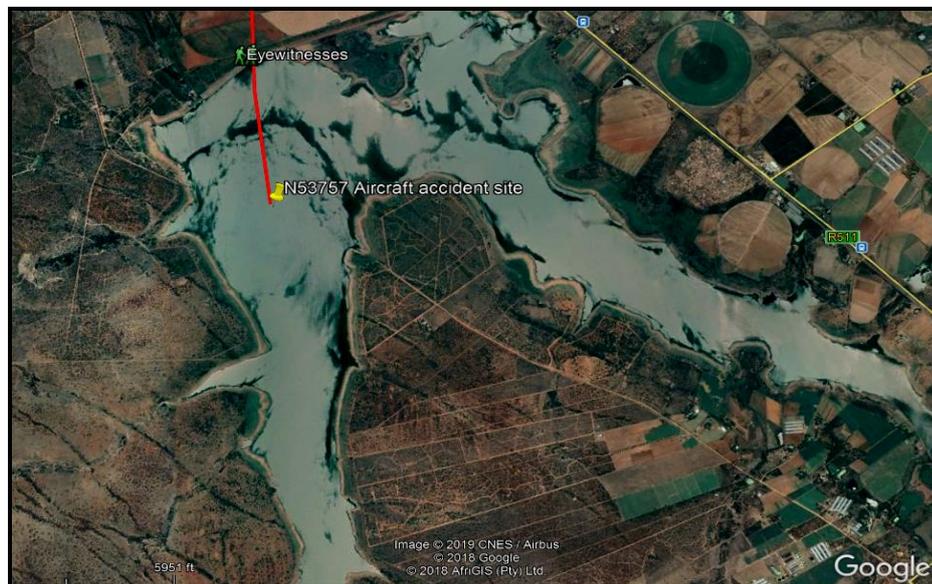
1.12.1 The aircraft accident occurred at Roodekoppies Dam in the North West Province. The dam is resident to carnivorous animal species that feed on the fish and any available food. According to the pilot's report, the aircraft was ditched into Roodekoppies Dam during a forced landing, following a reported engine stoppage. The aircraft then sank to the bottom of the dam.

Figure 4: Aerial view of the accident site

1.12.2 On the day of aircraft recovery, it was found at approximately seven metres below the water surface at GPS coordinates S25°24'57.66" E 027°34'59.36". After ditching the aircraft, the pilot had disembarked the aircraft and swam approximately 730m in a 108 degrees direction from the aircraft to the shore. The aircraft was intact and only sustained water and crash damage to the bottom engine cowlings. The damage is consistent with damages caused by impact with water at fairly low speed, as a result of a low forward speed. There was evidence of fuel dripping from the fuel tank at the accident scene during recovery.
