Final report RL 2019:07e

Accident in Othem, Gotland, on 11 August 2018 involving aircraft D-EHAC of the model Bolkow BO 208 C Junior , operated by a private individual.

File no. L-98/18

6 May 2019

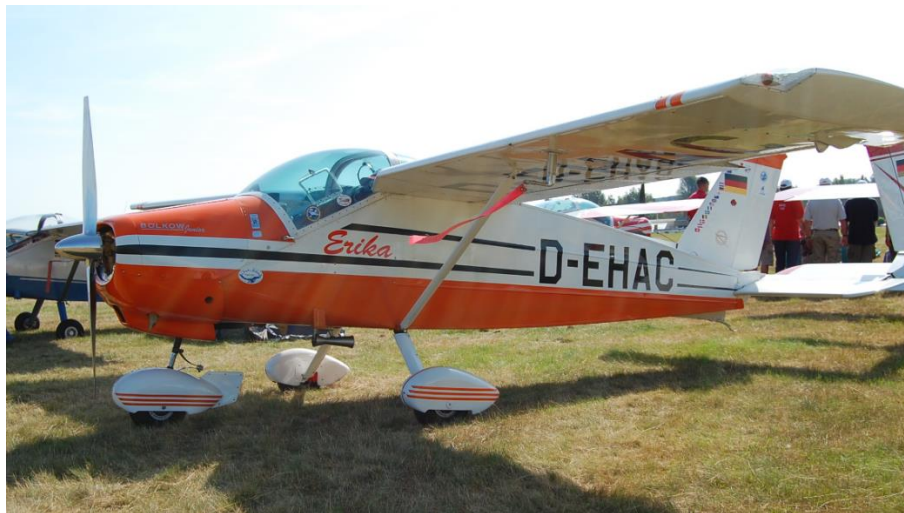
Figure 1. Aeroplane D-EHAC. Photo: Aeroplane owner.

Bölkow BO 208 C Junior is a single-engine, two-seater, high-wing aeroplane mainly made of metal, with wing struts and fixed landing gear and nosewheel (see figure 1).

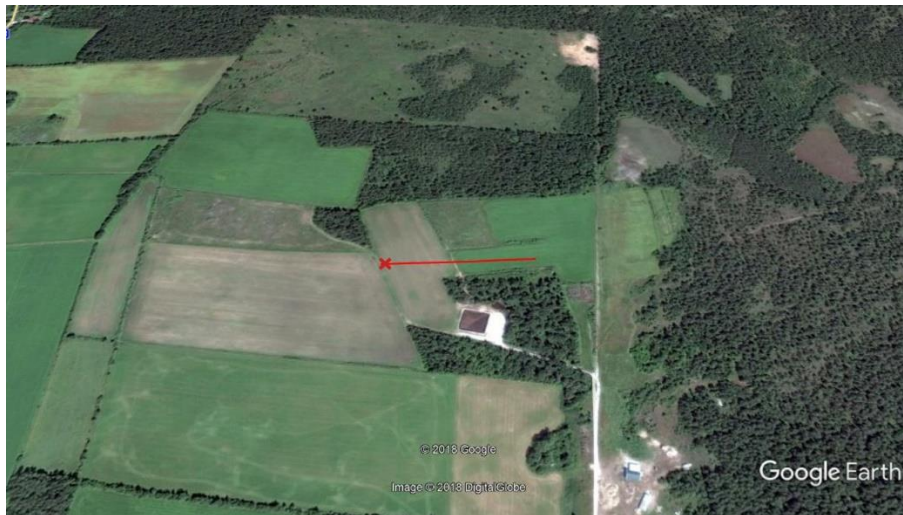
Figure 4. The aircraft's ground roll and the accident site. Map from Google Earth: © Lantmäteriet Ref. no. R61749_190001.

The image in figure 4 shows the approximate ground roll of the aircraft and the site of the accident marked with an X in red. The ditches that can be seen in the image were filled at the time of the accident.
