Final report RL 2019:10e

Serious incident at Trollhättan/Vänersborg airport on 9 October 2018 involving the aircraft YL-RAI of the model ATR-72-202, operated by RAF-AVIA.

File no. L-145/18

5 September 2019

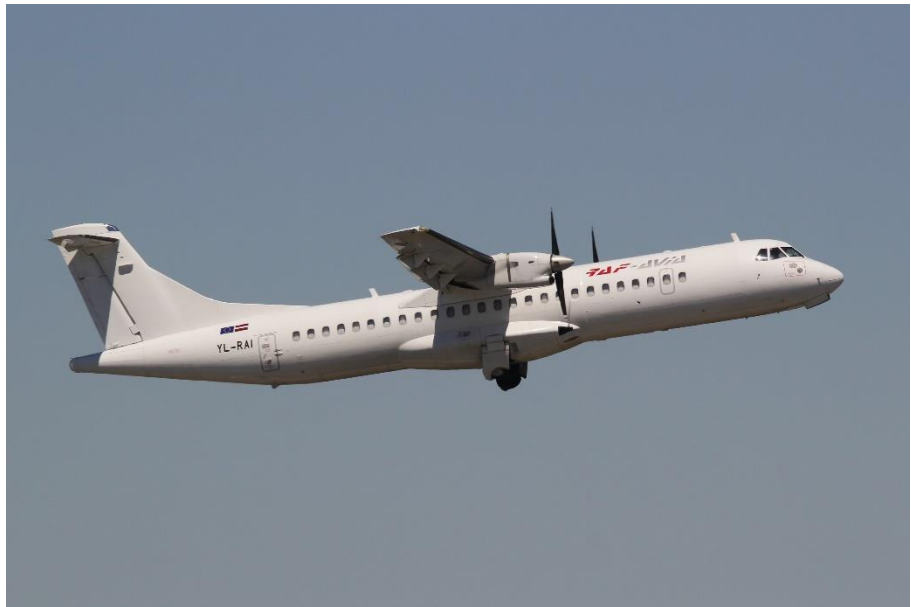
Figure 3. RAF-AVIA’s aircraft of type ATR72. Photo: RAF-AVIA.

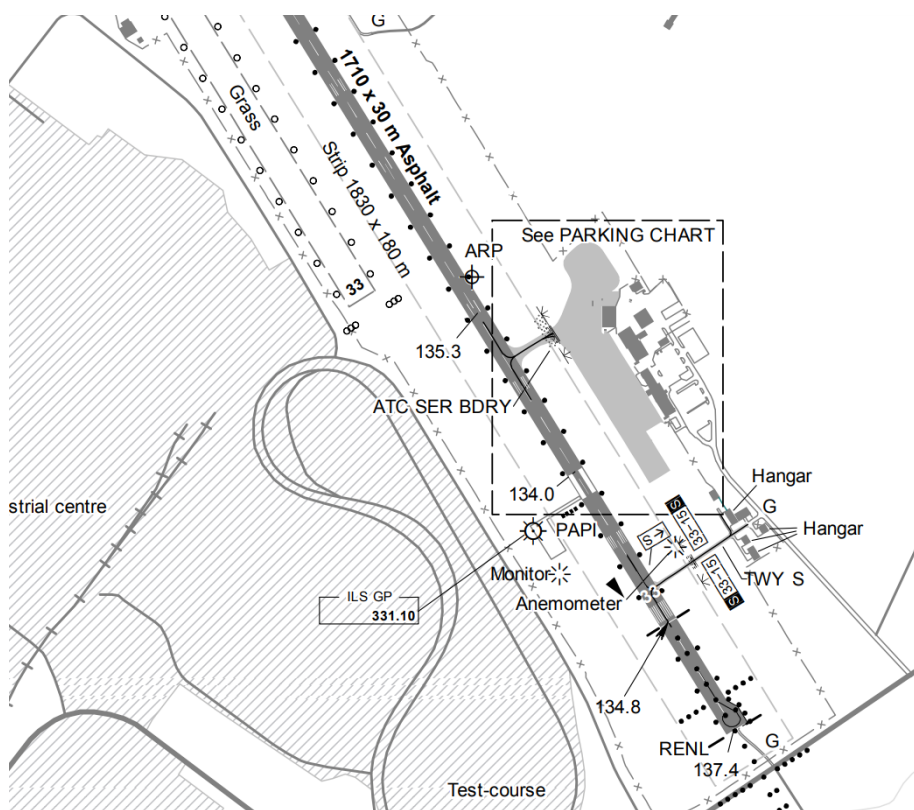
The runway is 1,710 metres long and 30 metres wide. The available landing distance on runway 33 is 1,501 metres, due to the threshold having been moved in onto the runway (see figure 4).

Figure 4. Aerial map of parts of Trollhättan/Vänernsberg airport (sectioned off).
 Source: AIP Sverige.

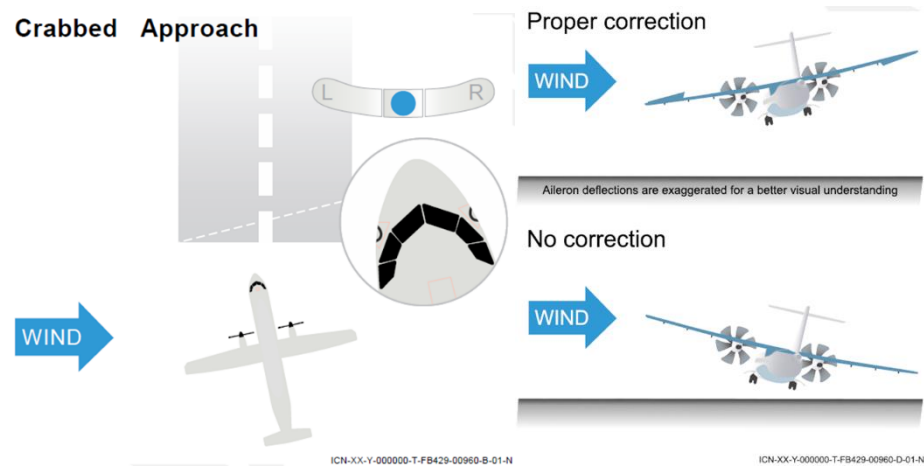
In 2016, ATR also published a flight operations information message (FOIM) due to a number of runway excursions involving the aircraft model. In the message, ATR highlights the risks of crosswind landings and underlines the importance of accuracy in managing ailerons into the wind, rudder and nosewheel steering (see figure 6 for examples). The message also emphasises the importance of bringing the control wheel forward after landing, in order to increase the steering capacity of the nosewheel.

Figure 6. Images from the FOIM stating that approach is to be carried out with wind correction and crabbing into the wind. Source: ATR.

The information from ATR's FOIM will be introduced in the aircraft model flight manual in June 2019. The reason for the delay, according to ATR, is a time-consuming update to the software used to manage the aircraft documentation.
