**AIRCRAFT ACCIDENT REPORT AND EXECUTIVE SUMMARY**

<b>Reference:</b>	CA18/2/3/9767	
<b>Aircraft Registration</b>	ZS-OOB	<b>Date of Accident</b>	29 January 2019		<b>Time of Accident</b>	0552Z
<b>Type of Aircraft</b>	Pitts Special S-2B		<b>Type of Operation</b>	Private (Part 91)		
<b>Pilot-in-Command Licence Type</b>	Commercial Pilot Licence		<b>Age</b>	71	<b>Licence Valid</b>	Yes
<b>Pilot-in-Command Flying Experience</b>	<b>Total Flying Hours</b>		6497.7	<b>Hours on Type</b>	1012.8	
<b>Last Point of Departure</b>	Rand Aerodrome (FAGM), Gauteng Province					
<b>Next Point of Intended Landing</b>	Rand Aerodrome (FAGM), Gauteng Province					
<b>Location of the accident site with reference to easily defined geographical points (GPS readings if possible)</b>						
Kliprivier area in Gauteng Province at GPS co-ordinates: 26° 26' 12.50" South 028° 7' 16.31" East and at a field elevation of 4922ft AMSL						
<b>Meteorological Information</b>	Wind: 326° at 14kts, Temperature: 27 °C, Dew Point: 12 °C, Visibility: 9999m and QNH: 1027 hPa.

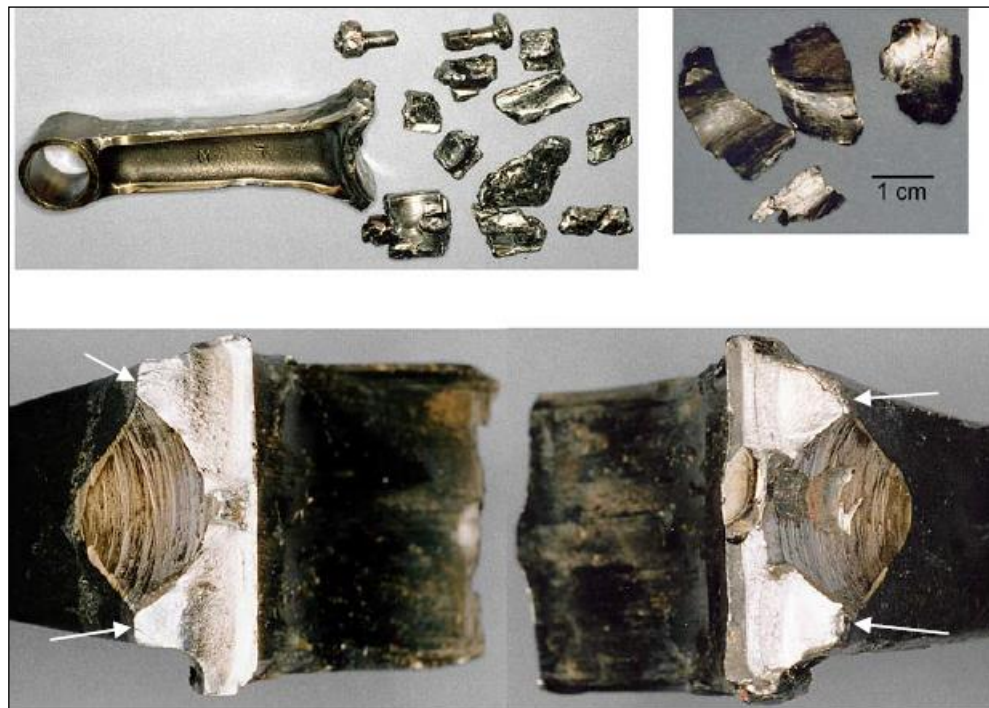
- *The big-end housing fractures were a result of fatigue crack growth from the outer surface to the inner surface of the housing.*
- *The sites of fatigue crack initiation are associated with regions of reduced cross-section created by the counterbore at the transition between the housing and the connecting rod 'I' beam, indicated by white arrows in Figure 10.*
- *The big-end bearings had been destroyed prior to the fracture of the big-end housing, evident from galling of the bearing to the inner housing.*

- The aluminium-tin/lead-tin bearing alloy of the big-end connecting rods were determined to have had separated from the steel back of the housing and the bearing inserts had uniformly reduced in thickness and forced out through the gap between the big-end housing and the crankshaft journal. (See figure 9, top-right image of bearing remnants.)

**Figure 10:** The recovered fragments of the big-end housing (top left), some of the larger fragments of the bearing inserts (top right), detailed view of both housing fractures at the transition to the rod “I” beam (bottom). The sites of fatigue initiation are arrowed. [Source: ATSB’s Analysis of Aircraft Reciprocating-Engine Failure, pg.63]

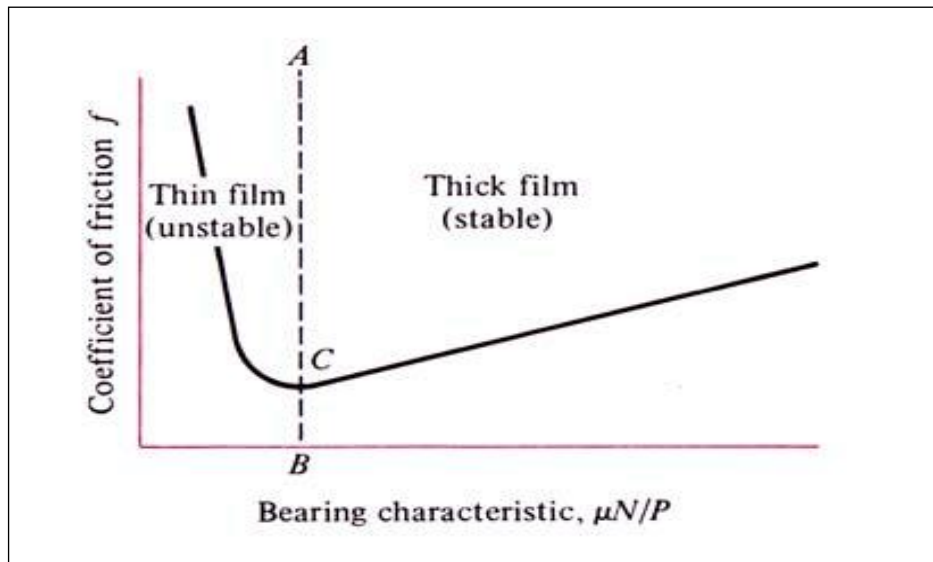
**Figure 11:** Variation of the coefficient of friction with bearing characteristic parameter. (Source: <https://www.atsb.gov.au/media/29980/b20070191.pdf>, p 124)

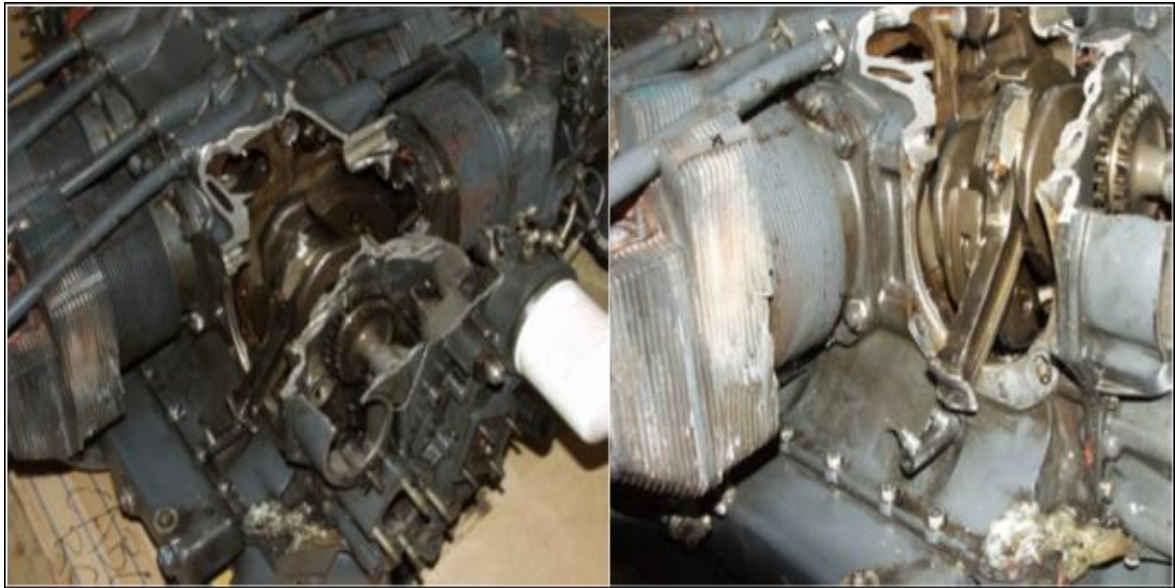
Examination of the fracture surfaces in the connecting rod little-end housing revealed that fracture initiated from a region of fatigue cracking. Fatigue cracking initiated on the inner

surface of the housing. Examination of both the housing inner surface and the No.6 piston pin found that galling had occurred between the pin and the housing inner surface.

**Figure 12 and 13** show similar failures from ATSB. An overview of the rear of the left engine after being removed from the aircraft; and the fractured small end of the No. 6 connecting rod.

For galling to occur between the piston pin and the inner surface of the housing, the bronze bush normally fitted to the housing must not be present. It is evident in this case that the bronze bush had been destroyed during engine operation. An examination of other connecting rods from the engine revealed that the bushes were in various states of destruction. Subsequent examination of a connecting rod from the right engine of the aircraft (following engine overhaul after the occurrence involving the left engine) found that the little-end bush was progressively being destroyed.
