AIRCRAFT ACCIDENT SHORT REPORT

CA18/2/3/9768: ZU-INH: During a low-level aerial flight in the Kruger National Park the engine stopped, and the pilot executed a forced landing.

Aircraft registration : ZU-INH

Aircraft manufacturer and model : Aeroprakt Ltd, A22-LS

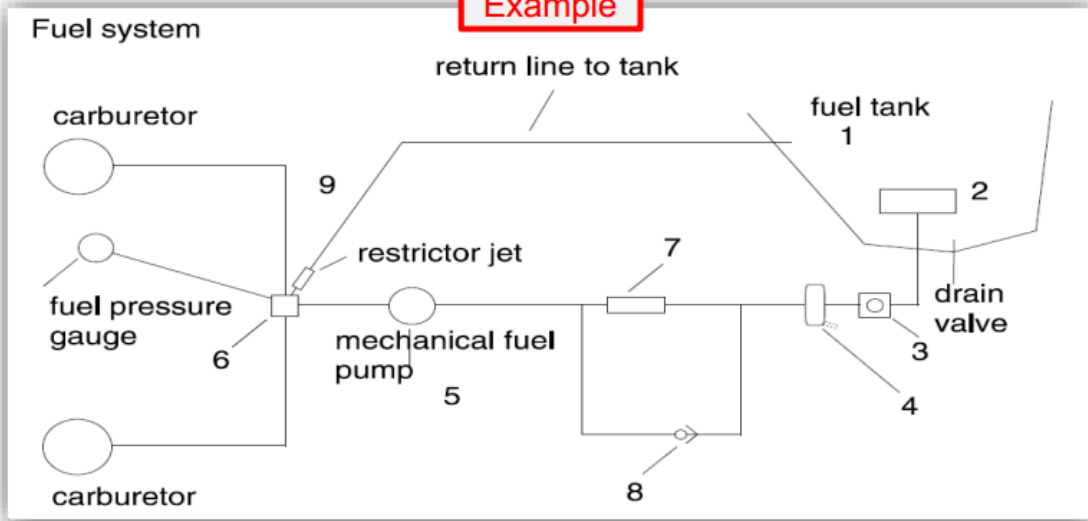
Example

- 3.16 The primary purpose of the fuel return line, according to the engine manufacturer, serves to avoid the formation of fuel vapour in the system.
- 3.17 The engine manufacturer issued very specific guidance material as per the Installation Manual (see Annexure B) on the requirement of the fuel return line and what routing it should follow (needed to route back to the fuel suction system, that is, the fuel tank of the aircraft). The aircraft was fitted with a fuel return line, but the plumbing was found not to follow the requirements as set out by the engine manufacturer, but instead the fuel return line connected to a filter as illustrated in this report.

The airframe fuel system, specifically the plumbing, with regards to the fuel return line on this aircraft was found to differ from the guidance provided by the engine manufacturer as contained in the Rotax 912 Series Installation Manual, Edition 2. The fuel return line should feed back to the fuel tank suction side of the airframe fuel system, which was not the case.
