AIRCRAFT ACCIDENT INVESTIGATION BUREAU

INVESTIGATION REPORT ON

ACCIDENT TO THE B737-MAX8 REG. ET-AVJ OPERATED

Report No. AI-01/19

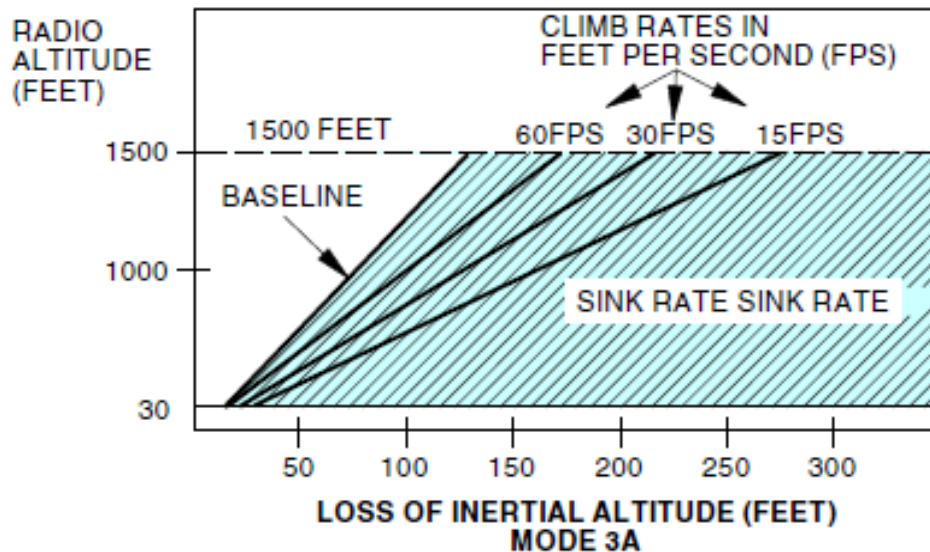
FIGURE26: ALERT ENVELOPE FOR THE MODE 3A (FROM AMM §34-49-00)

The mean vertical speed of the Airplane before the Maximum value was around 12 ft/s. An alert triggering around 1,271 ft – after 229 ft of altitude loss was consistent with the GPWS Mode 3A alert envelop shown in Figure 26.

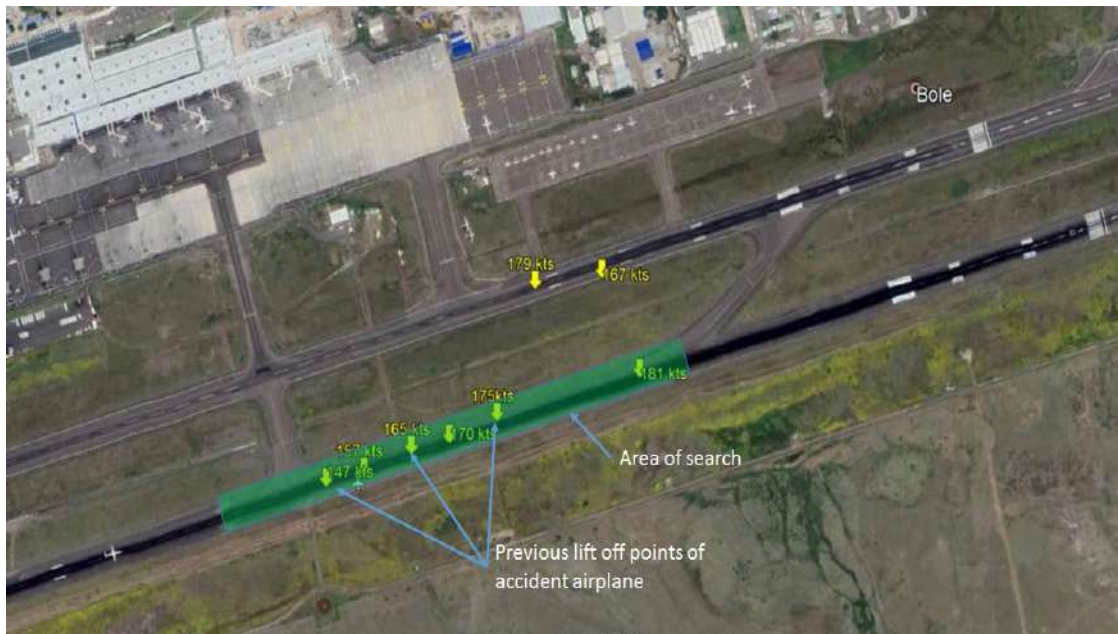
PICTURE: 29 AREA OF SEARCH FOR AOA VANE & BIRD REMAIN

The EAIB investigation, Airworthiness group chairman and team members obtained permission to walk the runway and its sides to check for airplane debris and any evidence of a bird-strike or tail strike. The Investigators walked the area of runway 07R (12,400 feet in length) highlighted in green in the picture 29 below. The length and width of the runway inspected was approximately 3,000 feet and 150ft to the left and

right of the centerline. The team started the search in the vicinity of taxiway C and extended toward taxiway D as well as back towards taxiway B. Those participating in the walk searched along in the grass and the runway side where small broken rocks were. The team walked two rounds along the same area but there were no bird remains and AOA vane wreckage. The investigation team confirmed that there was no evidence of a bird and AOA vane remains in the highlighted search area. The team also noted no evidence of damage to the runway surface in this area consistent with a tail strike. FDR data shows that Left AOA deviations began when the airplane was located over taxiway D.

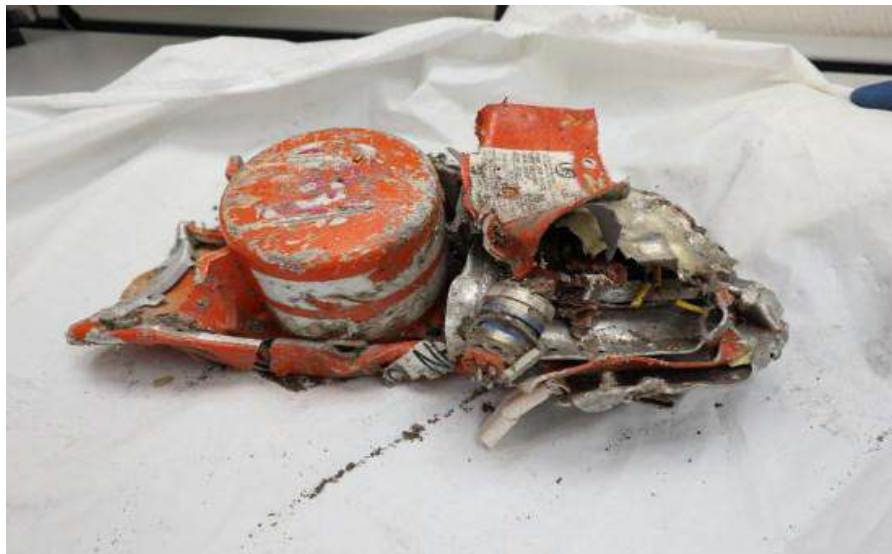
FIGURE 33: DFDR IN THE SUITCASE

The memory puck was opened and the electronic board containing the memory component support was extracted. The memory board identification was P/N 205-E5458-04, S/N 001157901 and the flex identification was 024-E5675-20 REV, 1809-1.

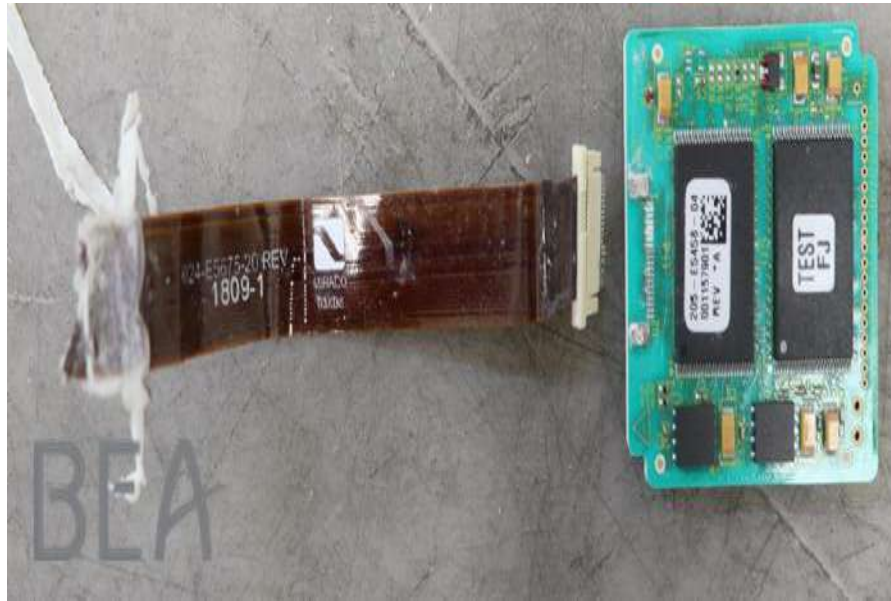
FIGURE 34: FDR MEMORY BOARD, FLEX AND CONNECTOR

The memory board was visually inspected with a Keyence microscope. Apart from the connector pads, the memory board was in good condition. There was no trace of impact. The two memory chips as well as the micro-processor were found in good condition.

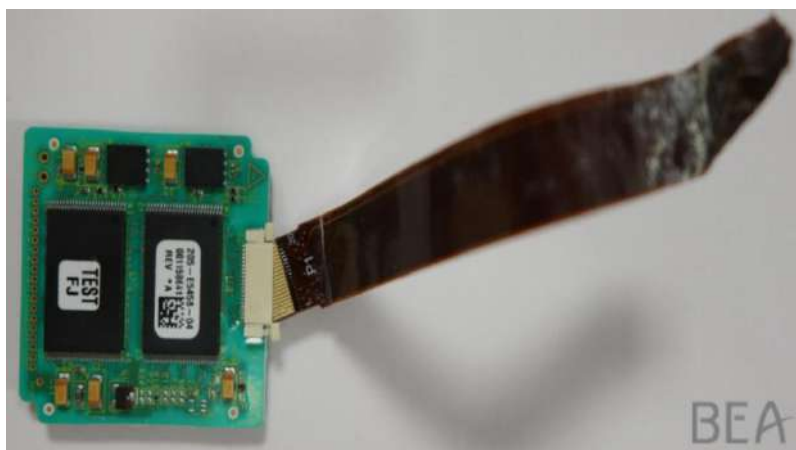
FIGURE 39: CVR MEMORY BOARD AND FLEX

The CVR memory board and flex were visually inspected with the Keyence microscope. There was no damage on the board and the connector was in good condition.

A second observation with the X-ray was made, which confirmed that the connector soldering were in good condition.

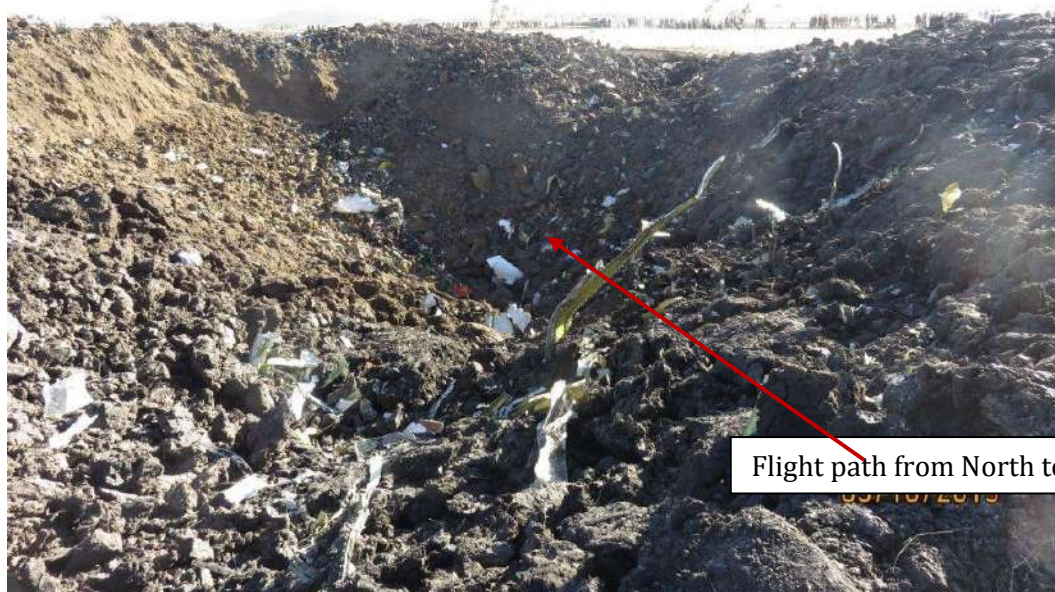
FIGURE 41: CLOSE VIEW OF THE CRATER BEFORE EXCAVATION

The Airplane impacted terrain at a farm field and created a crater approximately 10 meters deep (last Airplane part found) with a hole of about 28 meters width and 40 meters length. Most of the wreckage was found buried in the ground; small fragments of the Airplane were found scattered around the site in an area about 200 meters wide and 300 meters long. Damages to the Airplane were consistent with a high energy impact.

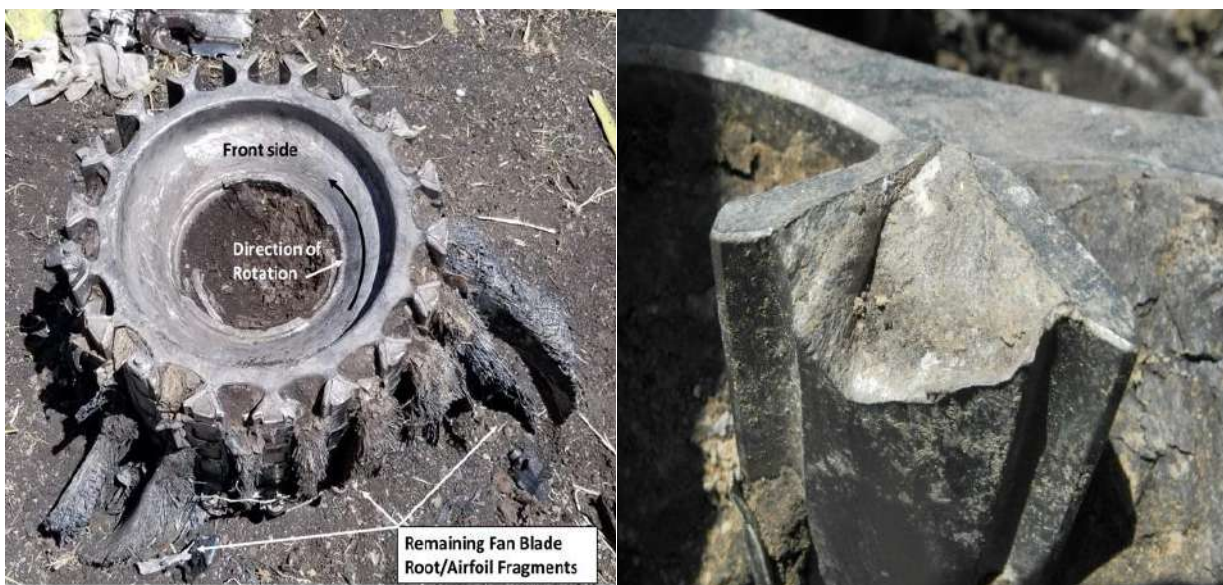
FIGURE46: R/H ENGINE - S/N 602695 - FAN DISK FIGURE47: R/H ENGINE - S/N 602695 - RETENTION LUGS - FRACTURED

The right engine core was recovered from the site and examined by the group. The recovered core of the right engine was more damaged than the left-hand engine. The engine was reportedly recovered at a depth of approximately 10 to 15 meters depth on the right side of the excavation site.

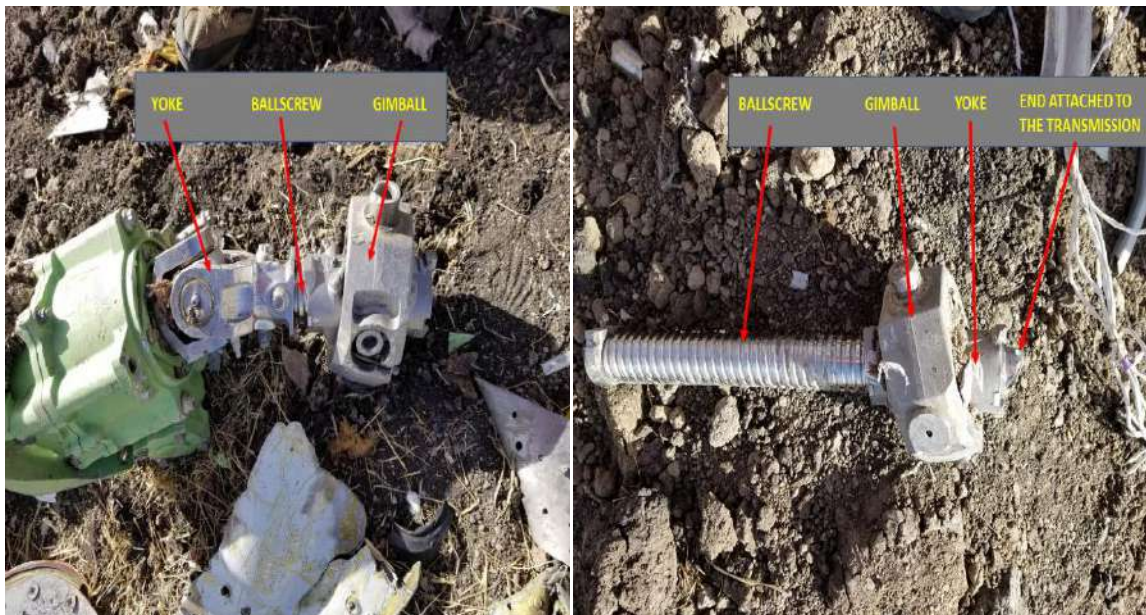
FIGURE54: FLAP TRANSMISSION & BALLSCREW FIGURE55: FLAP TRANSMISSION

Two parts of the actuation system were located and examined at the impact site. One consists of the ballscrew, yoke, gimbal and flap transmission; the other consists of just the ball screw, yoke, and gimbal (see **Figures** respectively).

The installed location of each unit has not been identified. The position of each gimbal is consistent with the flaps in the fully retracted position.

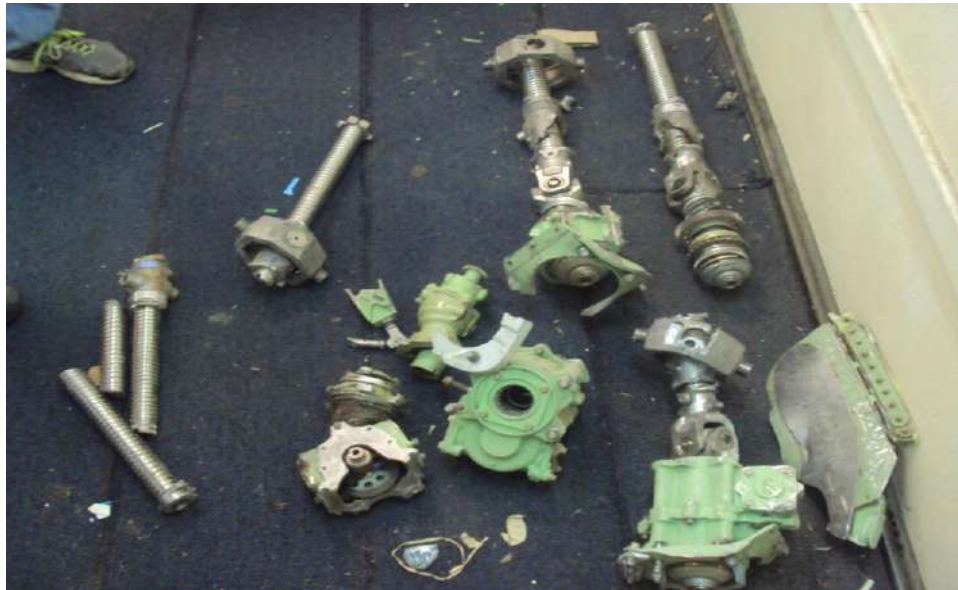
FIGURE56: TRAILING EDGE FLAP TRANSMISSIONS AND BALL SCREWS

During the examination of the wreckage pile located at the Addis Ababa airport EAIB store, the Airworthiness group identified a total of 4 (including the ones identified at the impact site) trailing edge flap transmissions (there are 8 total); three of these had the ball nut and gimbal still attached.

Again, all three were found in the fully retracted position. There was one additional transmission portion that was found as well as three ball screw segments. All examined damage appears consistent with high energy impact.

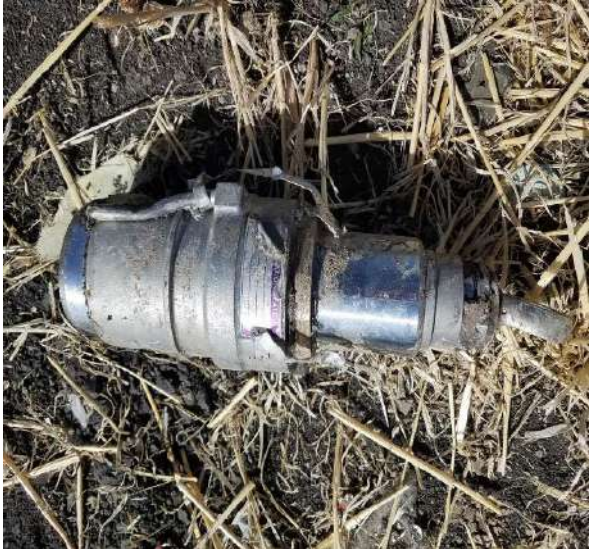
FIGURE 57: SLAT ACTUATOR (POSITION UNKNOWN)

Three of the 8 leading edge slat actuators were photographed (see Figures below) at the impact site. The installed location for each actuator has not been identified. The actuator position, as photographed, is in the fully retracted position.

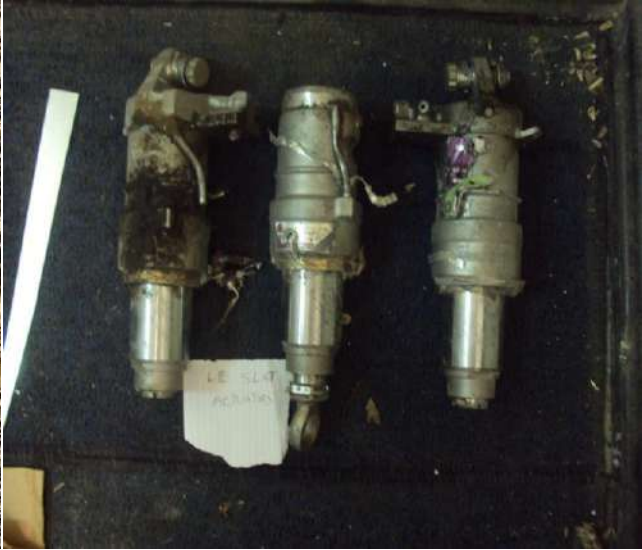
FIGURE 58: LEADING EDGE SLAT ACTUATORS

During the examination of the wreckage pile located at the Addis Ababa airport EAIB store the Airworthiness group identified a total of three leading edge slat actuators at the impact site. The actuator position, as photographed, was in the fully retracted position.

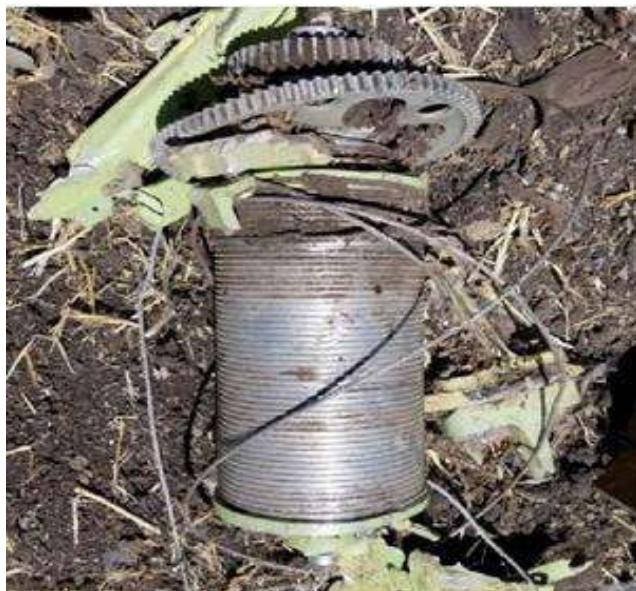
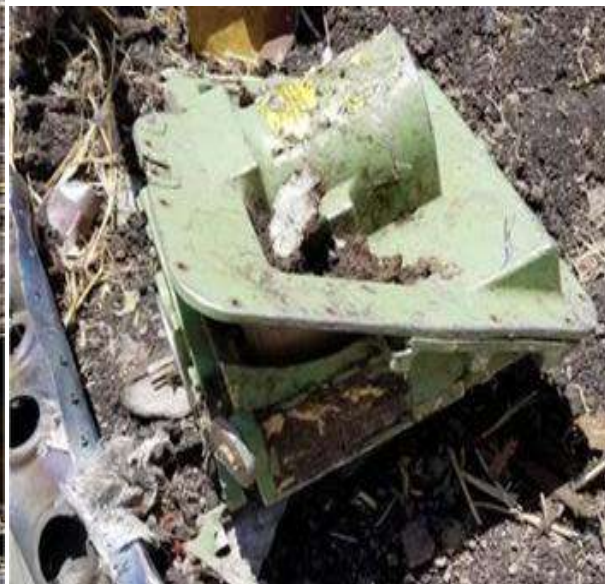
Two parts of the control system were located and examined at the impact site. One consists of aft cable drum; the other consists of the stab trim actuator (see Figures 59 & 60 below respectively). These

components do not provide any evidence of what position the horizontal stabilizer may have been at the time of impact.

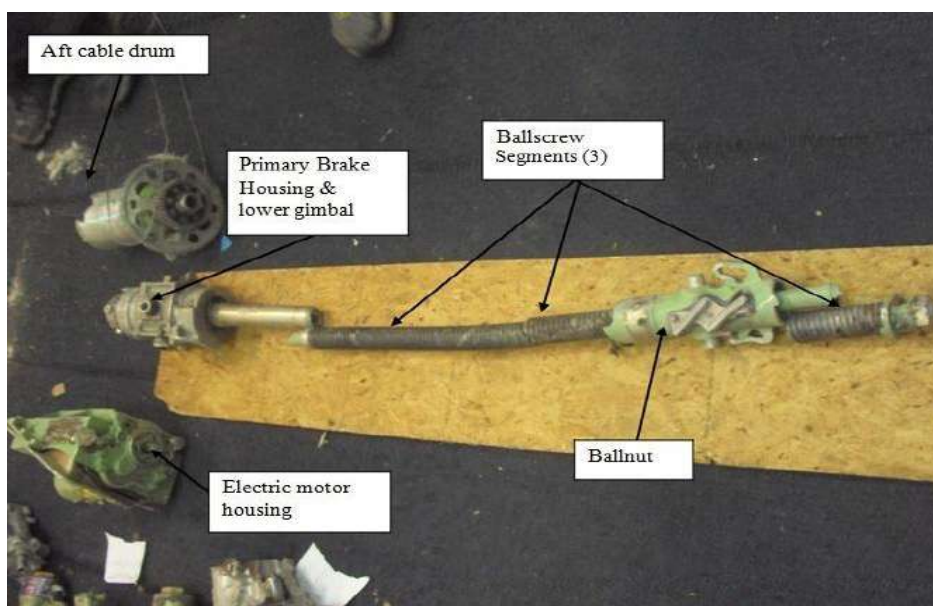
FIGURE 61: RECOVERED STABILIZER TRIM COMPONENTS

Most of the located components of the stabilizer trim system were located once the wreckage was transported to Bole International Airport. The only part of the stab trim system located on site was the motor housing (see above). Referencing **figure-54** above, the parts located in the wreckage pile at the airport consisted of the Primary Brake Housing (has the Lower Gimbal on it), the entire jackscrew (fractured into three pieces), and the ballnut (jammed onto the screw). Damage to the components of the stabilizer trim system is consistent with a high energy impact.

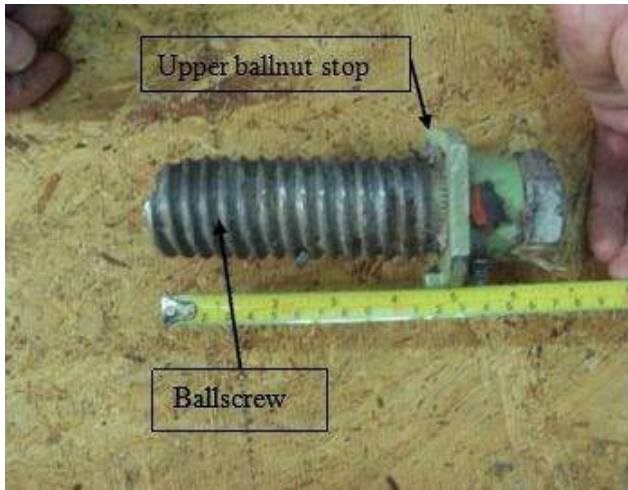
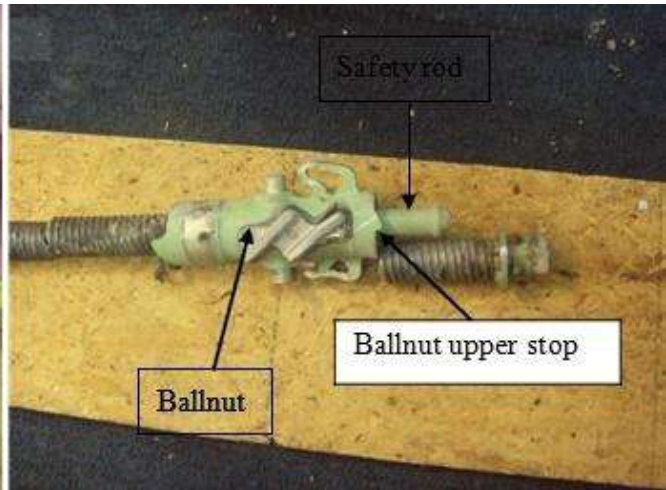
The figure below shows the relationship of the ballnut position along the ball screw. There is a safety rod which acts as a secondary load path should the ball screw fracture in service for any reason. It is attached to a separate set of secondary gimbals below the primary support gimbals on the primary brake housing and to the top of the ball screw. Figure 54 shows the safety rod and that it protrudes out from the ball nut. However, the fracture faces on the 5" long upper screw portion (*note the measurement in Figure 53*) match those found near the ballnut upper stop. This is consistent with the safety rod being pulled out several inches prior to final fracture.

Examining the fracture surfaces, the upper screw segment fits with the fracture face just inside the ballnut giving a measurement between the stops on the ballnut and the upper ballnut stop of ~5". Referencing Boeing document D251A122 (737NG Control Position Data), this measurement equates to a stabilizer trim setting of 1.5 degrees Airplane Nose Down (AND) or an indicated position of 2.5 units of trim. Although the data is for the 737NG, the position of the MAX stab trim holds the same relationship. According to Boeing:

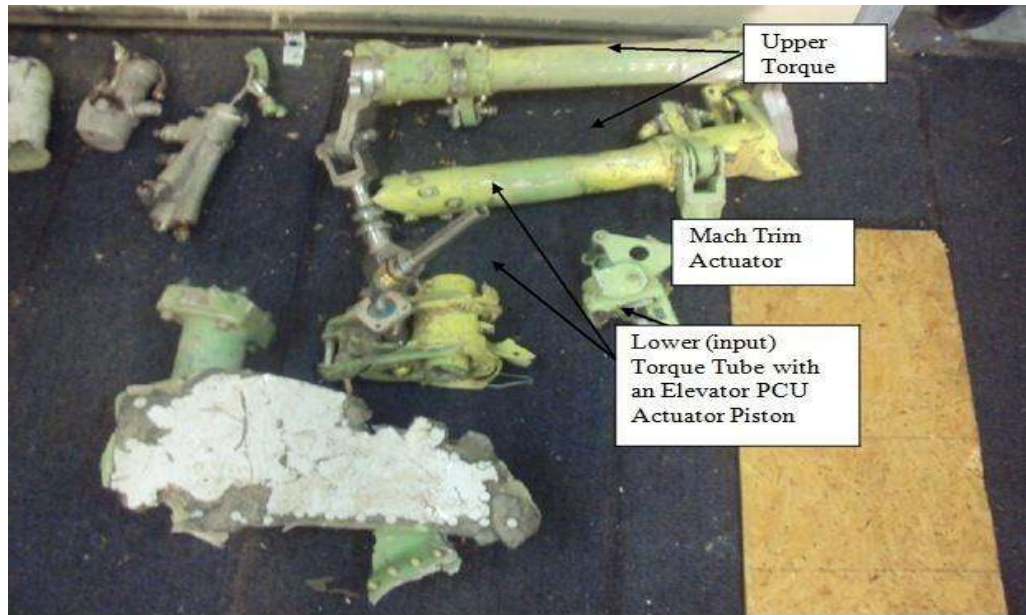
FIGURE64: ELEVATOR PCU ACTUATOR PISTON

The only components that were located for this system were the output torque tube, the mach trim actuator, a small portion of the Elevator feel and centering unit, and a small piece of the elevator input torque tube. Figure 55 above shows the recovered components of the elevator control system. Note that all components, like the lateral components show significant damage consistent with a high-energy impact. The upper torque tube was fractured in half. Only a small portion of the lower (input) torque tube was recovered along with a piston of the Elevator Power Control Unit actuator. The Mach Trim Actuator was found in the fully retracted position.

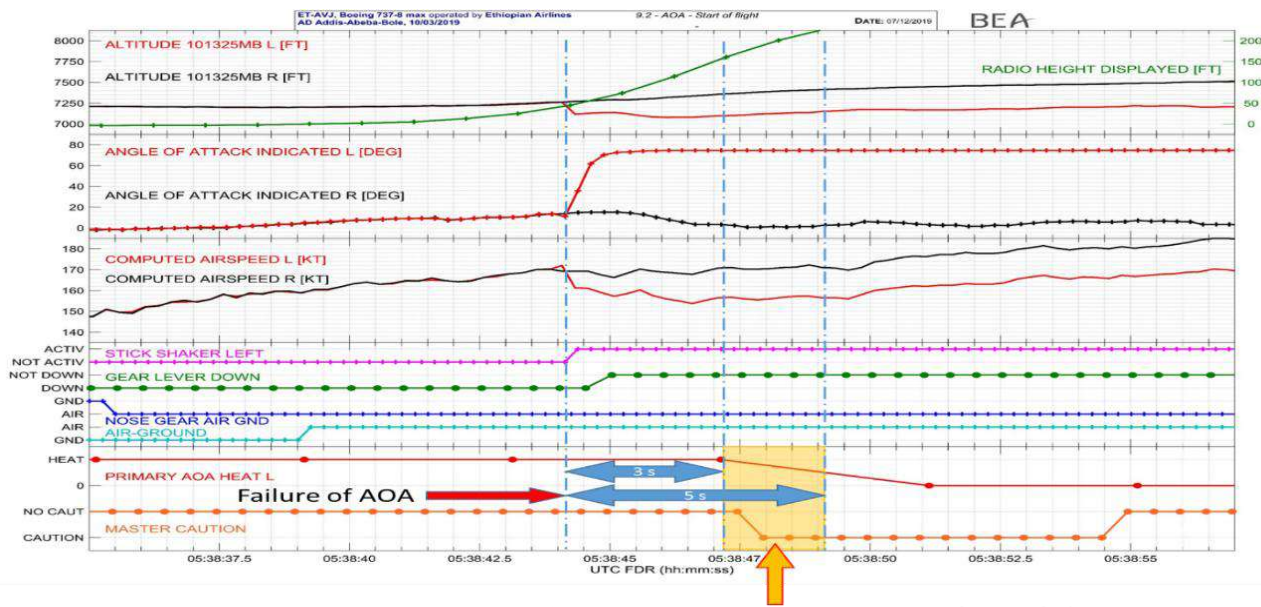
FIGURE 67: AOA VALUES DURING THE BEGINNING OF THE FLIGHT

From the CVR transcript, at 5 h 42 min 48 s, the Captain requested the recall of the master caution. At that time, master caution had only triggered once. Following the master caution recall, the crew exchanged “Master Caution Anti Ice” and “Left Alpha Vane”.

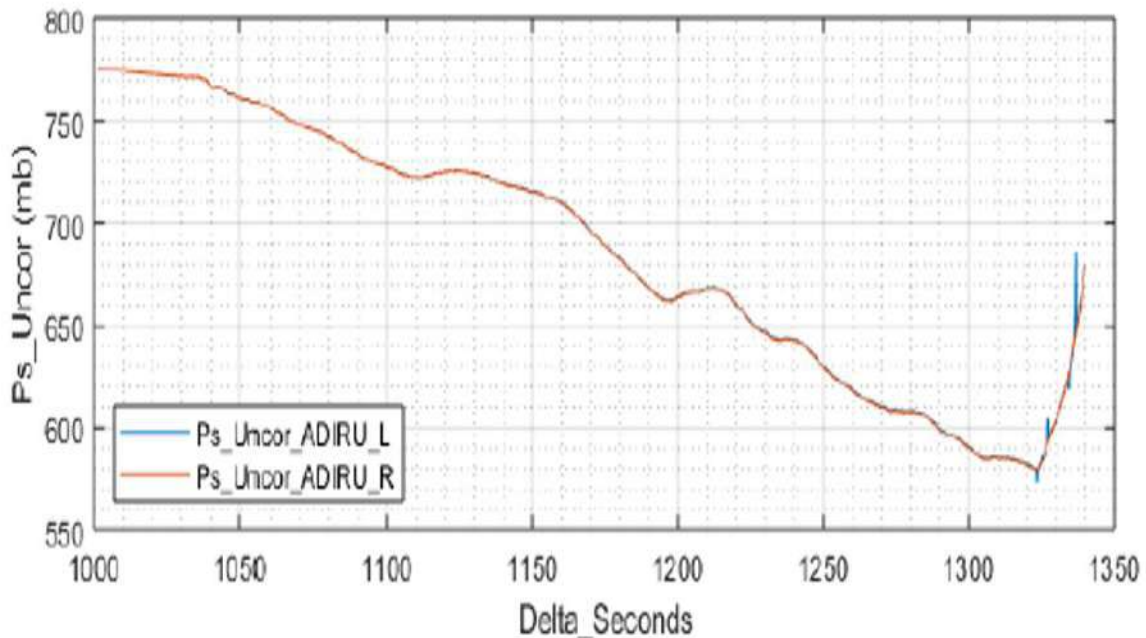
FIGURE 69: UNCORRECTED STATIC PRESSURE COMPUTED BY THE AIRPLANE MANUFACTURER

Uncorrected static pressure values from both sides were identical. The difference between the LH and RH side corrected pressure values were therefore only due to the AOA correction.

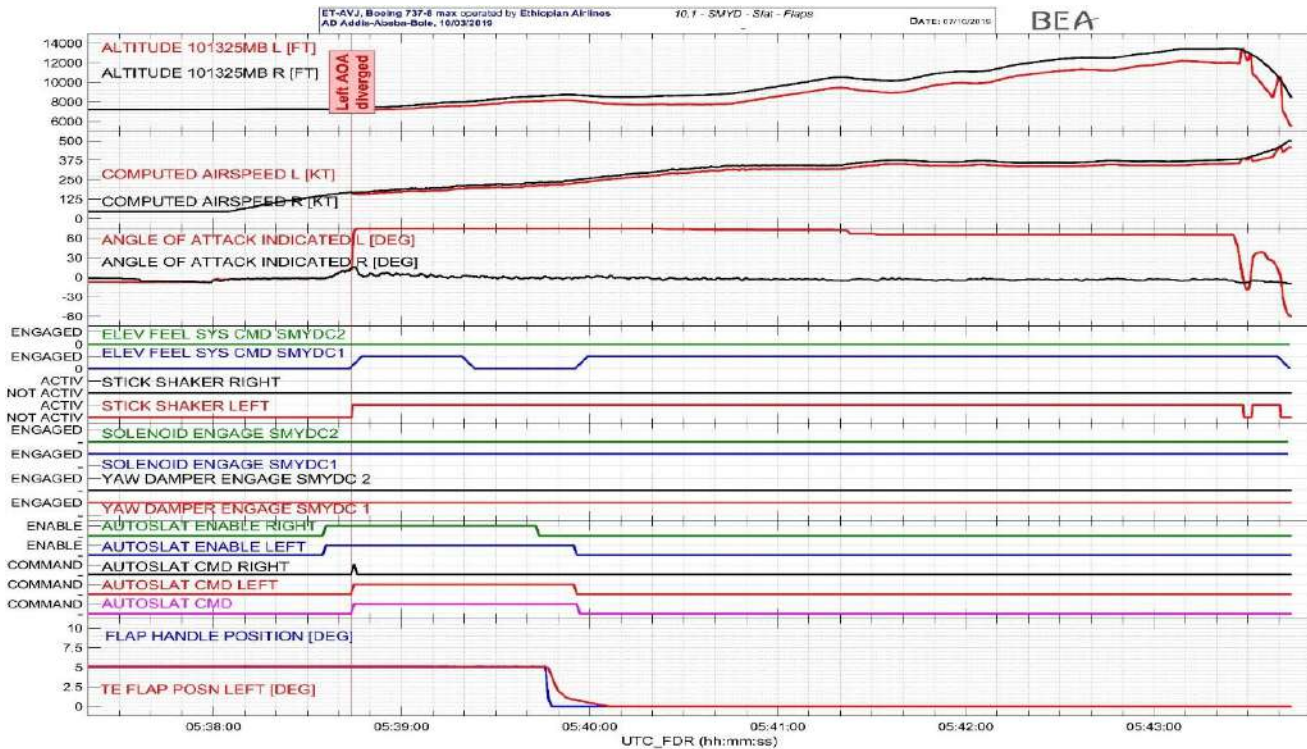
FIGURE74: AUTOSLAT, LEFT STICK SHAKER AND ELEVATOR FEEL SYSTEM

- the autoslat system triggered (SMYDC 1),
- the LH stick shaker engaged
- the LH elevator feel shift triggered.

At 5 h 39 min 56 s, the autoslat command ceased, the flap handle was at 0 position and flaps were moving up (flaps position lower than 1) with LH computed airspeed values reaching 230Kt and RH computed airspeed value 250Kt.

At 5h 39 min 44s SMYDC-2 disabled the RH autoslat function due to the RH computed airspeed (230Kt reached). SMYDC1 disabled the LH autoslat function 12s later due to the invalid LH computed airspeed.

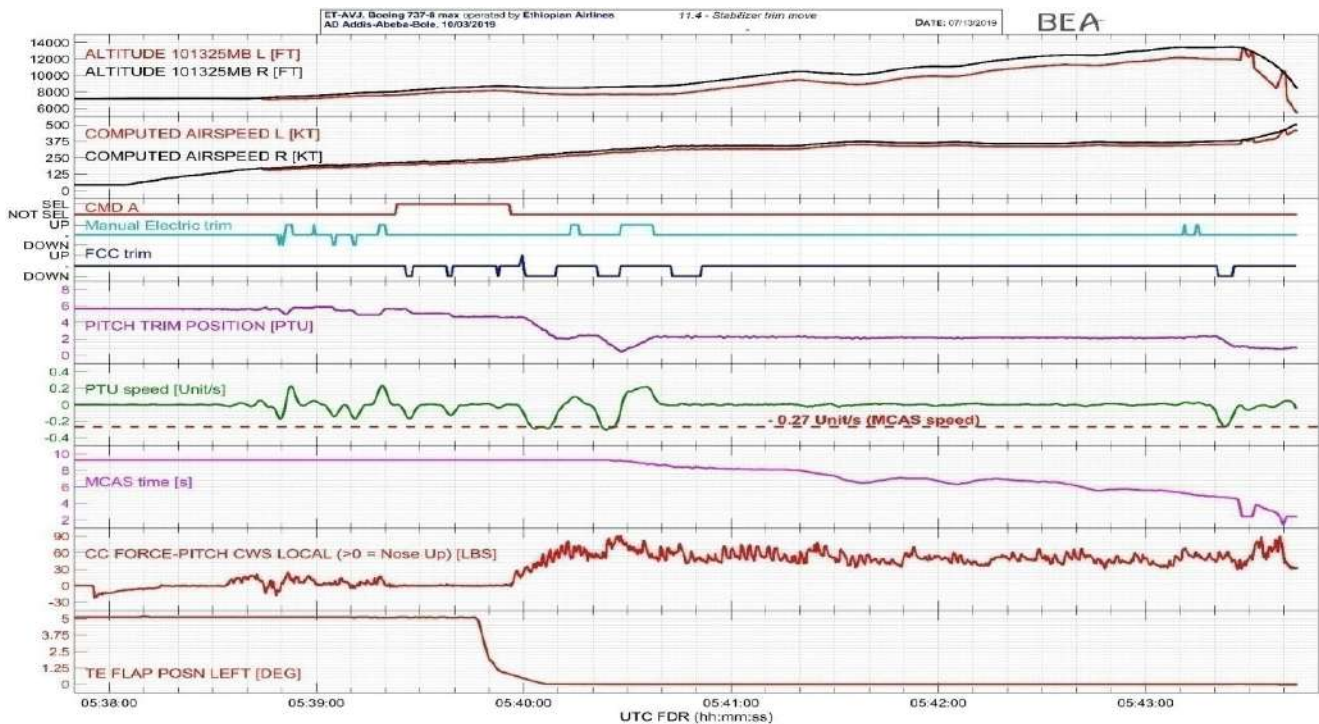
FIGURE 76: STABILIZER COMANDED MOVES

normal and intended function of stabilizer trim in manual flight). Between the liftoff and the engagement of CMD A, the stabilizer moved between 4.9 and 5.9 units. When A/P was engaged, the stabilizer was at 5.6 units.

Under A/P, 3 FCC A/P trims down commands were recorded and the stabilizer trim values decreased to 4.6 units. When A/P disengaged, one single sample of FCC trim UP was recorded (Speed Trim activation).

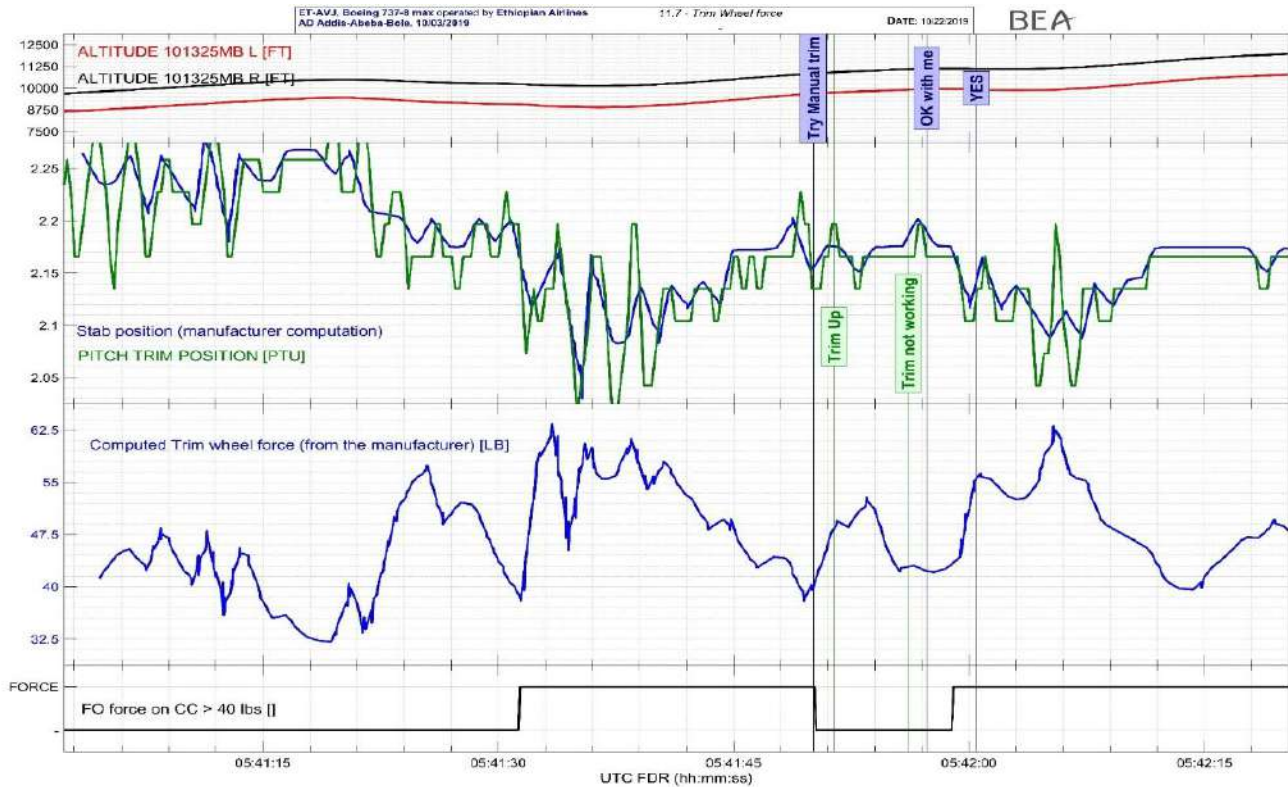
FIGURE 77: FORCE NEEDED TO MOVE THE TRIM WHEEL

By the time the FO tried to move the trim wheel manually a force between 42 lbs and 53 lbs was required according to the Airplane manufacturer computation, (see Figure 77).

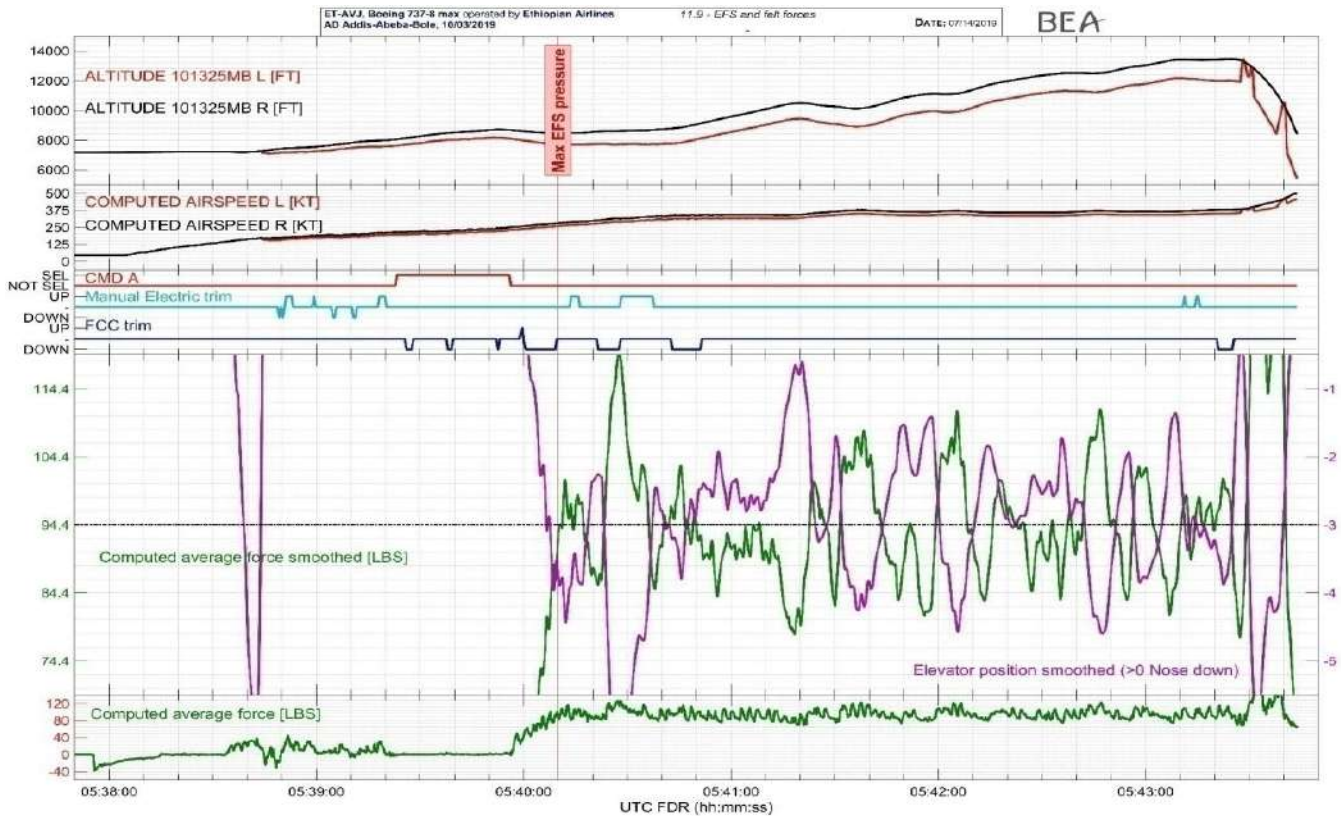
FIGURE 79: FELT FORCE AND ELEVATOR POSITION

The gradient of force felt by the crew can be illustrated by the comparison between the force applied on the control column and the position of the elevator. Note that because the flight conditions resulted in the Maximum feel pressure, the activation of EFS had no effect on these forces.

Figure 79 shows that from 5 h 40 min 10 s until the end of the flight:

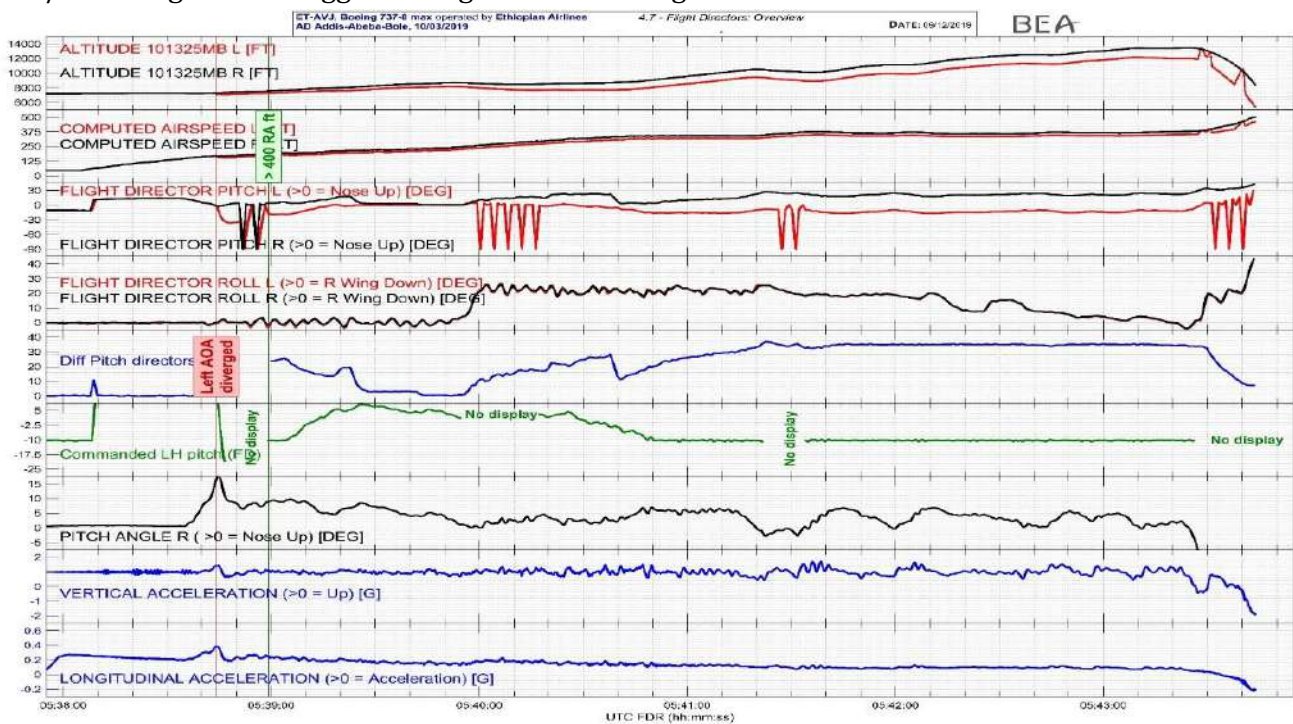
FIGURE 80: FLIGHT DIRECTOR DURING FLIGHT

Then the RH pitch director did not experience invalidity pattern anymore but 3 other periods of invalidity were recorded on the LH pitch director.

Each time the LH or the RH invalidity pattern was recorded, the recorded invalidity code (NCD - No Computed Data) indicates that the pitch F/D bar was removed from the PFD (biased out of view or BOV). The F/D fail flag did not trigger during the accident flight.

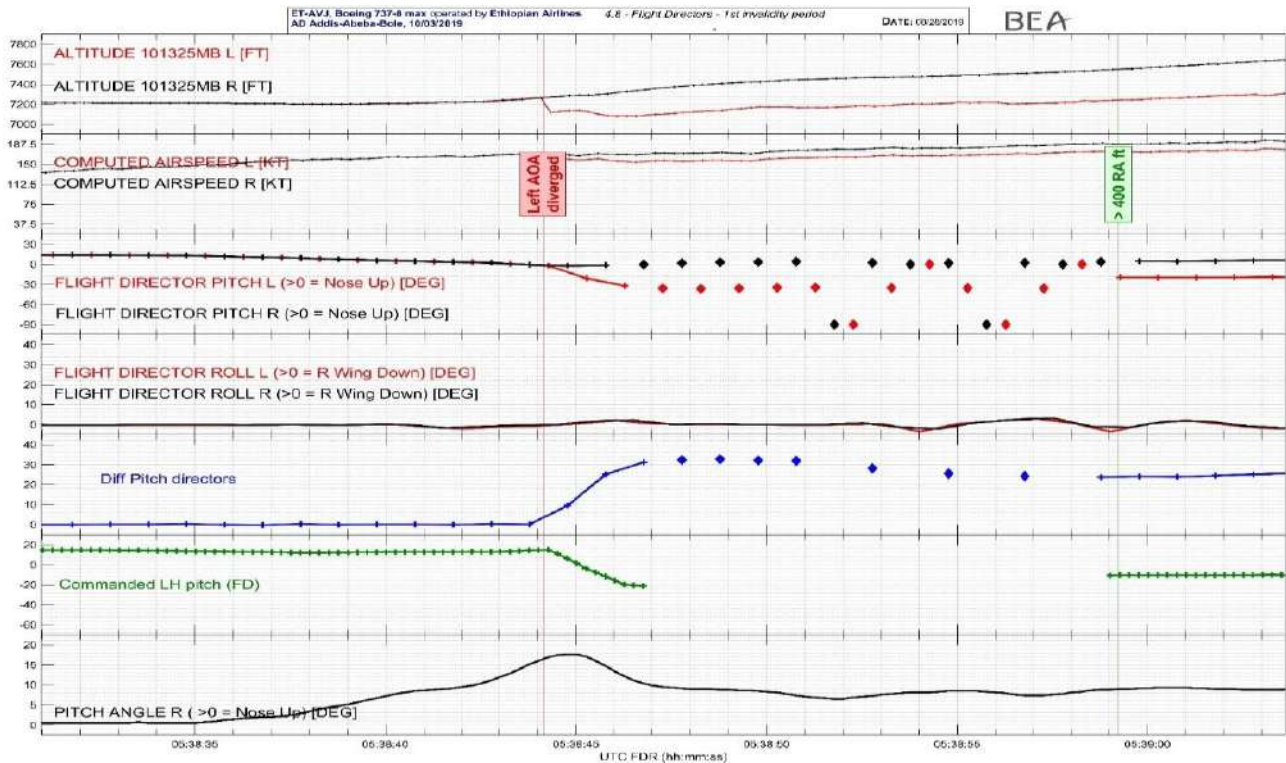
FIGURE 81: FLIGHT DIRECTORS - START OF THE FLIGHT

When the LH and RH AOA values diverged, LH pitch F/D commands recorded values quickly decreased to -32° while RH pitch F/D recorded values slightly increased to -0.4° . The difference between LH pitch F/D values and RH pitch F/D values were greater than the threshold above which FCCs comparators triggers and both F/D pitch were biased out of view.

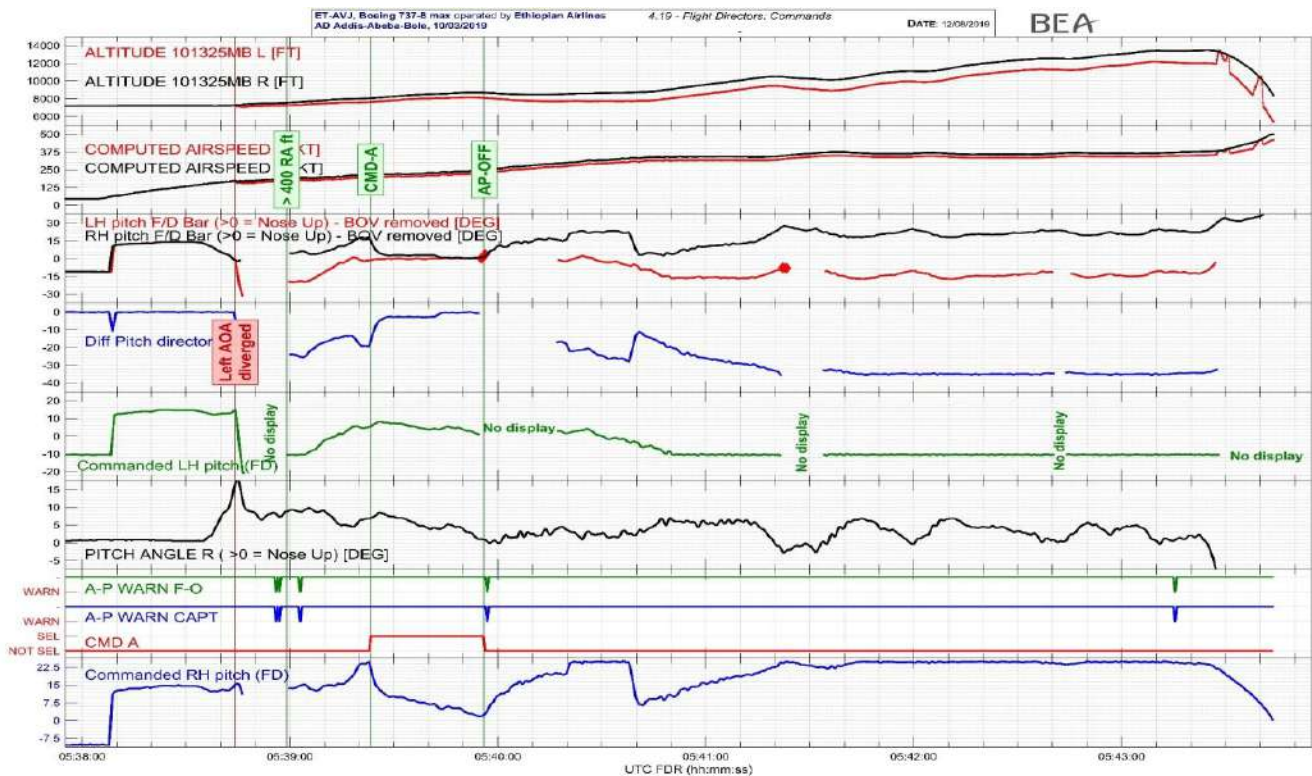
FIGURE82: PITCH F/D COMMANDS

- The F/D was in speed mode.
- The Airplane should have been climbing but the computed vertical speed value of the Airplane had been lower than the Climb threshold for 5 consecutive seconds.
- At the LH side the Airplane approached to stall
- LH F/D pitch commands (A/P not engaged)

Note: No anomalies were observed in the RH pitch F/D bar positions the RH pitch F/D bar positions are then considered as valid positions based the Airplane attitude, altitude, and speed engaged modes. Except under the autopilot, the LH pitch F/D bar position was at least 10° lower than the RH pitch F/D bar. The commands provided by the LH pitch F/D bar were not consistent with the true Airplane status and the engaged modes, due to the effects of the erroneous AOA on the calculation of the minimum operation speed.

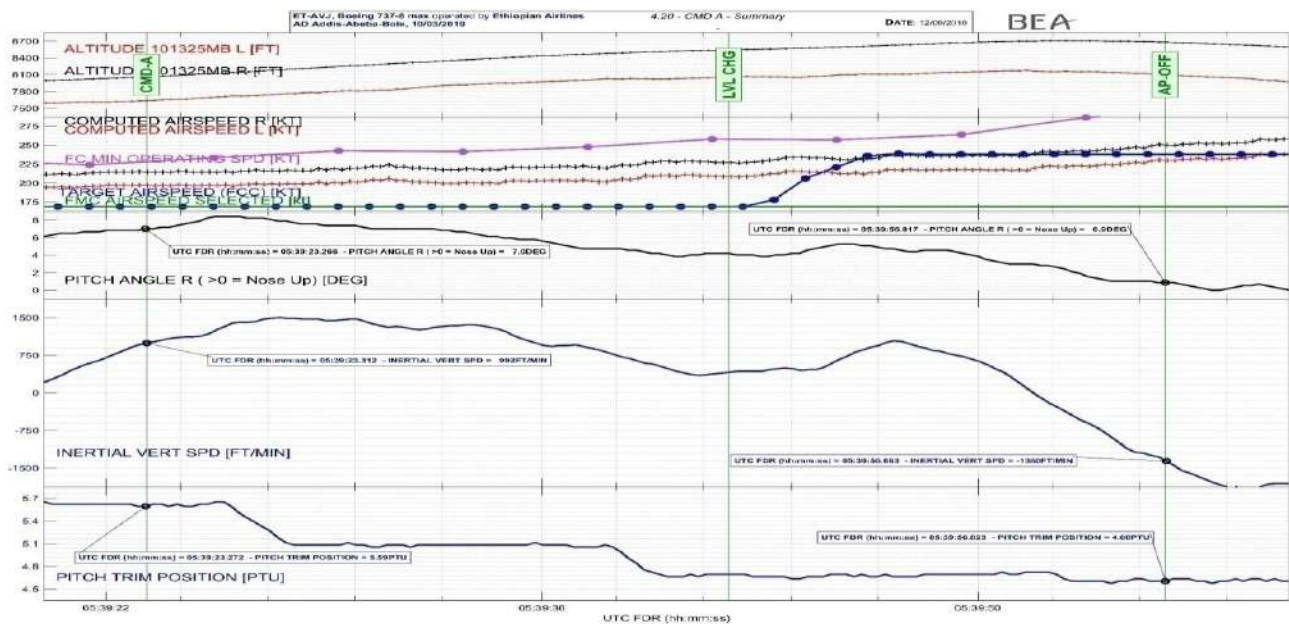
FIGURE85: CMD A - SUMMARY

At the connection of CMD A, the Airplane was climbing with a vertical speed of around 1,000 ft/min increasing, a pitch value of around 7° increasing and a stabilizer position of 5.6 units.

When CMD A automatically disconnected, the Airplane was descending with a vertical speed of around -1,400 ft/min, a pitch angle of around 1° and a stabilizer position of 4.6 units.

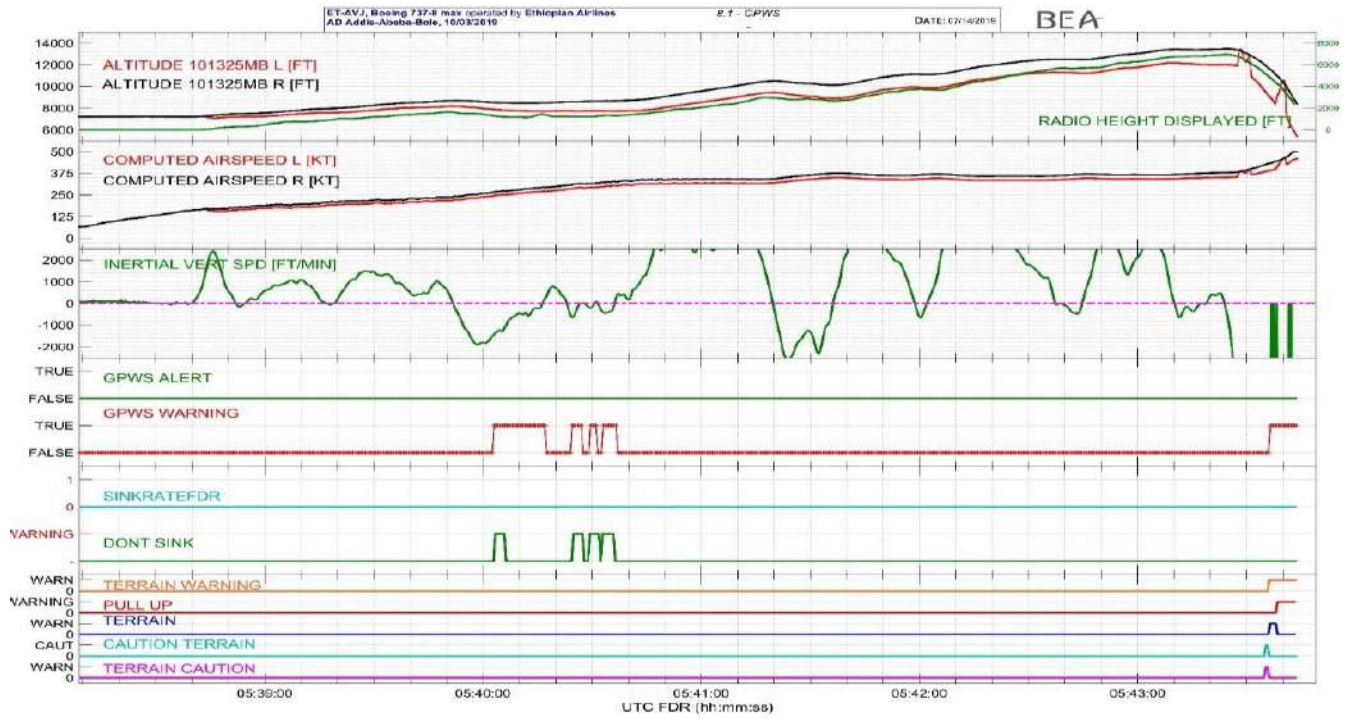
FIGURE87: GPWS ALERTS

At the end of the flight, the combination of the vertical speed and the height of the Airplane made the terrain and pull up warning trigger.

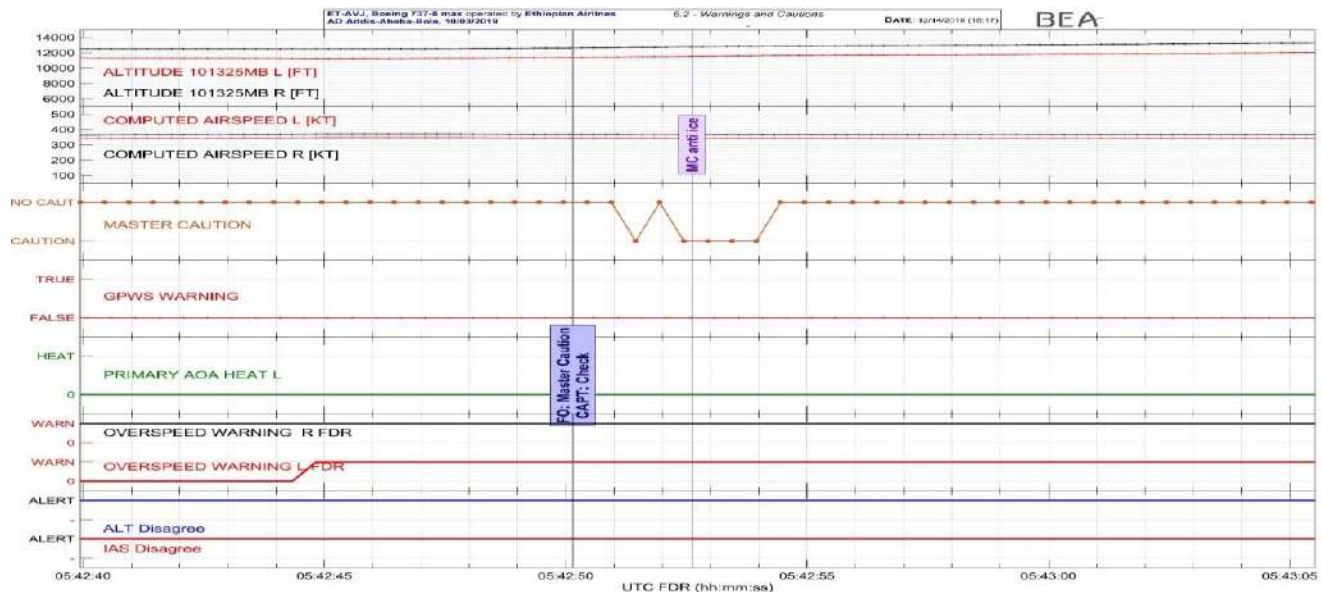
FIGURE 89: MASTER CAUTION RECALL

The first master caution triggered at 5 h 38 min 48 s during 7s. The reason for this master caution was anti-ice left alpha vane. This caution is triggered when low current is sensed in the AOA vane internal heater circuit. At 5 h 42 min 47 s, the crew exchanged about the master caution.

Then master caution triggered a second time at 5 h 42 min 51 s during 2.5 s. The crew detected: “Master Caution/anti Ice/left Alpha Vane”.
