AIRCRAFT ACCIDENT INVESTIGATION BUREAU

INVESTIGATION REPORT ON

ACCIDENT TO THE B737-MAX8 REG. ET-AVJ OPERATED

Report No. AI-01/19

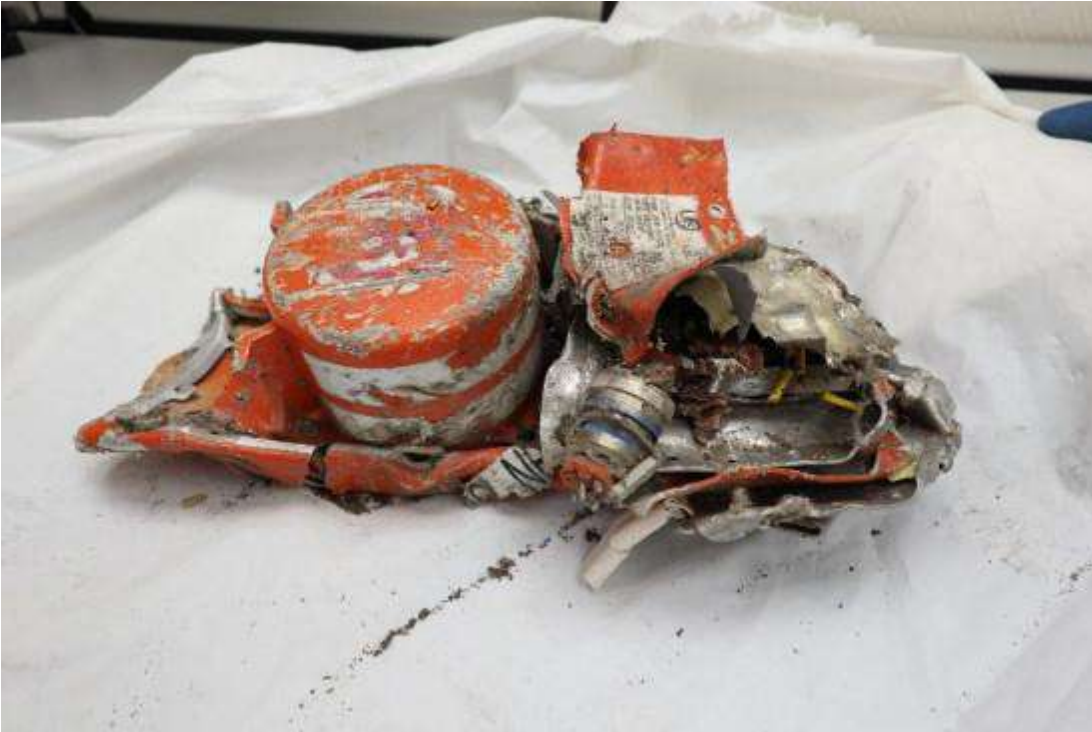
The FDR was first visually examined. The chassis was damaged and folded on itself. The acquisition boards were visible as well as some internal connectors. The protected module Crash Survival Module Unit (CSMU) was still attached to the chassis and presented scratches. There was no ULB attached to the CSMU. A recorder identification plate was found close to the CSMU on the chassis, but not fixed to the chassis, on which the following numbers were written: P/N 2100-4945-22, S/N 001217995

FIGURE 1: FDR FOUND IN THE SUITCASE BROUGHT BY ETHIOPIAN EAIB

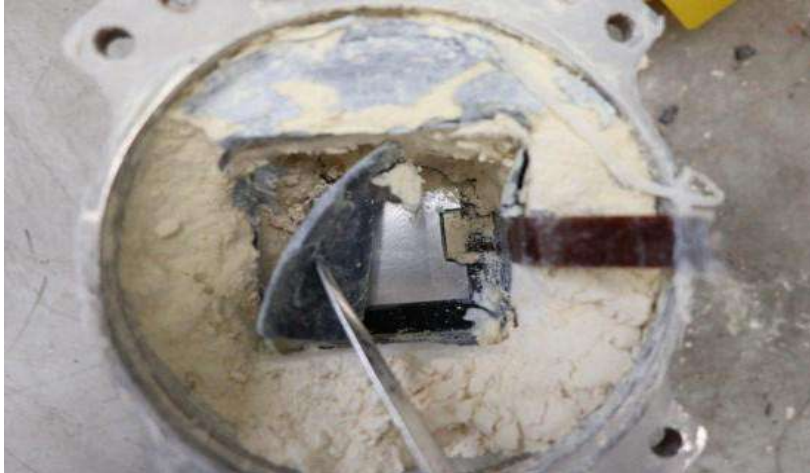
FIGURE 2: AT OPENING THE FDR CSMU, SHOWING THE MEMORY PUCK AND FLEX

It was first attempted to extract the memory puck by gently pulling on the flex. It was found that the connector was not properly attached to the memory puck.

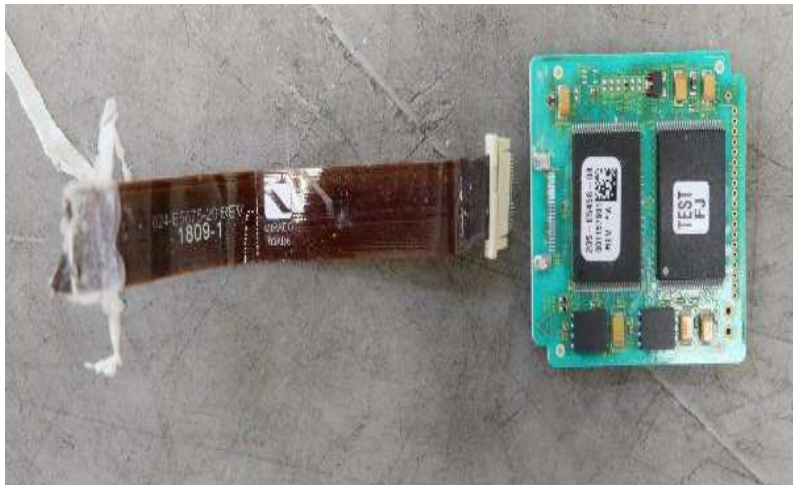
FIGURE3: FDR MEMORY BOARD, FLEX AND CONNECTOR

When examining the flex and connector, it was found that the missing pads from the memory board had migrated to the connector pins. There were also pieces of PCB material on the connector pins.

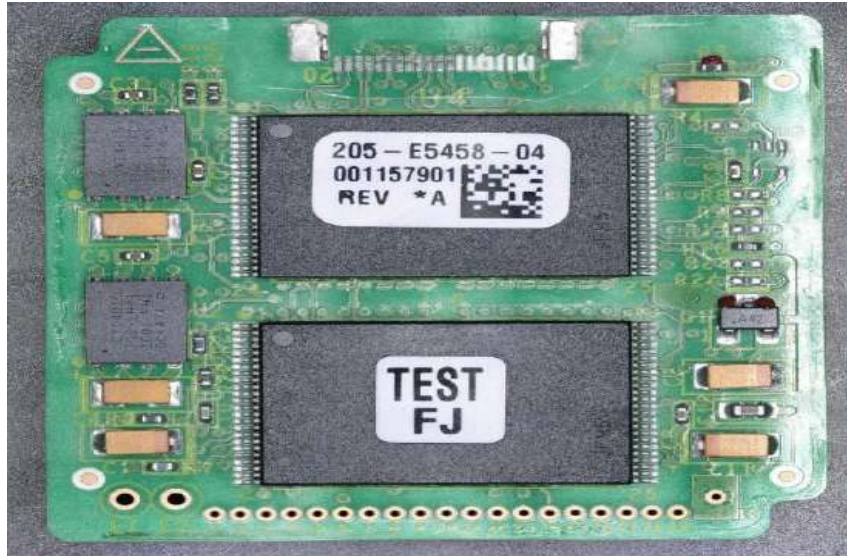
FIGURE 4: FDR MEMORY BOARD

At the connector location on the memory board the first 8 pads (on Figure 4)) were found missing. The holes were filled with insulation dust. The last 12 pads were in good condition.

The FDR memory board was also inspected with the X-ray machine. This confirmed that the first 8 pads of the connector were missing on the memory board (*Figure 4*) and that the 12 others were in good condition. There was continuity between those 12 pads and their vias (left side on *Figure 4*).

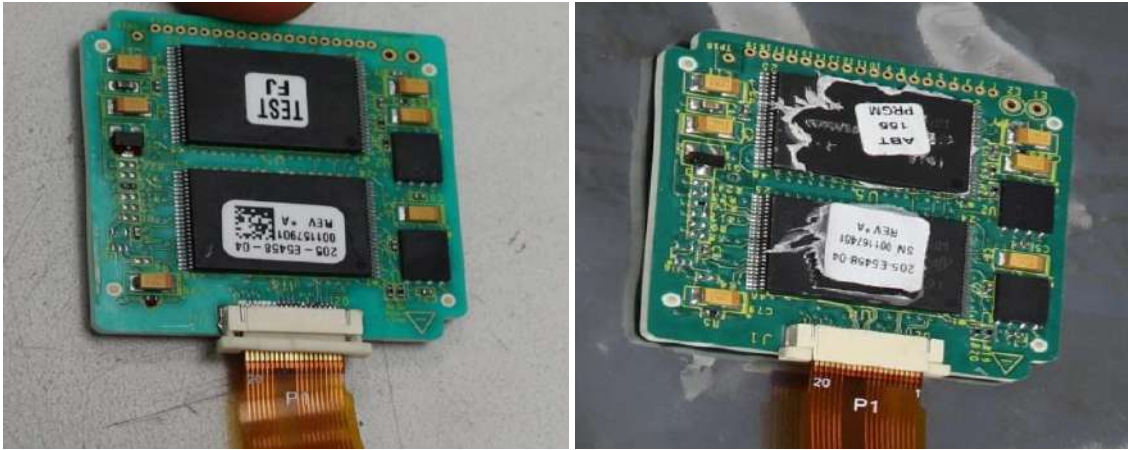
FIGURE 7: ET-AVJ FDR MEMORY BOARD WITH INTERFACE BOARD CONNECTOR FROM BEA SURROGATE RECORDER (LEFT), BEA SURROGATE RECORDER MEMORY BOARD WITH ORIGINAL CONNECTOR (RIGHT), BOTH MOUNTED WITH FLEX CABLE PIN VISIBLE AND "P1" WHEN PERFORMING READOUT

On March 16th, all parties agreed that it was only necessary to resolder the last 12 pins of a new connector (pins 9 to 20, on the left side of *Figure 10*) to the FDR memory board to download the data.

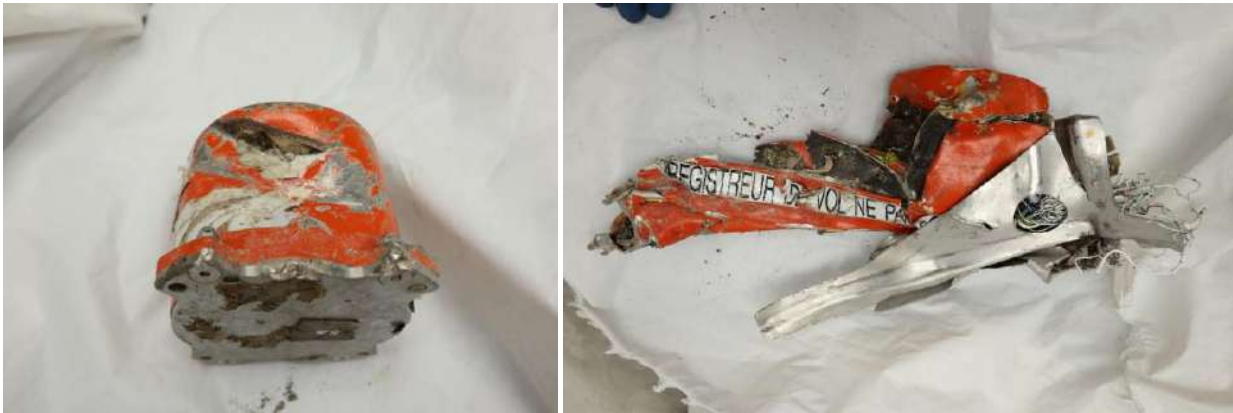
The CVR CSMU was already separated from its chassis when it was brought to the BEA facilities. There was no ULB attached to it and no identification plate was found on the CSMU.

The isolated chassis was damaged and still partially attached to the Airplane rack on which it was mounted. There was no identification plate on it. Wires were visible on the back side.

FIGURE 8 CVR CSMU AND CHASSIS WHEN BROUGHT BY ETHIOPIAN EAIB

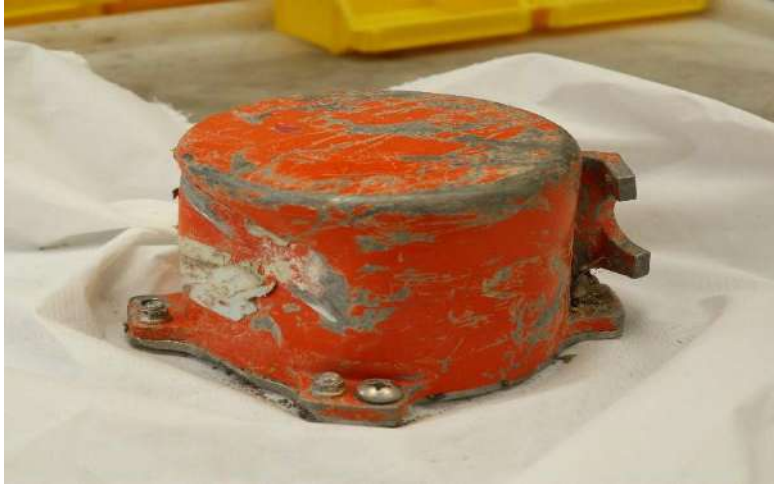
The CSMU case showed an opening. The hole on the side opposite to the ULB fixation allowed seeing the internal insulation material

FIGURE 9: CVR WHEN OPENING THE SUITCASE BROUGHT BY ETHIOPIAN EAIB

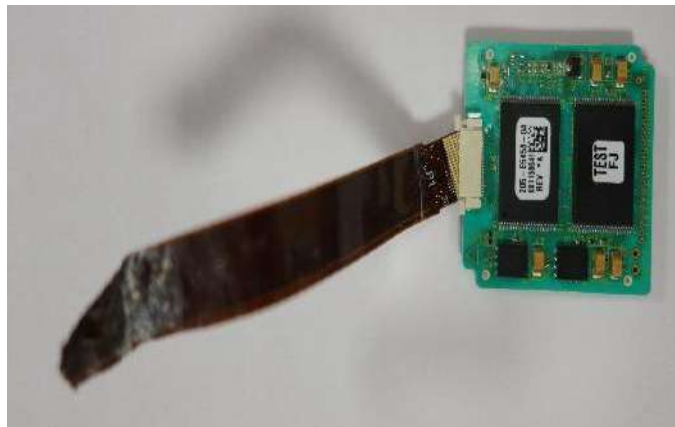
FIGURE 10: CVR MEMORY BOARD AND FLEX

The CVR memory board and flex were visually inspected with the Keyence microscope. There was no damage on the board and the connector was in good condition.

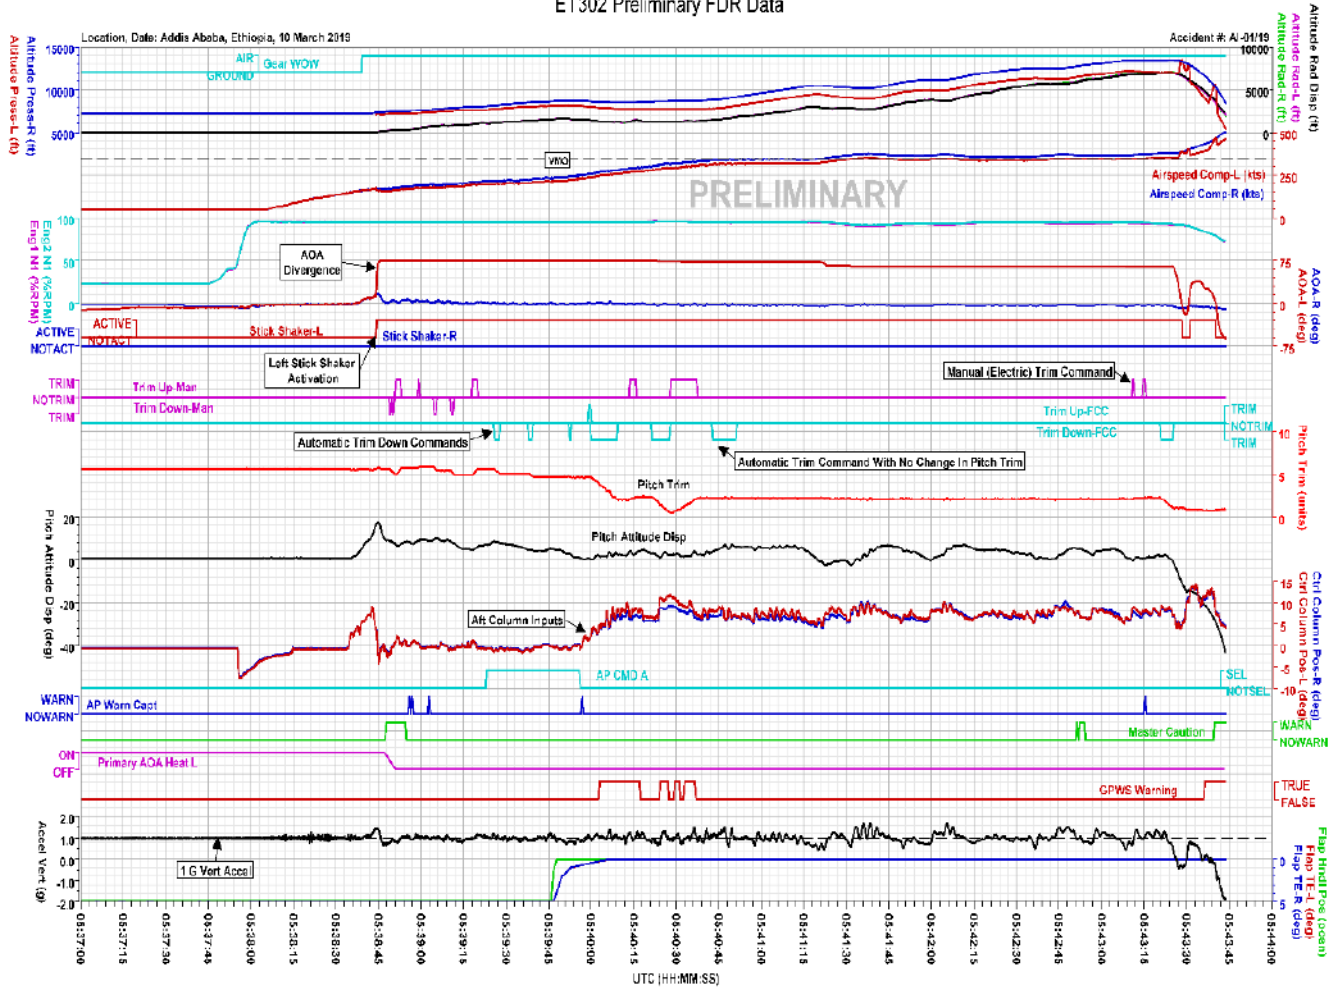
ATTACHMENT2: ET -AVJ GENERAL VIEW OF FDR DATA

As the validation process, a focus was made on the angle of attack parameters. The left and right angle of attack parameters showed significant differences during the accident flight. Those two parameters showed similar values during the end of the previous flight (and were within coherent range).
