The Islamic Republic of Iran
Civil Aviation Organization
Aircraft Accident Investigation Board

Final Report

File Number: S980102 ATG

Type of Aircraft: Fokker 100

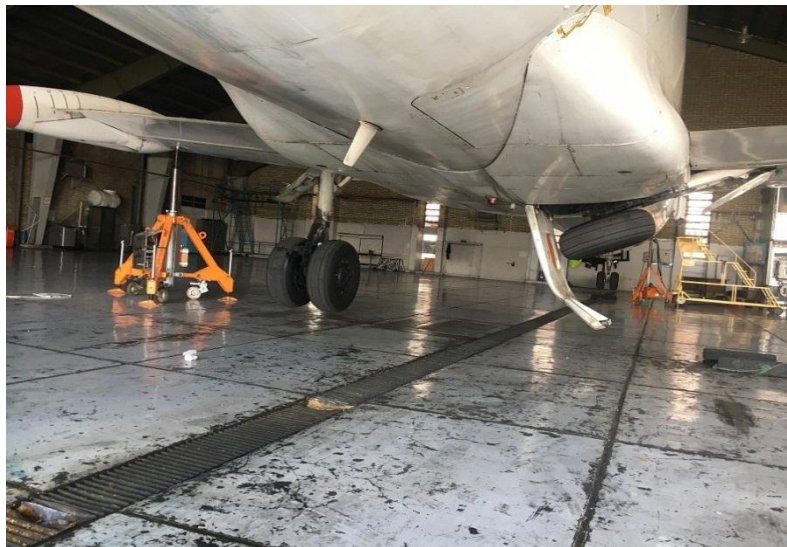
The aircraft was jacked up in the hangar to test the Landing Gear operation but the right main landing gear was not extended as expected.

There was not any damage to the aircraft fuselage generally, but due to contamination on the aircraft hydraulic system, only the "Restrictor Check Valve" landing gear on the right side of the aircraft was damaged.
