AIRCRAFT ACCIDENT REPORT AND EXECUTIVE SUMMARY

Reference:	CA18/2/3/9780	
Aircraft Registration	ZS-ICB	Date of Accident	29 March 2019		Time of Accident	1430Z	
Type of Aircraft	Piper PA 30		Type of Operation		Training (Part 141)		
Pilot-in-command Licence Type	Airline Transport Pilot Licence		Age	30	Licence Valid	Yes	
Pilot-in-command Flying Experience	Total Flying Hours		3846.3		Hours on Type	148.4	
Last Point of Departure		Rand Aerodrome (FAGM), Gauteng					
Next Point of Intended Landing		Syferfontein Aerodrome (FASY), Gauteng					
Location of the accident site with reference to easily defined geographical points (GPS readings if possible)							
Westonaria 16nm south-west of Johannesburg CBD at the following GPS co-ordinates: S20° 11' 54" E027° 46' 43.5" with an elevation of 5393ft							
Meteorological Information		Wind: 170° at 06 kts, Visibility: CAVOK, Temperature: 28°C, Dew point: 07°C, Query Nautical height (QNH): 1022hpa					
Number of People On-board	2+0	No. of People Injured	2	No. of People Killed	0

Reference Number : CA18/2/3/9780
Name of Owner : Panayiotou C
Name of Operator : Johannesburg School of Flying
Manufacturer : Piper Aircraft Corporation
Model : PA-30
Natio

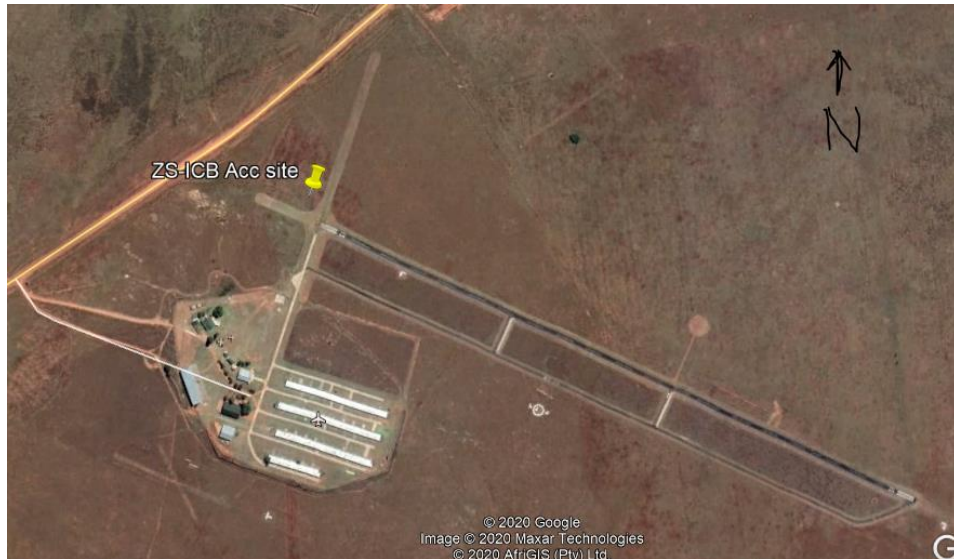
- 1.1.4 The accident occurred during daylight at Global Positioning System (GPS) co-ordinates S20° 11' 54" E027° 46' 43.5" at an elevation of 5393ft.

Figure 1: Location of the wreckage at FASY.
