Final report RL 2020:04e

Accident at Varberg/Getterön Airport on 5 May 2019 involving the powered sailplane SE-USN of the model SF 25 C, operated by a private individual.

File no. L-53/19

29 April 2020

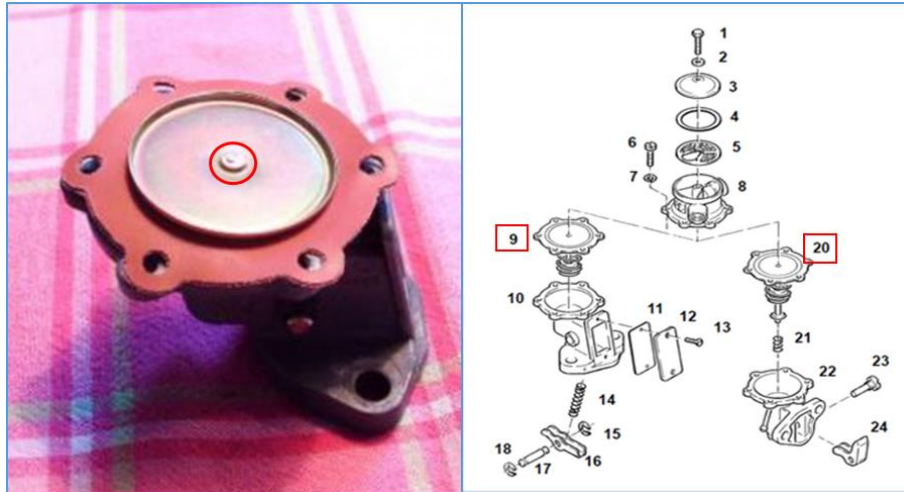
The diaphragm is mounted on a rod with a metal plate on either side of the membrane. The metal plates and the diaphragm are held together by the rod being deformed plastically so that it exerts pressure on both sides, this is known as riveting (see Figure 4).

Figure 4. Left image, reference image of a new diaphragm. The flattened rivet head is seen in the middle of the circle. Image: SAUER. Right image, exploded-view drawing of mechanical fuel pump (APG). Numbers 9 and 20 are the diaphragm with diaphragm spring. Image: Limbach Flugmotoren GmbH.

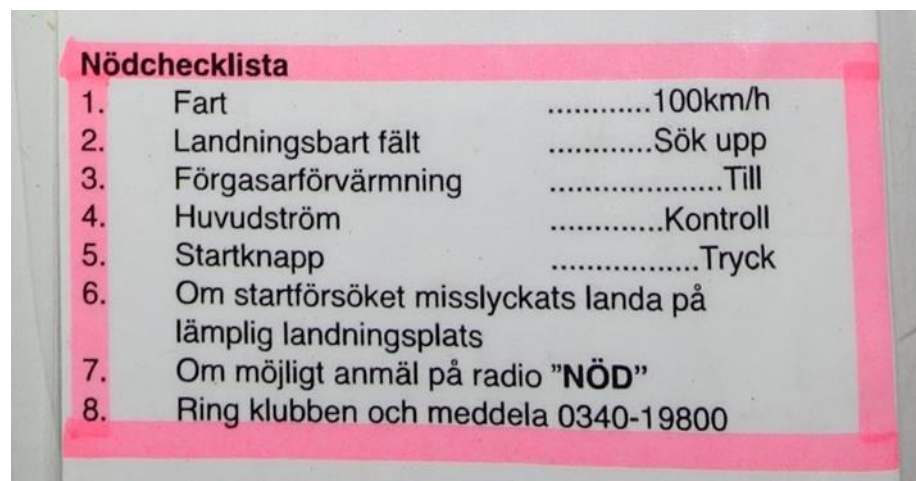
Figure 5. Image of the emergency checklist on board.

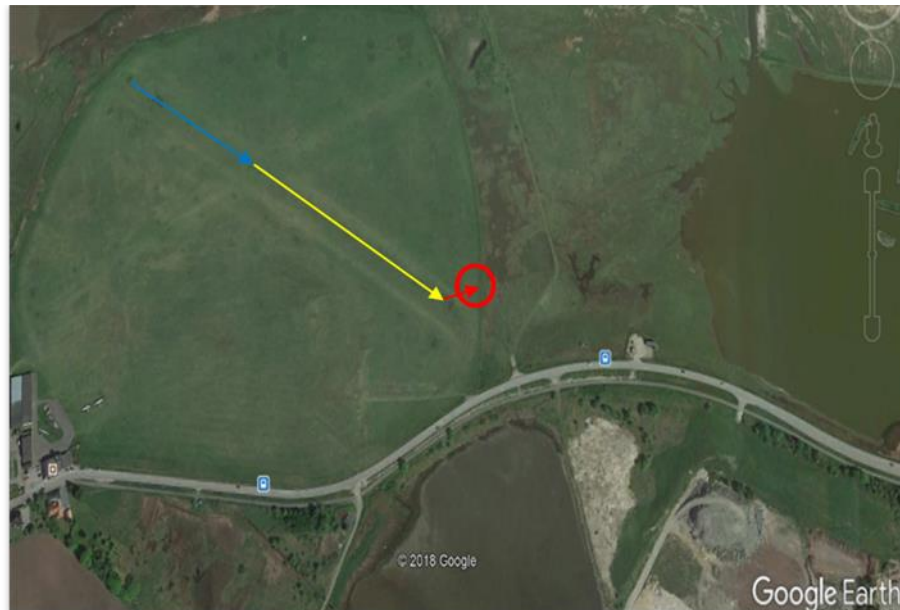
The aeroplane came to a stop just after and to the left of the end of runway 12 (see Figures 10 and 11).

Figure 10. The arrows indicate the aeroplane's direction and the aeroplane's final position is marked with a red circle. The arrows and the red circle have been drawn by SHK. Image: Google Earth.
