Final report RL 2020:08e

Accident at Storsandskär, Västerbotten County, on 14 July 2019 involving the aeroplane SE-MES of the model GA8-TC 320, in conjunction with parachuting activities at Umeå Parachute Club.

File no. L-96/19

9 September 2020

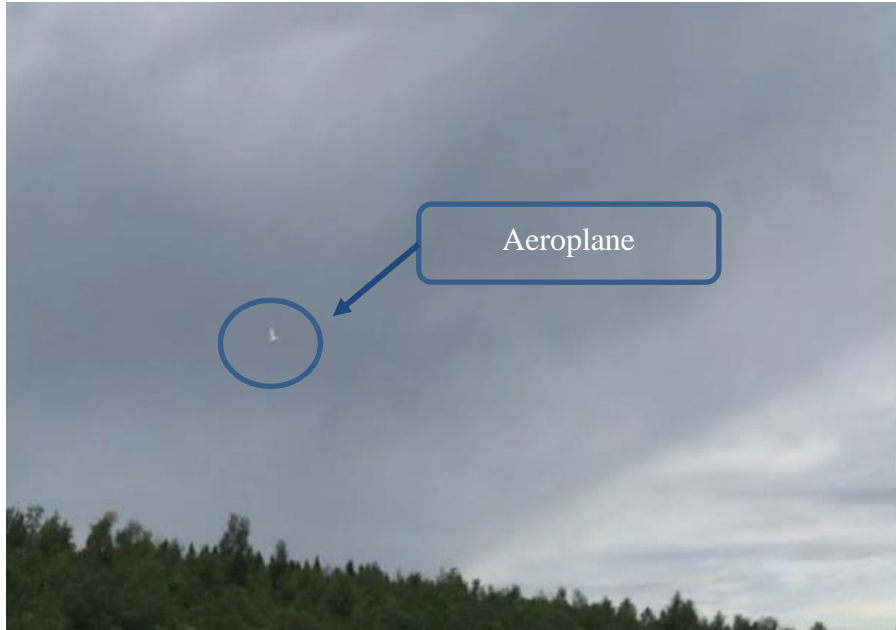
Figure 16 shows the aeroplane under the clouds at the time of the accident.

Figure 16. Cloud formation with the aeroplane falling in the final stage. Markings and text by SHK. Photo: Eva Johansson.

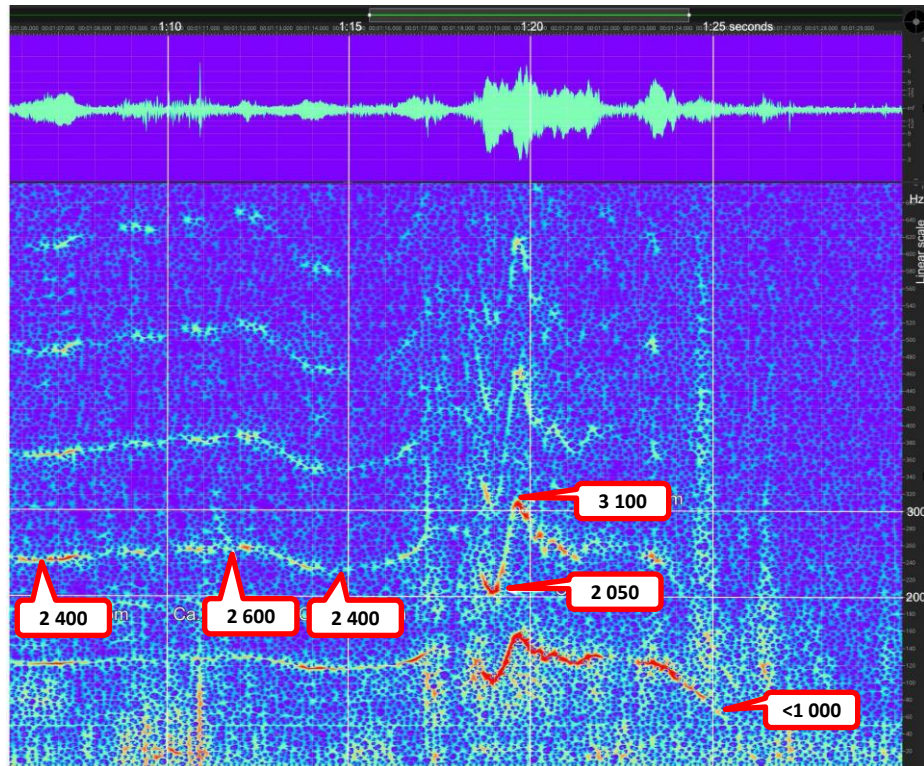
The last thirty seconds of the sound from the CCTV recording shows changes in the engine rpm. The first overtone has been chosen for measurement.

From 2,400 rpm, there are rapid changes between 2,050 and 3,100 rpm. The sound of the engine then drops below 1,000 rpm.

Figure 20. Enlarged spectrogram for the final part of the CCTV sound recording of the engine sound.

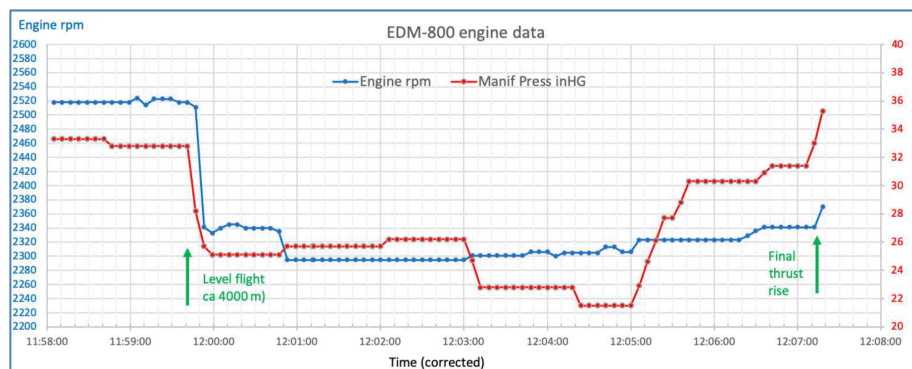
Figure 24 shows the final stage of the recorded data. It is possible to observe that the manifold pressure increases at 12:05:00, which indicates an increase in throttle in conjunction with the pilot receiving clearance to climb higher because of clouds.

At 12:07:04, a further increase in manifold pressure and an increase in engine rpm was recorded.

The recordings suddenly stop at 12:07:16.

Figure 24. Final stage of the recorded data.

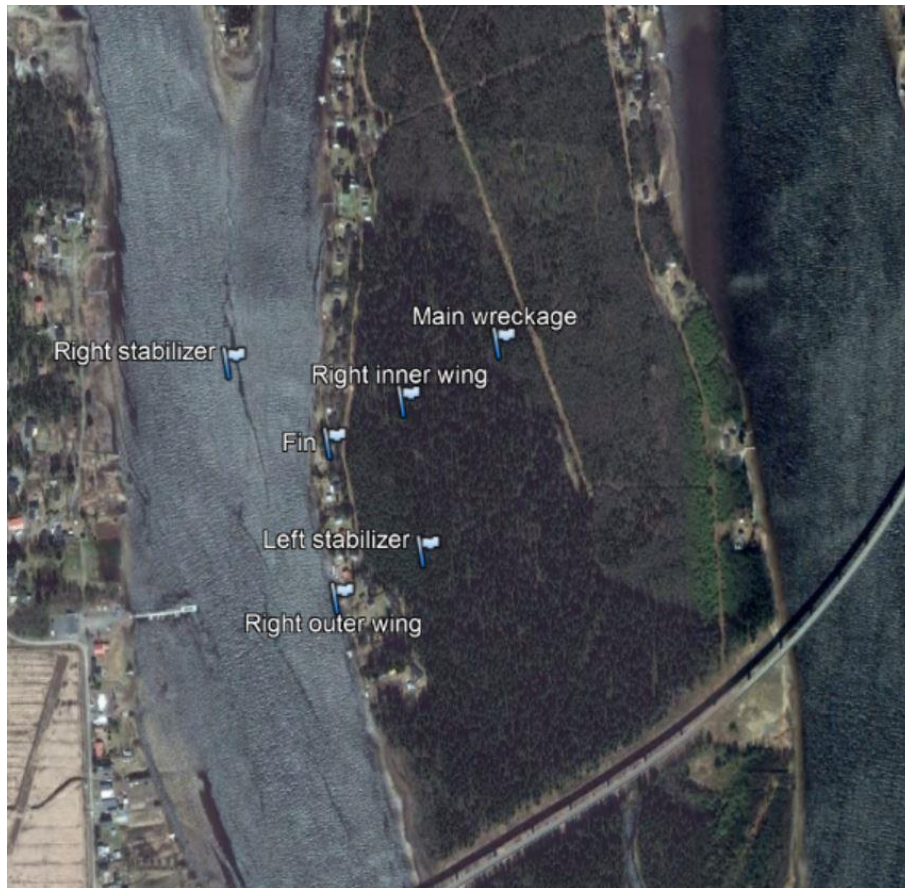
The right wing was broken into two pieces, as was the stabiliser. The outer section of the right wing and the right section of the stabiliser were found in the Ume River, to the west of Storsandskär. The inner section of the right wing was found 125 metres to the west of the wreckage. The tail fin was found 225 metres away in a westerly direction and the left section of the stabiliser was found 250 metres south-west of the fuselage.

The locations of the parts from the wreckage have been marked on Figure 33. The right outer wing and the right part of the stabilizer fell into the Ume River and were salvaged before SHK arrived at the site. The positions of these are according to information from The Swedish Maritime Administration and private individuals.

Figure 33. The accident site with the location of the parts of the wreckage. Photo: Google Earth: © Lantmäteriet Ref. no. R61749_190001.

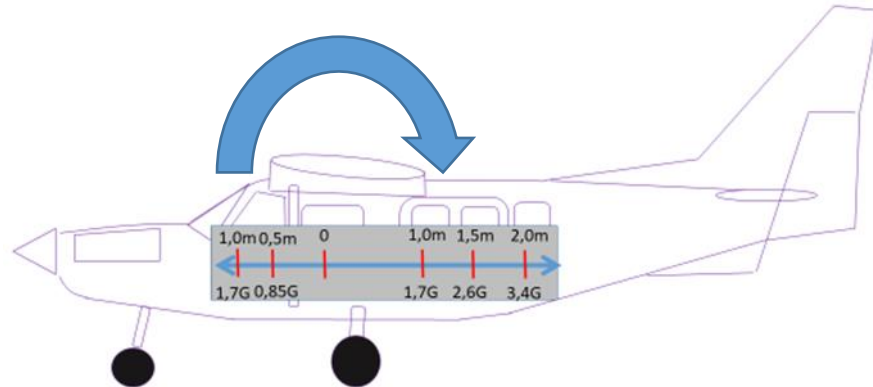
Figure 34. G-forces along the length of the aeroplane after the wing broke during that part of the sequence of events that is recorded on film.

After the aeroplane broke up, it rotated at 0.6 revolutions/second with the left wing up, which, according to SHK's calculations, resulted in g-forces of up to 3.5 along the length of the aeroplane (see Figure 34).

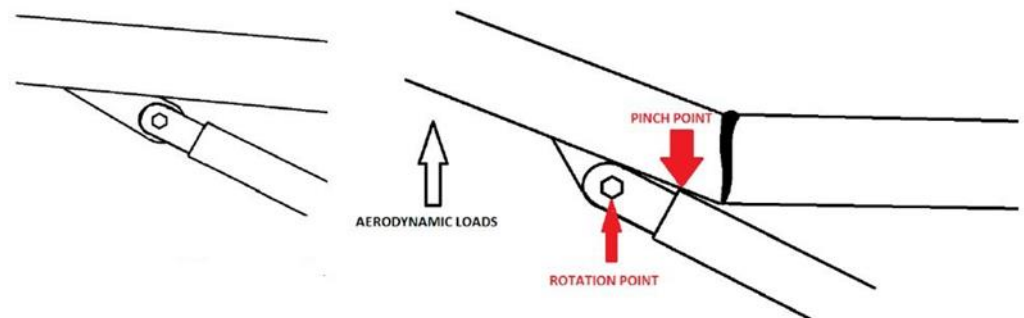
The broken attachment to the right wing strut was pushed into the underside of the wing and was not in its normal position (see Figure 37).

Figure 38 shows the probable sequence in which the outer section of the right wing broke. Please note that the attachment is pushed in towards the lower surface of the wing and that the attachment is rotated.

Figure 38. Sequence of failure of the right wing and attachment to the wing strut. Image: CASA.

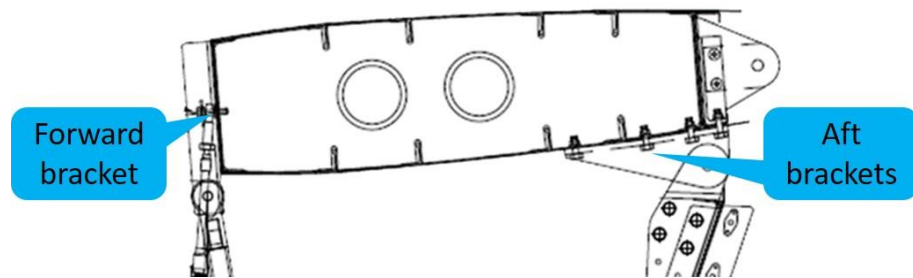
Figure 41. Cross-section of the stabiliser showing its attachments. Image: GibbsAero.Pty Ltd Service Manual. Amendment 54. Page 27-19. Figure 27-15, textboxes by SHK.

The stabiliser has three attachment points (see Figure 40 and 41). It is mounted to a forward bracket that is riveted to the stabiliser's front spar. This bracket is also attached at the jackscrew for stabiliser trim. The rear part of the stabiliser is attached to two brackets; right and left. These brackets are the stabiliser's pivot points.

The two rear brackets for attachment of the stabiliser were mounted to the lower surface of the stabiliser using four screws (see Figure 42). The lower right image shows the lower surface of the stabiliser where one of the brackets has been mounted. There was damage to the skin panel and the screw holes in the stabiliser. The other attachment on the stabiliser showed similar damage.

This damage indicates that all the screws were mounted in place at the time of the failure.

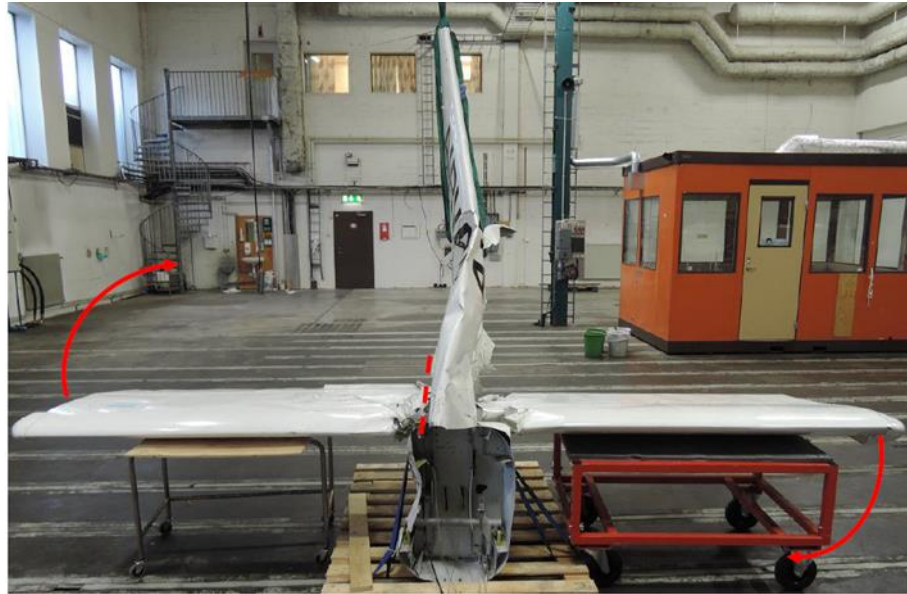
Figure 46. Sequence of failure of the stabiliser and the fin.

Figure 46, which shows the empennage looking backwards from the direction of travel, illustrates the likely sequence in which the various parts of the empennage, the stabiliser and the fin, have broken up in the air.

Damage and broken skin panels on the right side of the fin indicate that the fin has been pushed and broken to the left seen in the direction of flight. The red dashed line shows the area where the tail fin has initially failed.

The damage to the stabiliser's attachments, structure and skin panels indicates that the right part of the stabiliser has been broken off upwards and to the left. Damage to the top side also indicates that it has been pushed towards the right side of the fin.

Damage to attachments and structures of the left part of the stabiliser indicates that it has been broken off downwards.

All the fracture surfaces that have been examined show signs of rapid overload fractures. There were no signs of fatigue, corrosion or other material defects.

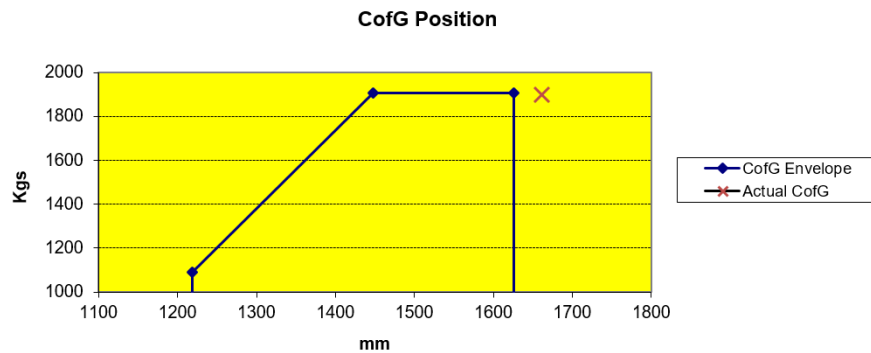
Figure 48. The centre of gravity prior to door opening, 1,659 mm.

The permitted area at maximum mass is 1,448–1,626 mm. According to this calculation, mass and balance were outside of the mass and balance diagram.

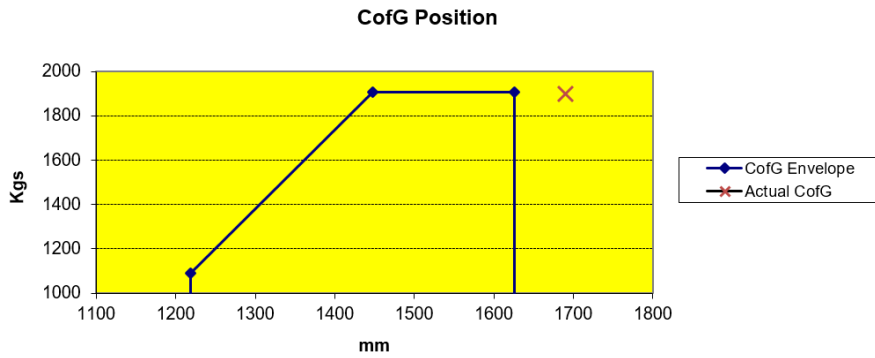
Figure 49. The centre of gravity during door opening, 1,694 mm.

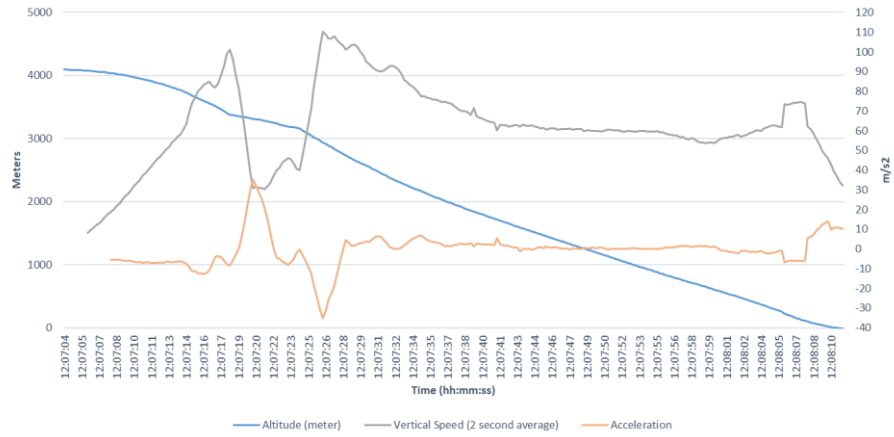
Figure 51. The blue curve shows the altitude in metres, the grey curve shows the rate of descent in metres per second and the yellow curve shows vertical acceleration in metres per second squared.

The calculations show that there have been vertical accelerations of up to 35 m/s^2 , which entails a vertical g-force of 3.5 g.

At an altitude of just over 3,000 metres, the rate of descent was 100 m/s and the horizontal speed, calculated from radar data, was 45 m/s. This means that the dive angle was just over 60 degrees. This can be used to calculate the airspeed at 109 m/s (218 knots).

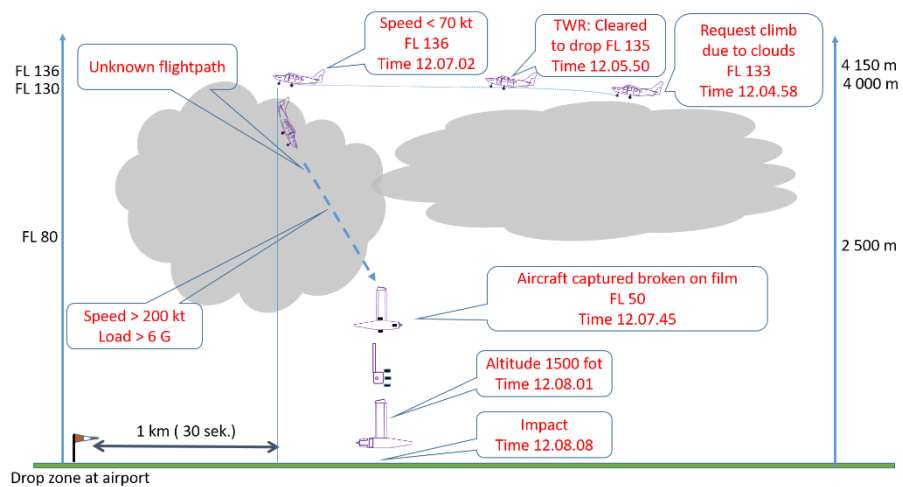
Figure 70. Analysis of the sequence of events (not to scale, times UTC).

SHK's assessment is that during this time interval the aeroplane was overloaded and the right wing was broken off, which led to an intense rotation to the right. As a result of this, the stabiliser and the fin broke loose.

The videos of the final stage of the sequence of events that were shot from the ground, show that the fuselage, without the right wing, tail fin and stabiliser, rotated in the horizontal plane with the left wing pointing upwards.

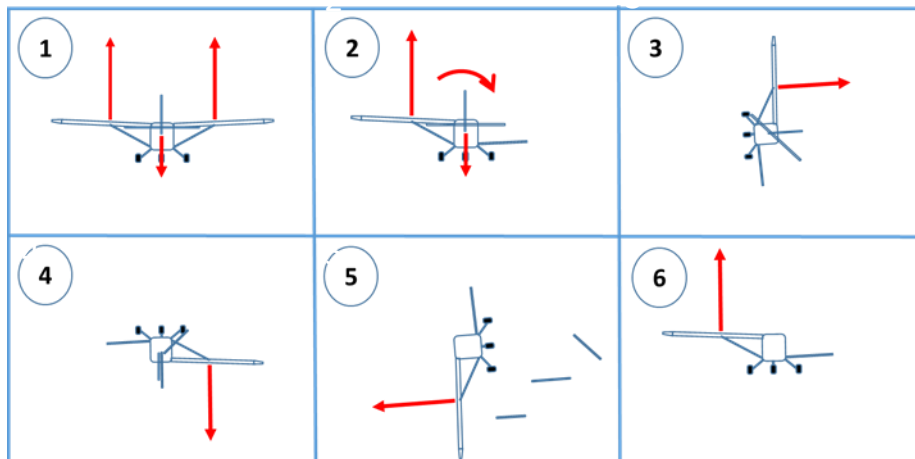
The practical possibility for those on board to get out of the aeroplane has been influenced partly by the g-forces they were subject to during the sequence of events, and partly by the circumstance that the parachutists have probably been thrown around in the cabin. In addition, it is likely that a very intense rotation to the right took place in conjunction with the wing breaking off. The aeroplane may well have rotated more than two revolutions to the right in the first second, when there was still lift on the left wing.

Figure 71. Forces present in conjunction with the wing rupture, separation of the stabiliser and tail fin.

This means that those on board have probably lost consciousness, at least temporarily, when these movements occurred.
