<b>AIRCRAFT ACCIDENT REPORT AND EXECUTIVE SUMMARY</b>
---

Reference:	CA18/2/3/9804	
<b>Aircraft Registration</b>	ZS-HLJ	<b>Date of Accident</b>	23 July 2019		<b>Time of Accident</b>	1106Z
<b>Type of Aircraft</b>	Bell UH-1H		<b>Type of Operation</b>	Fire-fighting (Part 137)		
<b>Pilot-in-command Licence Type</b>	Commercial CPL(H)	<b>Age</b>	53		<b>Licence Valid</b>	Yes
<b>Pilot-in-command Flying Experience</b>	Total Flying Hours	6596.7		Hours on Type	194.9	
<b>Last Point of Departure</b>	Letaba Air Base in Politsi near Tzaneen, Limpopo Province					
<b>Next Point of Intended Landing</b>	Letaba Air Base in Politsi near Tzaneen, Limpopo Province					
<b>Location of the accident site with reference to easily defined geographical points (GPS readings if possible)</b>						
Bosveld Citrus Farm in Politsi at GPS co-ordinates determined to be S23°45'22.71" E030°6'32.97" at 2643ft above mean sea level (AMSL)						
<b>Aircraft Damage</b>	Substantial					
<b>Meteorological Information</b>	Wind: 250°6.5kts; Temperature: 26°C; QNH: 1017hPa, Visibility: CAVOK

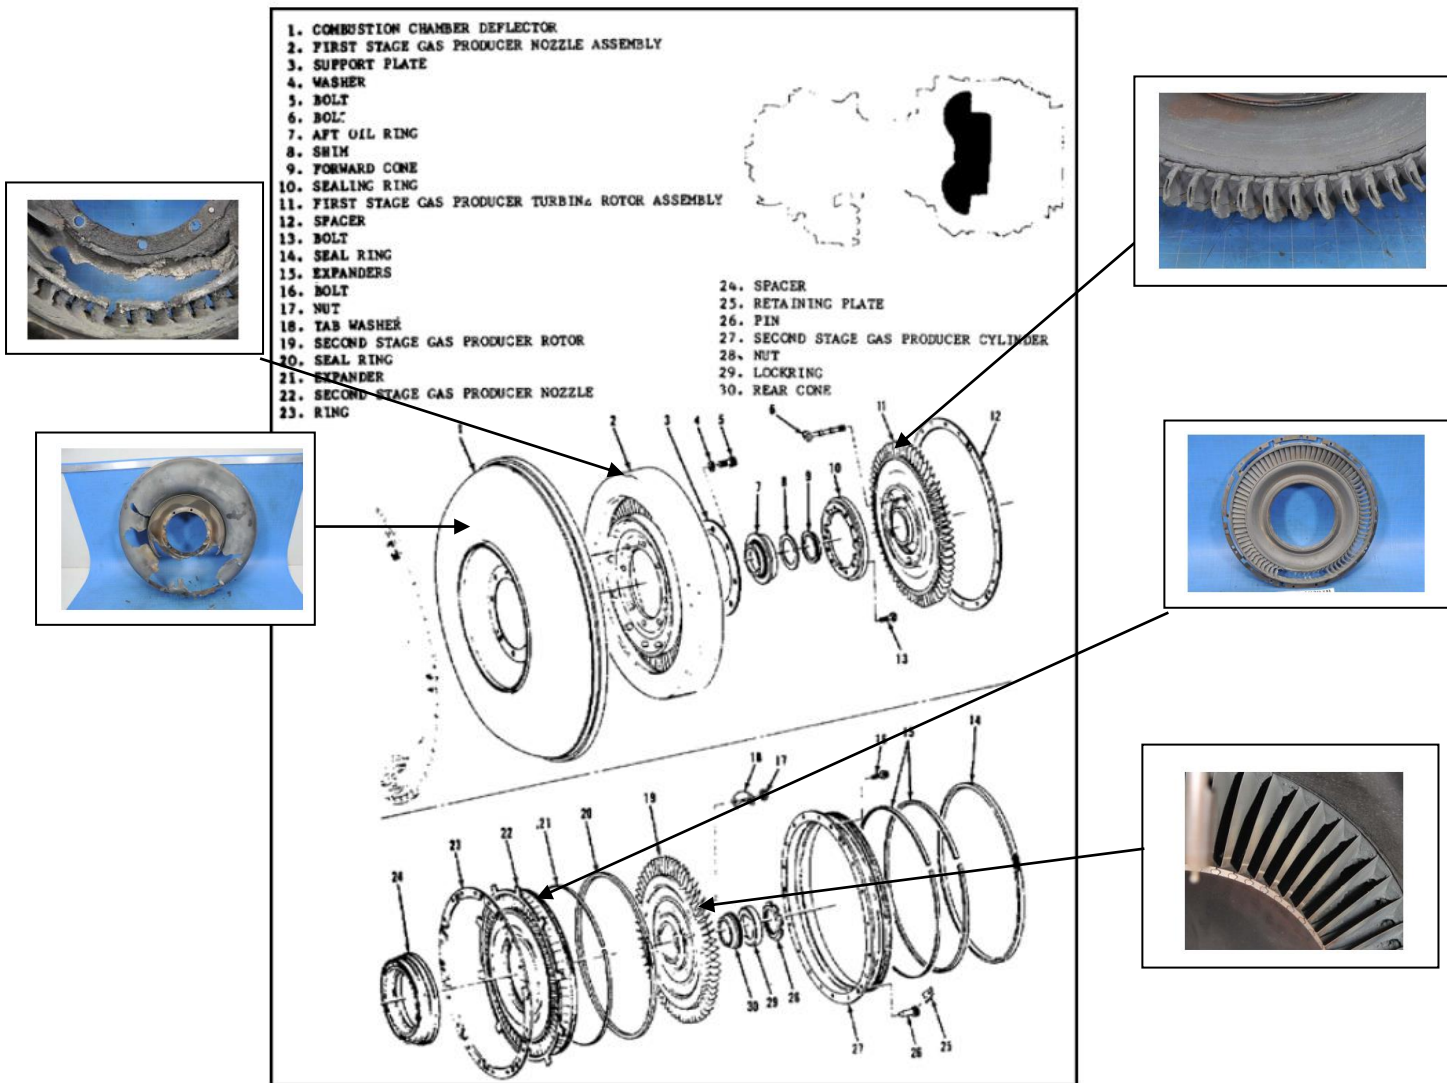
**Figure 13:** The exploded view of the combustion chamber assembly.

1.16.3 *Engine Cross Section - Area of Interest.* The following cross section will be referenced in the upcoming analysis sections. The items coloured in red (liner) and blue (nozzle) are of the first stage gas producer turbine nozzle assembly (P/N 1-110-520-18). Both parts make up one assembly and are denoted with separate colours for clarity.

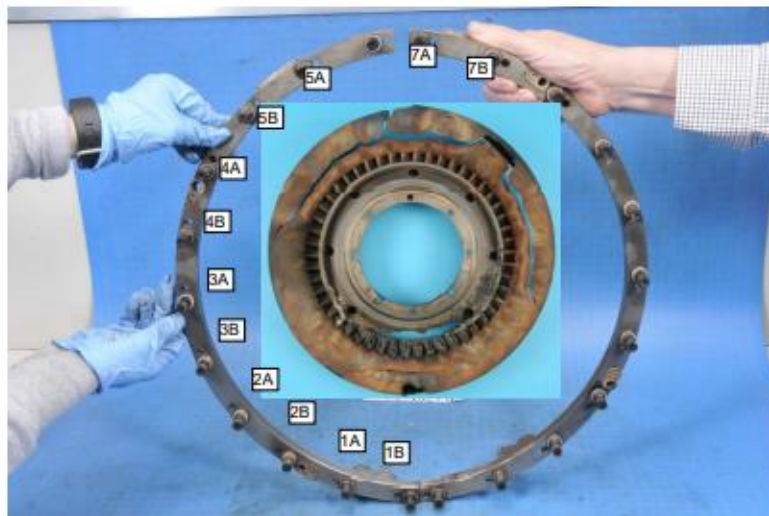
Figure 17: The fuel nozzle Designator Locations on the Engine (FLA).

Image below depicts the various locations of the fuel manifold nozzles/seals which will be referenced in the following analysis. In addition, the image below shows the orientation of the first stage turbine nozzle in relation to the fuel manifold nozzles.

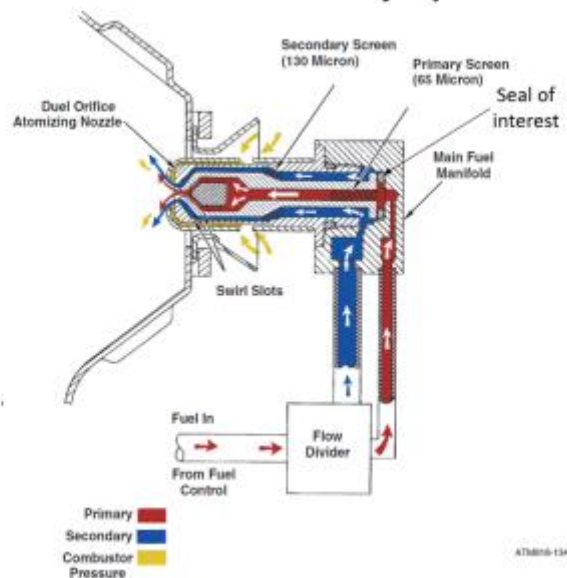
Figure 18: The fuel manifold and fuel nozzle assembly cross sections.

1.16.7 One can see from Image above, the primary and secondary circuits are independent from one another both within the fuel manifold as well as within the fuel nozzle. Separation between the two circuits is maintained by a weld joint within the fuel manifold as well as a seal at the base of the fuel nozzle. Honeywell's flow testing setup allows for fuel pressure to
