<b>AIRCRAFT ACCIDENT SHORT REPORT</b>
---------------------------------------

**CA18/2/3/9822:** Unstable approach that led to a deep landing and a rotation prior to reaching the take-off speed during a touch-and-go exercise, culminating in a crash.

<b>Date and time</b>	: 22 September 2019; 0455Z
<b>Occurrence type</b>	: Accident
<b>Aircraft registration</b>	: ZU-EHS
<b>Aircraft manufacturer and model</b>	: ICP Italy & Savannah Africa, Oribi
<b>Last point of departure</b>	: Hazyview/Numbi Airfield
<b>Next point of intended landing</b>	: Graskop Airfield
<b>Location of incident site with reference to easily defined geographical points (GPS readings if possible)</b>	: 26°20'54.65" S 027°46'41.62" E, on Runway 16 at Graskop Airfield
<b>Meteorological information</b>	: Wind: 220°/04 kt; Temperature: 22°C; Dew point: 7°C; QNH: 1016 hPa; CAVOK
<b>Type of operation</b>	: Private (Part 94)
<b>Persons on-board</b>	: 1+1
<b>Injuries</b>	: Serious injuries
<b>Damage to aircraft</b>	: Destroyed

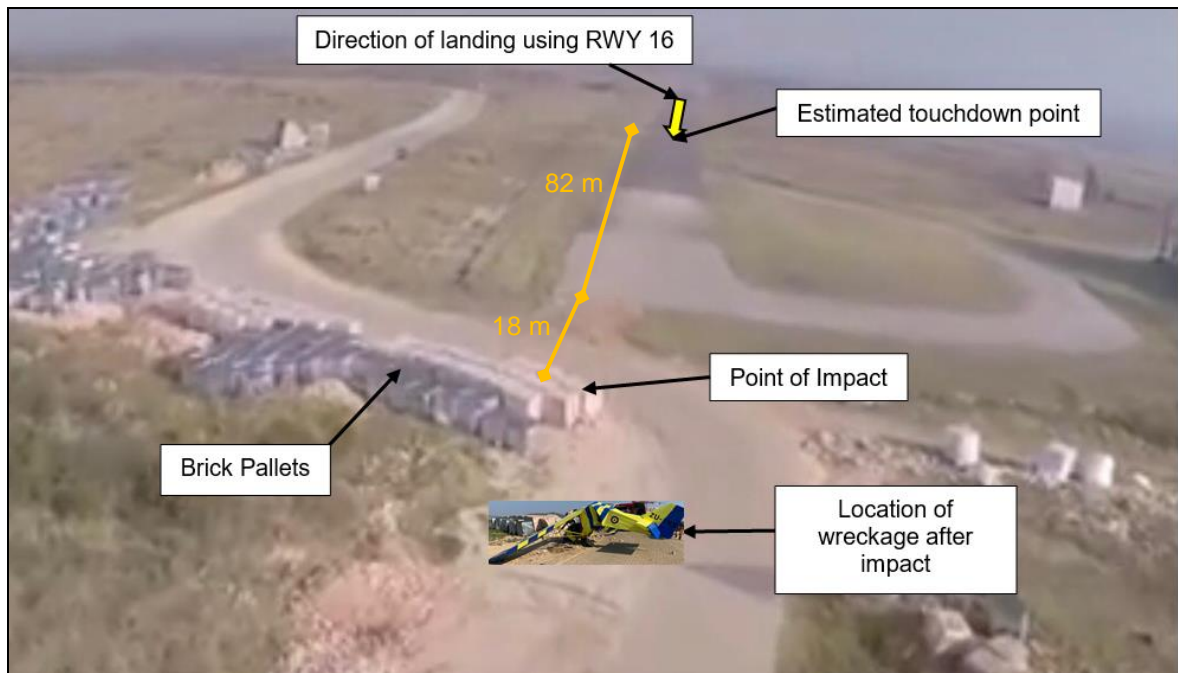
- 2.4. At about 0455Z, the race co-ordinator witnessed ZU-EHS approach and carry out a touch-and-go exercise on RWY 16 and, later, saw it struggle to gain height. The aircraft then crashed following an impact with pallets of bricks which were approximately 1 metre (3 feet) high and were positioned across the road from the end of RWY 16, approximately 100m from the threshold of RWY 34.

**Figure 1:** Location of accident site superimposed on Google Earth.

- 2.6. The pilot reported that subsequent to touch down at a speed of 60 miles per hour (mph) and, thereafter, applying full power for take-off, the aircraft became airborne but could not gain height. The aircraft then collided with pallets of bricks that were situated at the end of RWY 16, approximately 100m from the threshold of RWY 34.
