Final report RL 2020:11e

**Accident at Malmö Airport
17 November 2019 involving the aircraft
SE-LUX of the type Beechcraft 95,
operated by south Sweden Flight Academy
AB.**

File no. L-164/19

17 November 2020

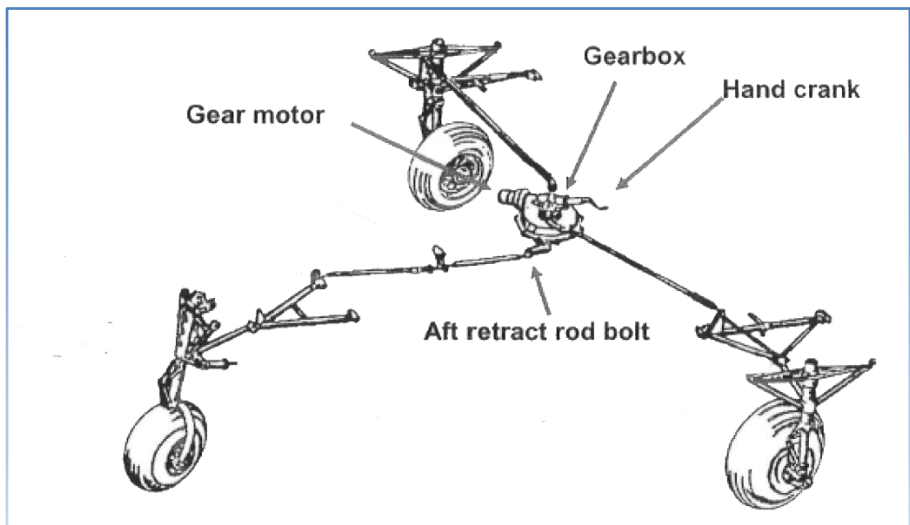
A two position landing gear switch located on the right hand side of the center console controls the motor. The gearbox has an extendable emergency hand crank located behind right front seat which is used to manually extend the landing gear if an electrical failure occurs. To extend the landing gear the hand crank should be rotated approximately 50 turns counter clockwise.

Figure 2. Landing gear mechanism Picture: Beech Baron 55 Shop Manual.

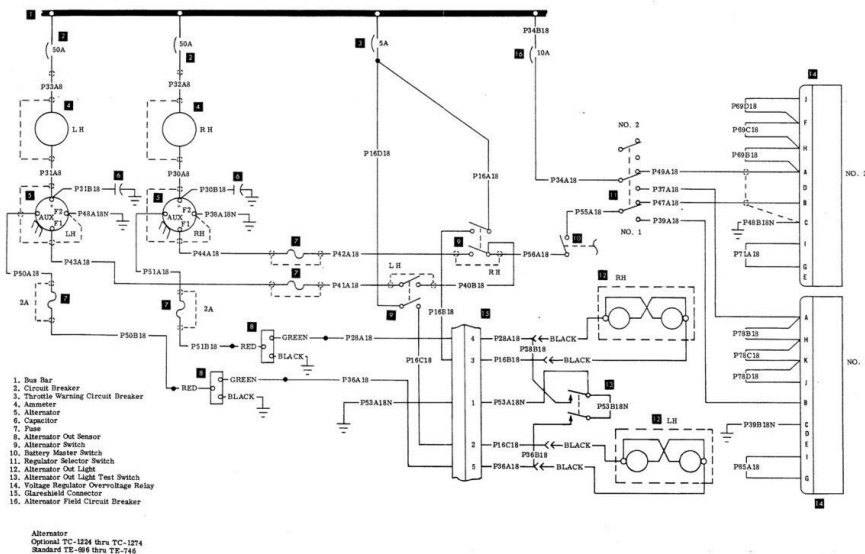
Figure 6. Alternator schematic. Picture: Beechcraft Baron 55 Shop manual.

The voltage regulators draw current from the single circuit breaker labeled alternator field.

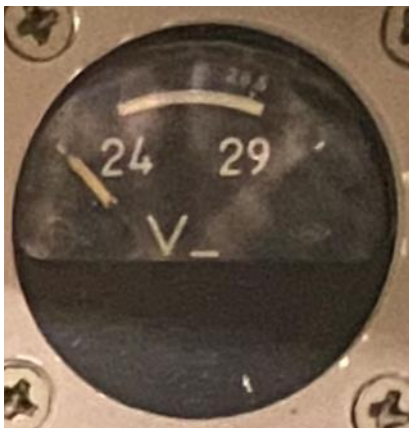
In the system there was also a voltmeter, located at the top right of the instrument panel. The range was between 24 and 29 volts, with an extra mark for 28.5 volts, which is the mark for normal charging voltage.

Figure 9. Voltmeter in SE-LUX.

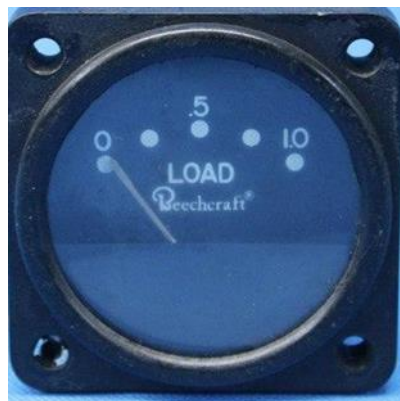
In order to be able to check the value down to 0.2, a load meter with a gradation according to figure 21 is needed.

Figure 11. The loadmeter described in the POH of SE-LUX.

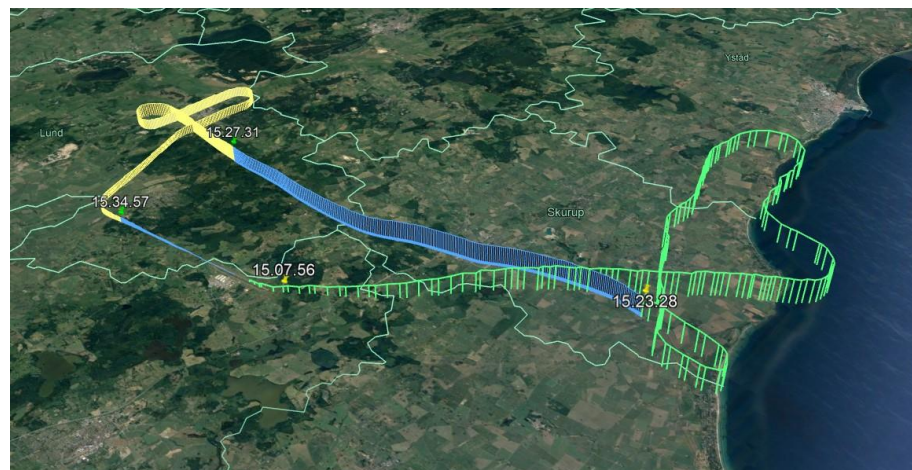
At 15:23:28 (UTC) the secondary radar return ceased which indicate the time when the aircraft suffered the total electrical failure (see Figure 11).

Figure 13. SSR ¹⁸in green, PSR ¹⁹in blue and iPad GPS data in yellow. The coloured line inserted by SHK. Picture: Google Earth.

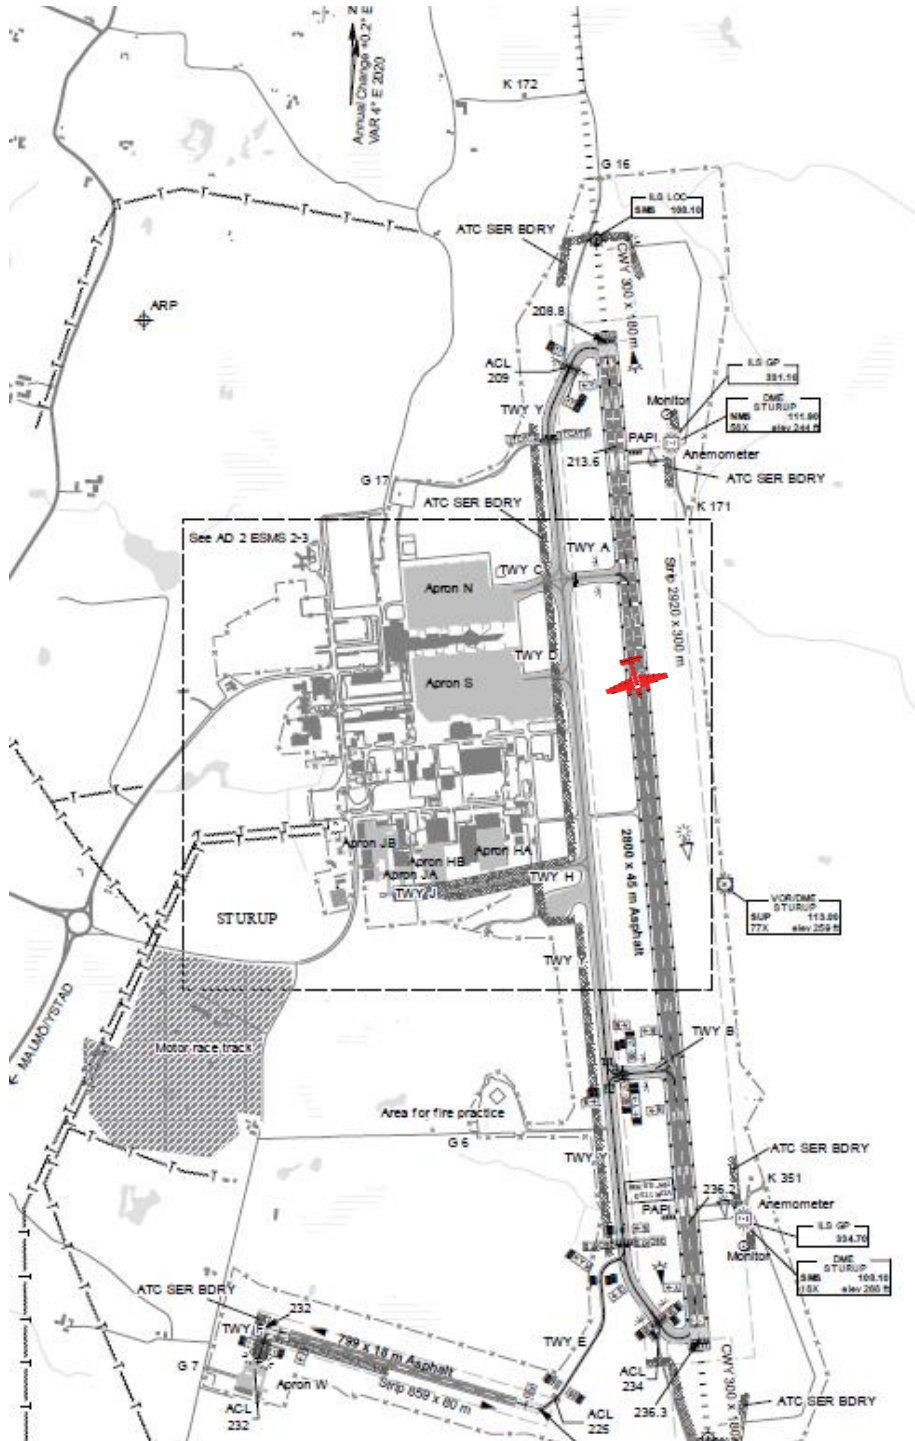
The aircraft belly landed at approximately 700 meters (2 300 feet) into the runway and skidded thereafter 300 meters (984 feet). In the overview image below the aircraft symbol represents where the aircraft stopped.

Figure 15. The aircraft symbol (inserted by SHK) shows the final position of the aircraft on the runway. Picture: AIP Sweden.
