AIRCRAFT ACCIDENT REPORT AND EXECUTIVE SUMMARY

Reference:	CA18/2/3/9848	
Aircraft Registration	ZU-EWD	Date of Accident	12 January 2020		Time of Accident	1612Z
Type of Aircraft	FK 14B POLARIS		Type of Operation	NTCA (Part 94)		
Pilot Licence Type	National Pilot Licence		Age	54	Licence Valid	Yes
Pilot Flying Experience	Total Flying Hours		787.2		Hours on Type	377.6
Last Point of Departure		Springs Aerodrome (FASI) – Gauteng Province				
Next Point of Intended Landing		Springs Aerodrome (FASI) – Gauteng Province				
Location of the accident site with reference to easily defined geographical points (GPS readings if possible)						
In an open area north of FASI, approximately 450m from the threshold of Runway 21, at GPS co-ordinates 26°14'22.42" South 028°24'04.34" East and at a field elevation of 5328ft AMSL						
Meteorological Information	Wind: 340° at 09kts; Temperature: 24°C; Dew Point: 11°C; Clouds: Few at 4000ft; Visibility: 9999m; QNH: 1023hPA

DESCRIPTION OF ACCIDENT

Reference Number : CA18/2/3/9848
Manufacturer : B & F TECHNIK VERTRIEBS GMBH
Model : FK 14B POLARIS
Nationality : South African
Registration Marks : ZU-EWD
Place : Springs Aerodrome (FASI)
Date : 12 January 2020

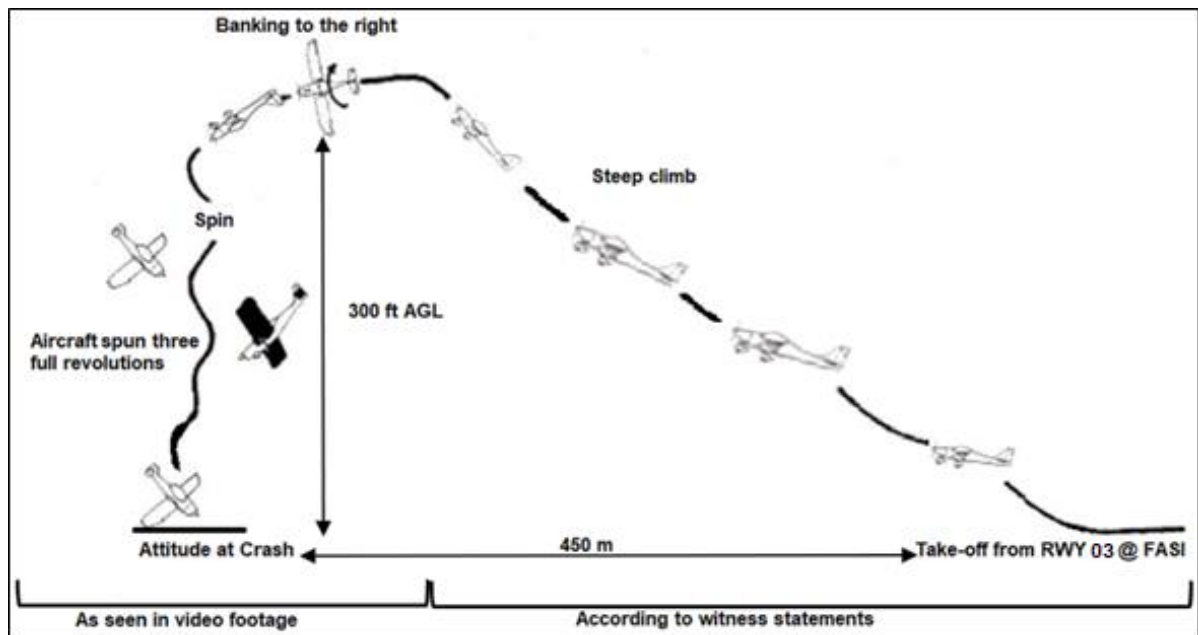
- 1.1.2. Two eyewitnesses; one, a flight instructor preparing to take-off from the same runway (RWY 03) after ZU-EWD, and the other, a resident residing approximately 300 metres (m) north-east of FASI; both observed the aircraft take-off and climb. They stated that the aircraft was observed making a sharp right turn in what was seen to have been an attempt to return to the aerodrome. The aircraft's right-side wing stalled which led to the aircraft entering a spin until it subsequently crashed onto the ground.

Figure 1: Schematic illustration of the accident flight.

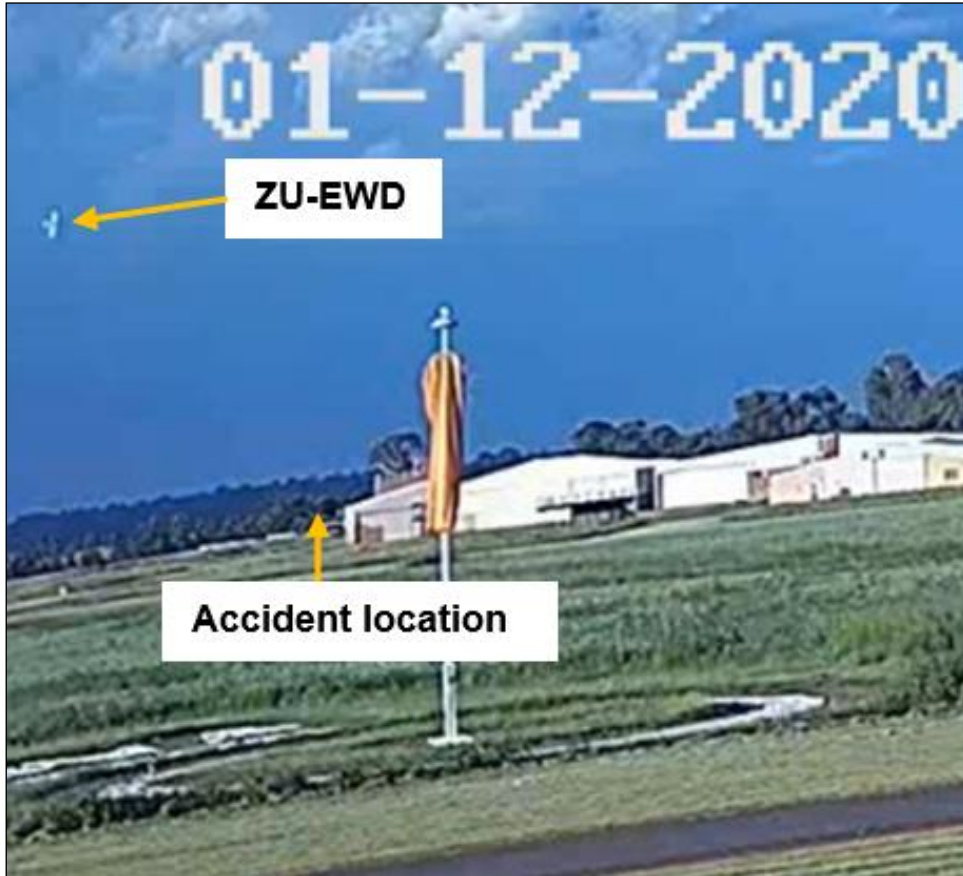
- 1.1.4. A close circuit surveillance camera located outside Hangar 28 at FASI, south-east of the accident site, had captured the accident as illustrated in Figure 1. The footage showed the ZU-EWD aircraft enter the frame from the left in a sharp right bank in a north-easterly heading (Figure 2). The aircraft was seen descending with a profile consistent to a stall, which developed into a spin before crashing. The aircraft was seen spinning and completing three revolutions before it crashed on the ground.

Figure 2: A close circuit surveillance image from a camera located outside Hangar 28 at FASI.
 (Source: Rainbow Skyreach (Pty) Ltd)

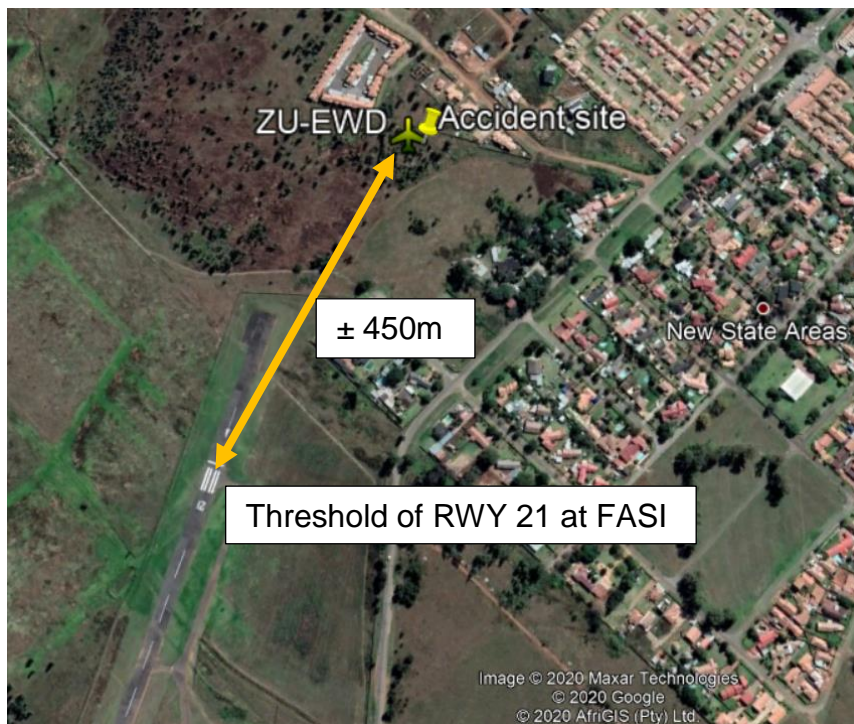
1.1.7. The aircraft crashed on an open field near a residential area, north of FASI, approximately 450m from the threshold of RWY 21 at the following Global Positioning System (GPS) coordinates: 26°14'22.4" South 028°24'04.1" East, at an elevation of 5340 feet (ft) above mean sea level (AMSL). Fine weather conditions with few clouds prevailed at the time leading to the accident.

Figure 3: The aerial view showing the accident site's proximity to the threshold of Runway 21 at FASI.
 (Source: Google Earth)

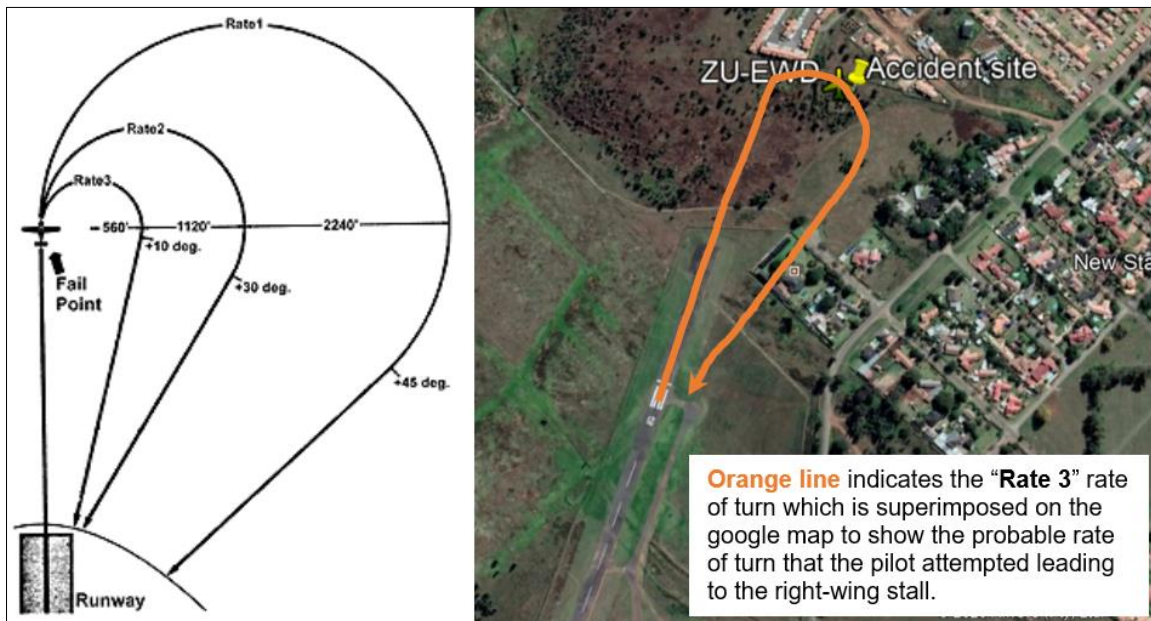
At 80 knots, a 45-degree bank would approximate to a four-times standard-rate turn, meaning 15 seconds will be necessary to change direction 180 degrees. Take another look at Figure 1: Although for a 70-knot turn it shows a radius of 560 feet and adding 10 knots will not make a lot of difference, to point back at the airfield it is necessary to fly through another 10 degrees. In terms of time, we have 4 seconds in which to react, 15 for the turn through 180 degrees and another 1 second for the extra 10 degrees needed to head for the airfield, for a total of 20 seconds.

Even if the rate of descent remains unchanged (although you know, and I know, that it is bound to increase while banked at 45 degrees) a third of a minute while descending at 1000 fpm means you will have lost 333 feet at the end of the turn, which started from 300 feet AGL.

Figure 15: Turn radius when attempting to turn back to the runway. (Source: FAA-P-8740-44 – AFS-920 (2017))

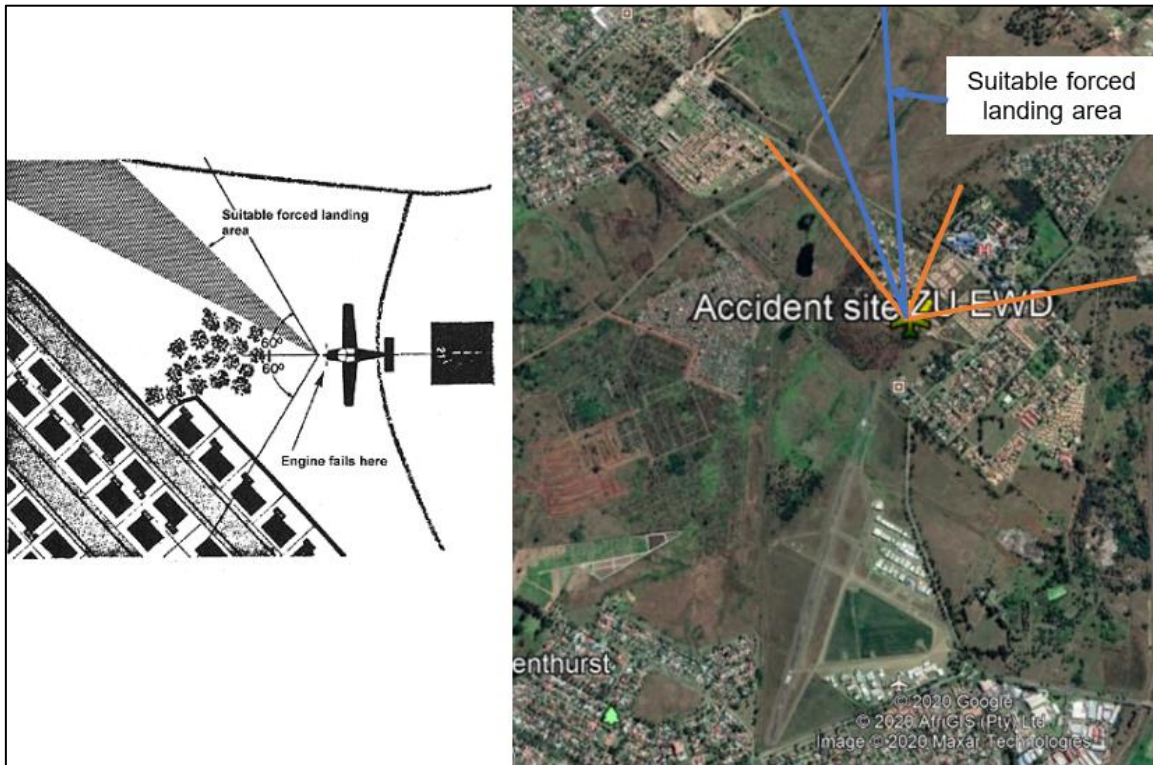
To demand that the landing must be straight ahead would be pointless and potentially dangerous. Ahead may lie the biggest and densest housing development of all time. 10 degrees to one side could be an open field. Figure 16 illustrates the options available if you scan the relatively wide area contained within a 60-degree arc left and right of the take-off path.

Figure 16: Suitable landing site up to 60 degrees on the left-side of aircraft heading. (Source: FAA-P-8740-44 – AFS-920 (2017))
