Final report RL 2021:03e

Accident at Stockholm/Skavsta Airport, Södermanland County, on 6 April 2020 involving the aeroplane SE-MKV of the model TB 9, operated by Skies Airline Training AB.

File no. L-27/20

30 March 2021

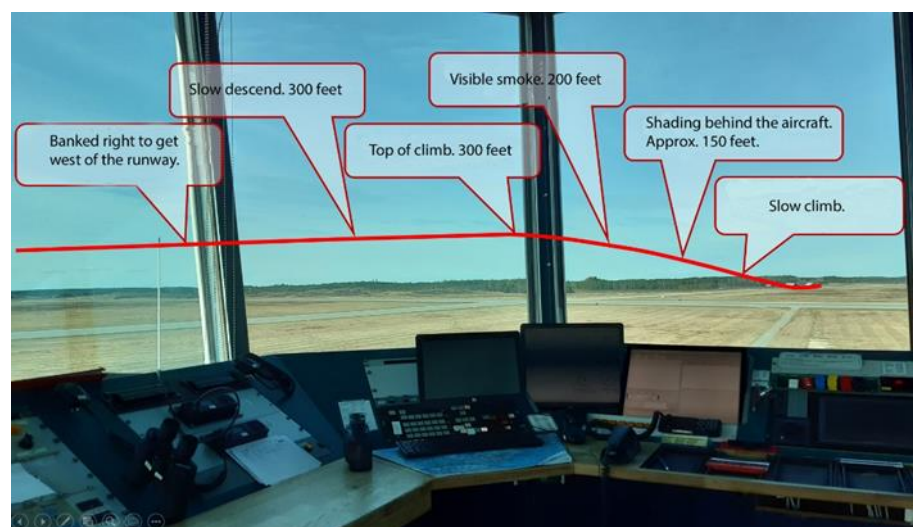
An air traffic controller and assistant who were monitoring the flight have described how their perception was that the aeroplane was climbing slowly and that mist formed behind the aeroplane during the initial phase. When crossing runway 08/26, it was thought that the aeroplane was no longer climbing before it then began descending. It then appeared that the aeroplane began a right turn and thus came to the west side of the runway. When the aeroplane had descended and passed the runway threshold, a left turn began at an altitude that was perceived to be about the same as the height of the tower. During this turn, the perception was that the aeroplane lost height at low speed and collided with the ground. Figures 1 and 2 show a pictorial description of how the sequence of events was perceived by the air traffic controller from the position in the tower.

Figure 1. The air traffic controller's description of the sequence of events (part 1): Photo: ATC Controller, Skavsta tower.

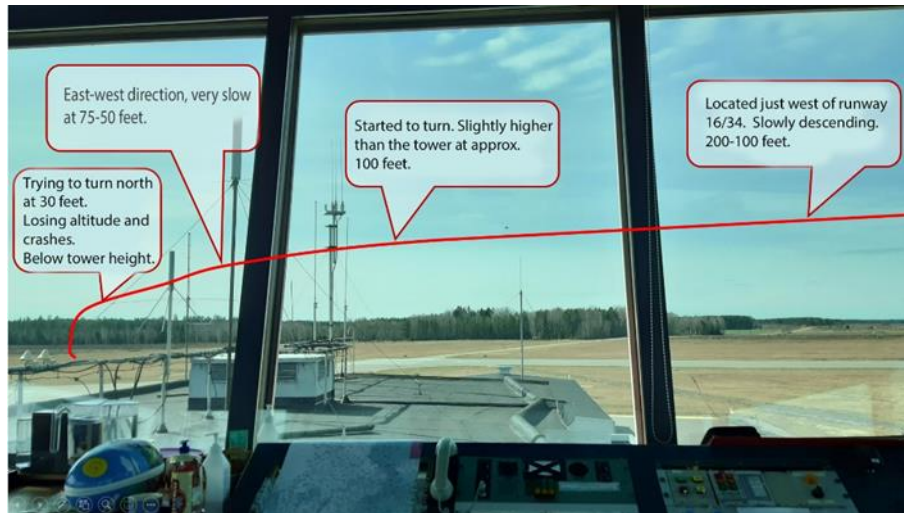
Figure 2. The air traffic controller's description of the sequence of events (part 2). Photo: ATC Controller, Skavsta tower.

The air traffic control assistant perceived a sort of mist following the aeroplane that resembled the appearance of a fuel leak.

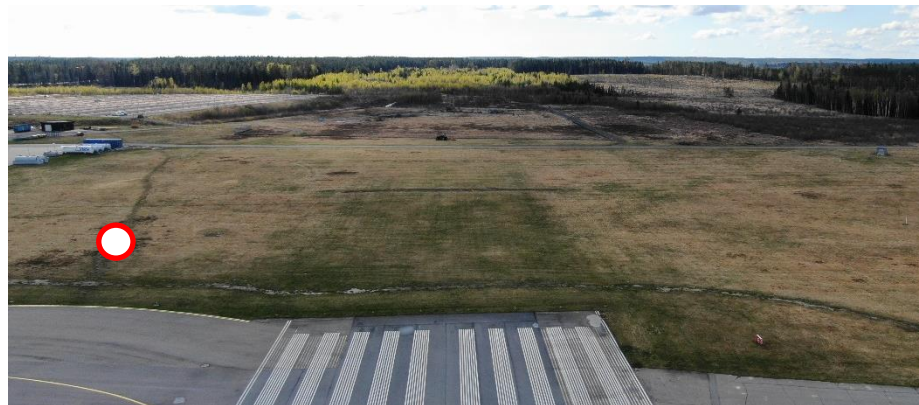
After the end of the runway, there was a 167 metre-long strip to a perpendicular road and then a further 30 metres of free space that ends in a fence. After the fence, there was an area with tall vegetation and then a wooded area with young trees. Figure 6 shows an image of the runway threshold taken from a drone at an altitude of 37 metres (120 feet).

Figure 6. Image taken from a drone showing the characteristics after the end of the runway, with a marking indicating the accident site.

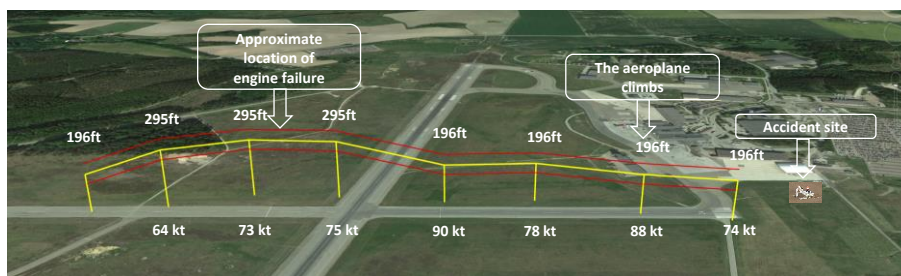
The heights in Figure 7 follow the yellow line and may deviate by plus/minus 50 feet. The deviations are because a radar height is rounded to the nearest hundred, which means that the actual profile may vary within the scope of the red lines. Radar data for lower heights has not been recorded. All heights are adjusted from QNH to the elevation of the runway threshold and show the height above the ground.

The speed markings under the profile lines refer to an approximate calculated indicated speed. When calculating speed, SHK has taken into account the reported wind at the time of take-off.

Figure 7. Radar data from LFV (yellow line) shows the route, approximate speed and height with a margin of ±50 feet (red line). Image: Google Earth with inserted route and text by SHK.

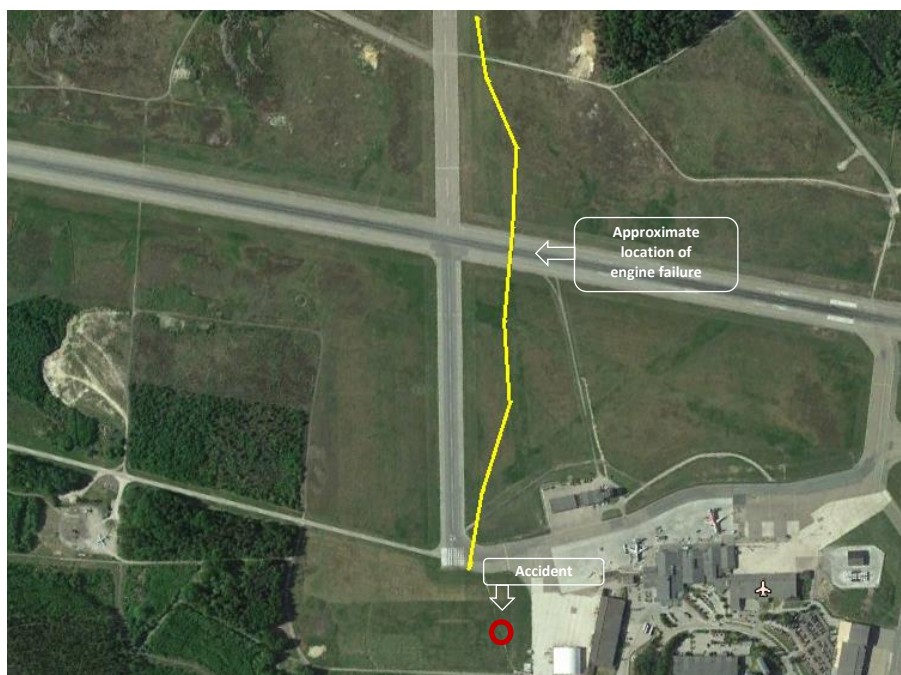
Figure 8. The route according to radar data from LFV (yellow line). Image: Google Earth with inserted route and text by SHK.

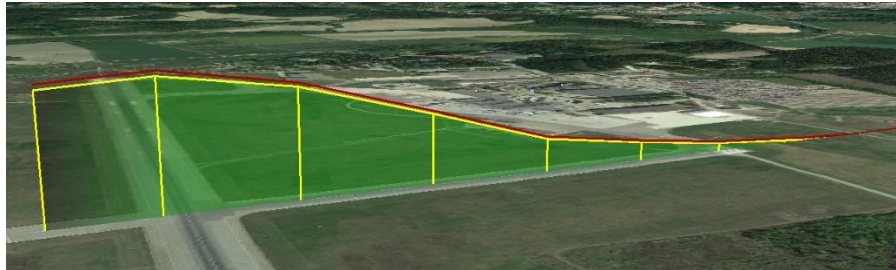
The profile below describes a flight with similar altitudes as in the accident, adjusted in position to Stockholm/Skavsta Airport.

Figure 16. GPS data for glide flight from a simulated engine failure at 300 feet above the runway.

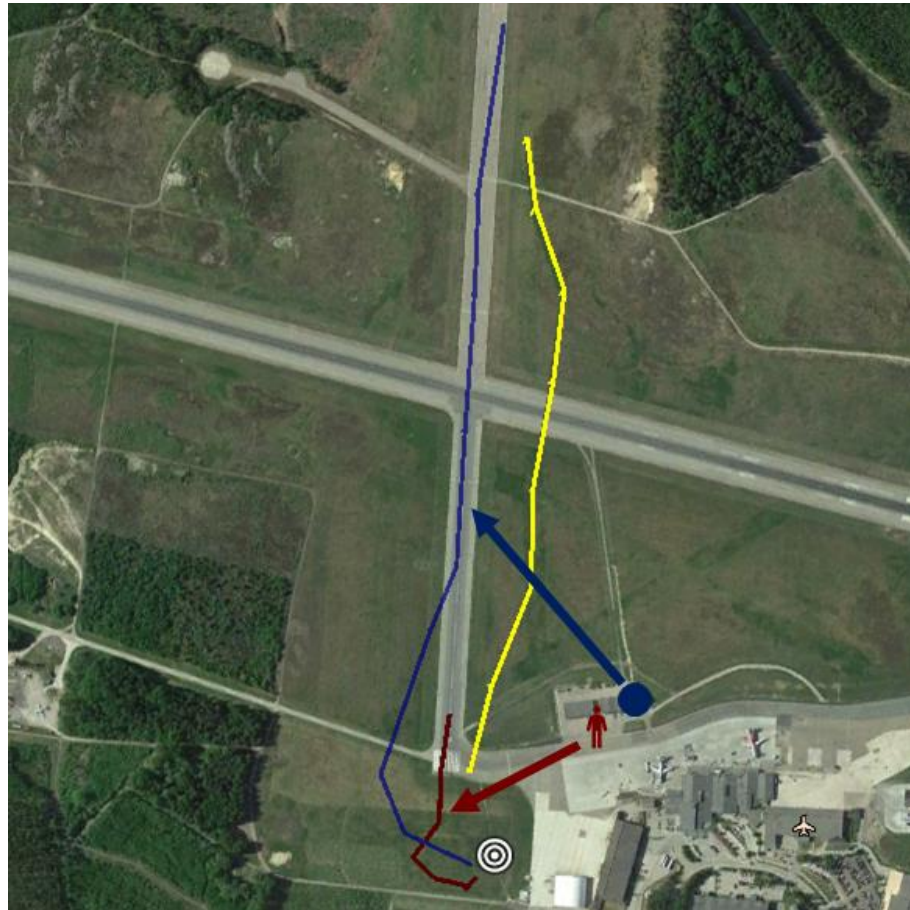
As described in previous sections, information about the occurrence has been provided by a witness in the tower and a witness on the ground. During the interviews, flights with a drone were performed as a reference for the witnesses to relate their memory recollections. Radar data concerning the flight in question are available. Figures 17 and 18 show the witnesses' experiences of the flight and the recorded radar data.

Figure 17. Radar data in yellow, information from the witness in the tower in blue and information from the witness on the ground in dark red. Image: Google Earth with markings added by SHK.

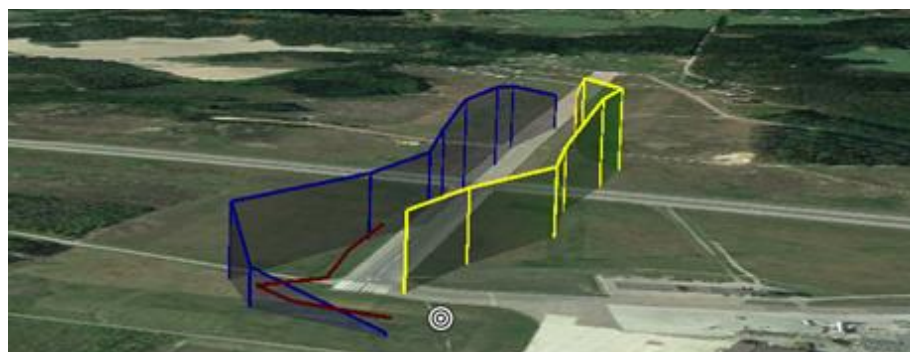
Figure 18. Radar data in yellow, information from the witness in the tower in blue and information from the witness on the ground in dark red. Image: Google Earth with markings added by SHK.
