DUTCH
SAFETY BOARD

Fly-away after compass malfunction

DJI Inspire 2 Unmanned Aircraft System

Den Haag, February 2023

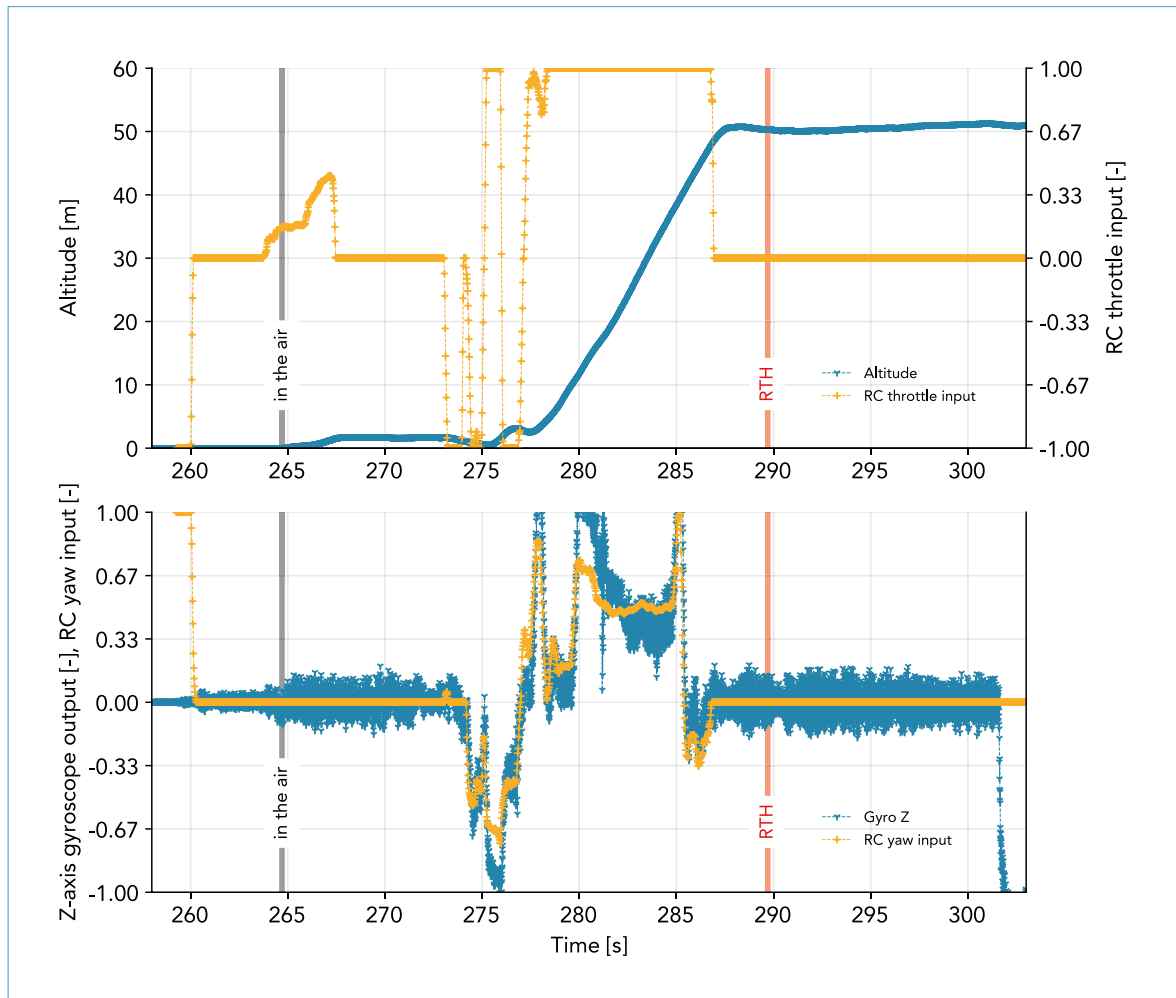
The response for throttle and yaw, depicted in Figure 8, is generally as expected. The sign (i.e. positive or negative value) of the throttle input is, apart from a delay, consistent with the change in recorded altitude. Hence, the changes in altitude can be attributed to the given throttle input. The changes in yaw as measured by the gyroscope are consistent with the yaw-input of the RC. This indicates that the changes of the UA heading can generally be attributed to the provided yaw input.

Figure 8: The altitude and remote controller throttle input versus time (top) and z-axis gyroscope output and remote controller yaw input versus time (bottom). The input from the left RC stick (in orange) is compared with the corresponding UA response (in blue). Also indicated are the moments when the UA was in-flight and when the RTH functionality was activated.

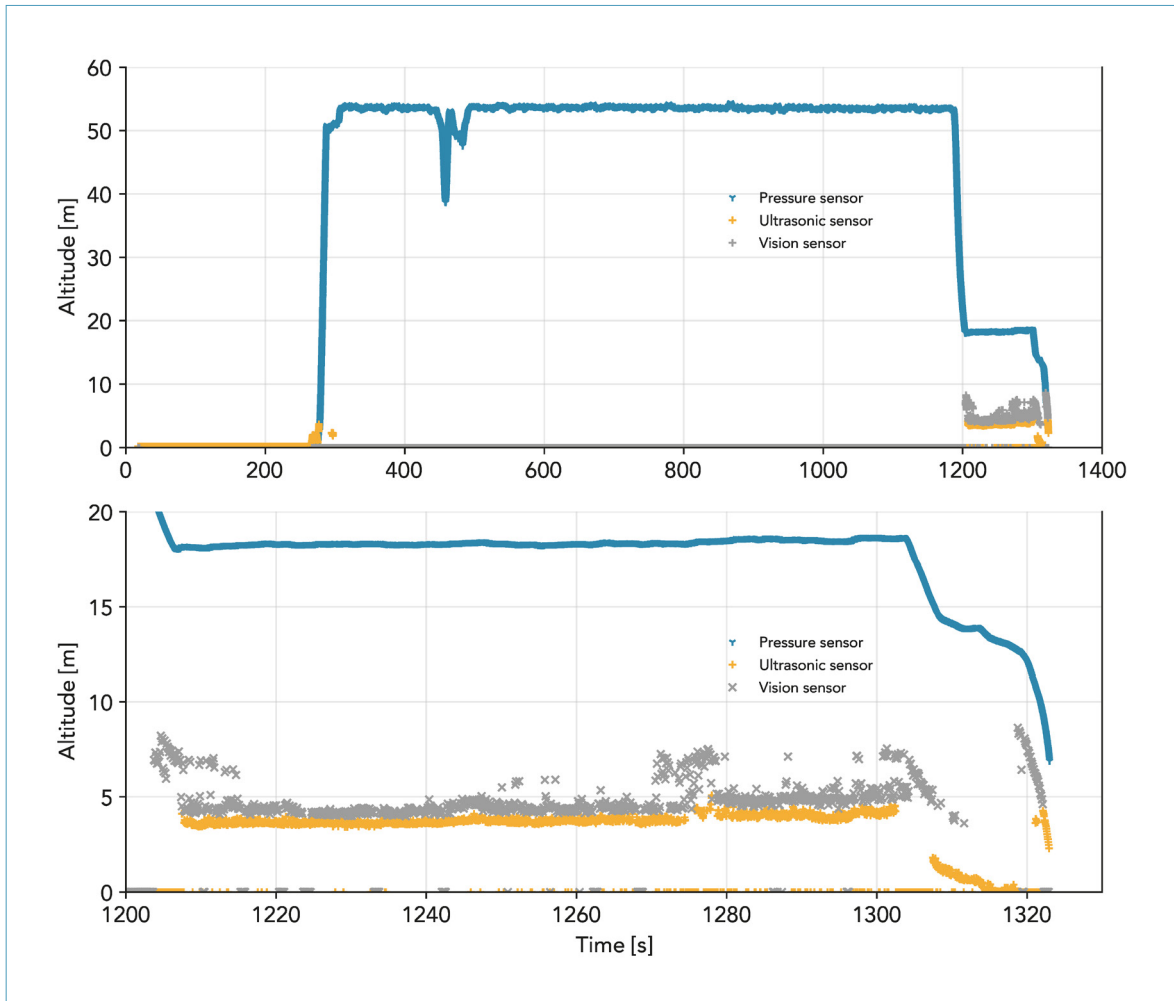
Figure 12: Time trace of the altitude (pressure sensor, ultrasonic sensor and vision based) for the complete flight (top) and final flight phase up to the crash (bottom).
