AIRCRAFT SERIOUS INCIDENT SHORT REPORT

CA18/3/2/1314: The nose landing gear failed to extend during a systems evaluation flight.

Aircraft registration : ZS-ISD

Aircraft manufacturer and model : Piper Aircraft Company, Piper PA-34-200

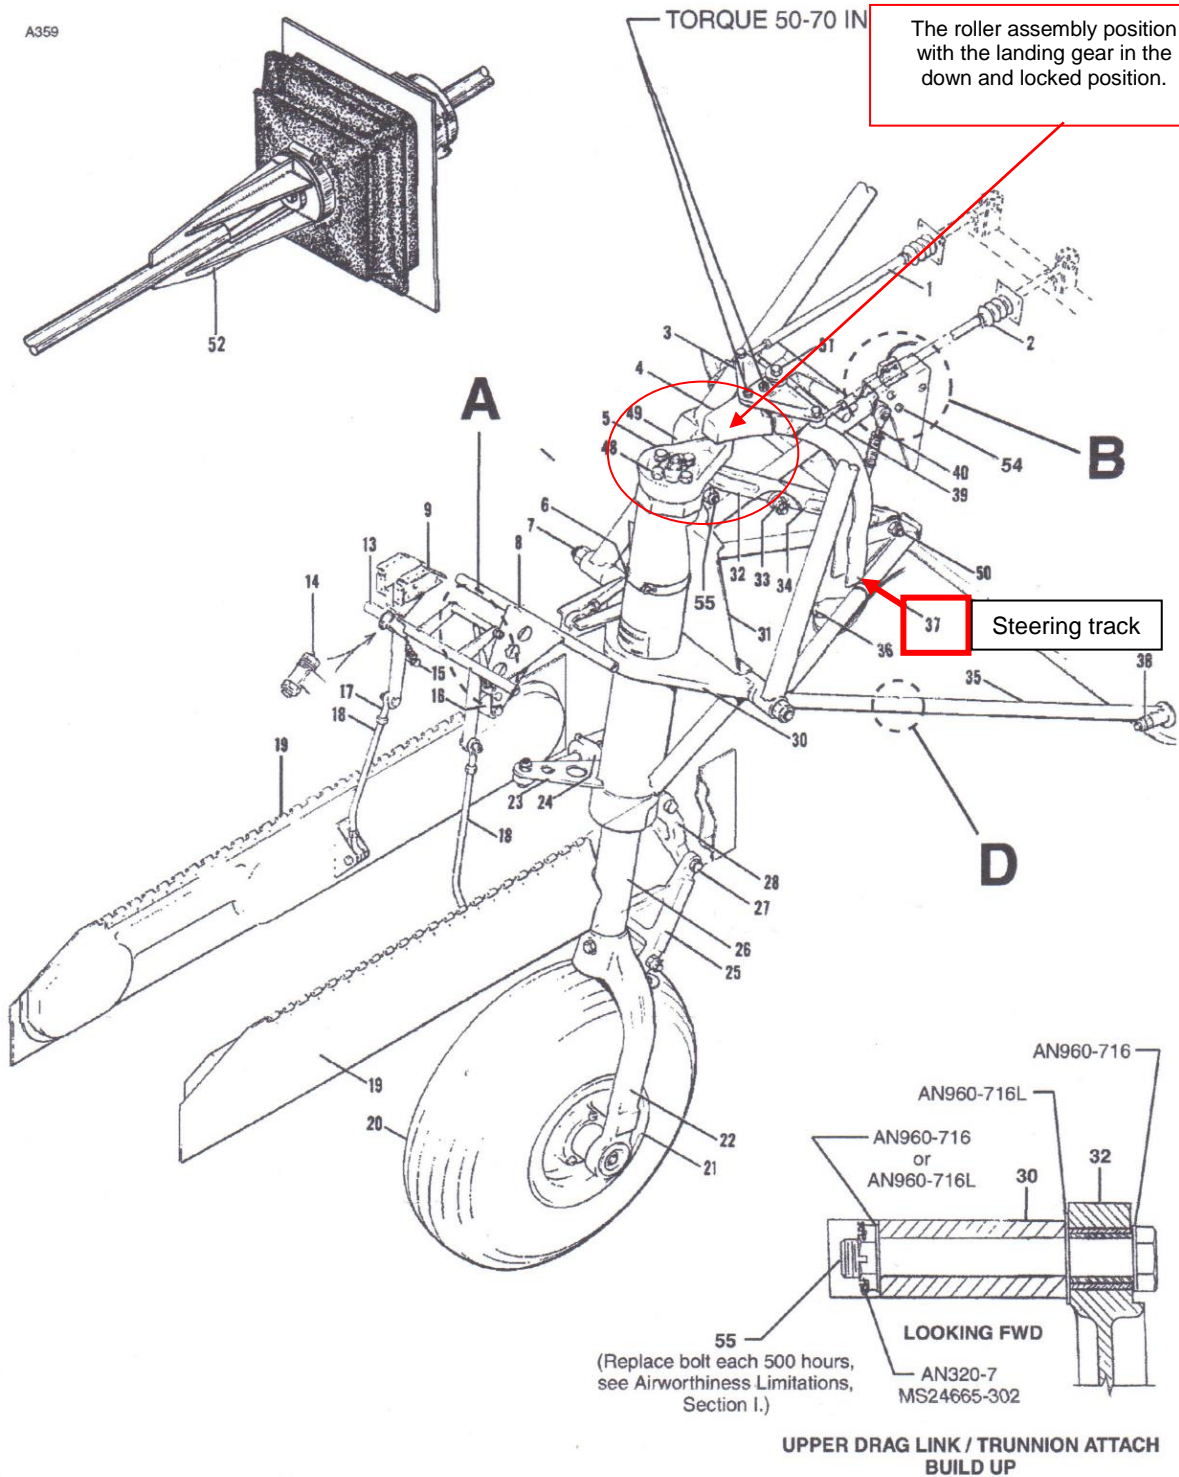
Figure 6: Schematic of the nose landing gear installation.

- 1.2 The investigation revealed that the nose landing gear roller assembly exited the steering track when the landing gear was retracted after take-off. This came about after the nose gear up lock-stopper became loose during flight, causing a roller assembly out-of-track condition. This made it impossible to lower the nose gear by using both the normal and emergency gear extension systems.

Mounted on the upper end of the nose leg is a tiller assembly, which is attached to a roller assembly. This roller sits within a curved track which it follows as the gear leg is raised. The track assembly itself is made up of two sections. The lower section is fixed to the aircraft structure, whilst the upper section is attached to a hinged quadrant casting to allow for nose-wheel steering. This quadrant is attached by cables to the steering arm. With the gear locked down, the roller assembly remains within the upper hinged section of the track, movement of which is transmitted to the nose wheel from the quadrant via the tiller. As the nose gear starts to retract, the nose wheel and tiller is centred automatically, and the hinged and fixed sections of track line up, allowing the roller assembly to follow the track as the nose leg retracts.
