DUTCH  
SAFETY BOARD

# Loss of control after interrupted winch launch, Gilze-Rijen Air Base

*The Hague, May 2021*

Identification number:	2020047
Classification:	Accident
Date, time of occurrence:	12 July 2020, 12.47 hours <sup>1</sup>
Location of occurrence:	Gilze-Rijen Air Base
Registration:	PH-1150
Aircraft type:	Rolladen-Schneider LS8-18
Aircraft category:	Glider
Type of flight:	Pleasure
Phase of operation:	Winch launch
Damage to aircraft:	Nose destroyed, fuselage and cockpit severely damaged, tail broken
Flight crew:	One
Passengers:	None
Injuries:	Pilot fatally injured
Other damage:	Fence
Light conditions:	Daylight

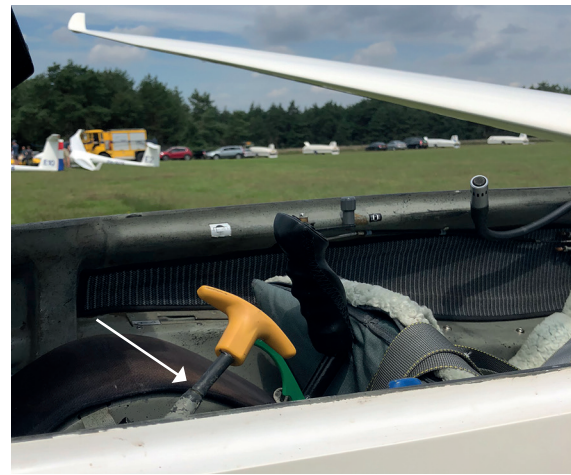
During maintenance of PH-1150, a temporary repair of the molded sleeve of the yellow release handle was made and the routing of the cable of the centre of gravity release hook was adjusted. On the first day of flying with PH-1150 after this work on the cable release mechanism, this was the day before the accident, three premature cable releases took place during winch launches. After the last flight before the accident flight, a breakdown of the temporary repair was observed. A technician who was informed about one premature cable release that day and the breakdown of the repair, checked the release mechanism at the end of that day and found no particularities. It is concluded that the premature cable release during the accident flight was caused by a malfunction of the release mechanism. The exact cause of this malfunction has not been established.

The winch cable is connected to the glider via the centre of gravity release hook (see Figure 3), which is attached to the bottom of the fuselage near the landing gear (see Figure 5). The pilot can release the cable during the winch launch, by pulling the yellow T-shaped handle in the cockpit. The cable release handle in the LS8 is normally guided a little further into the cockpit, via a molded sleeve<sup>17</sup>, to enable the pilot to access it better during flight (see Figure 4).

Figure 4: Molded sleeve and yellow release T-shaped handle in another LS8's cockpit. (Source: Dutch Safety Board)

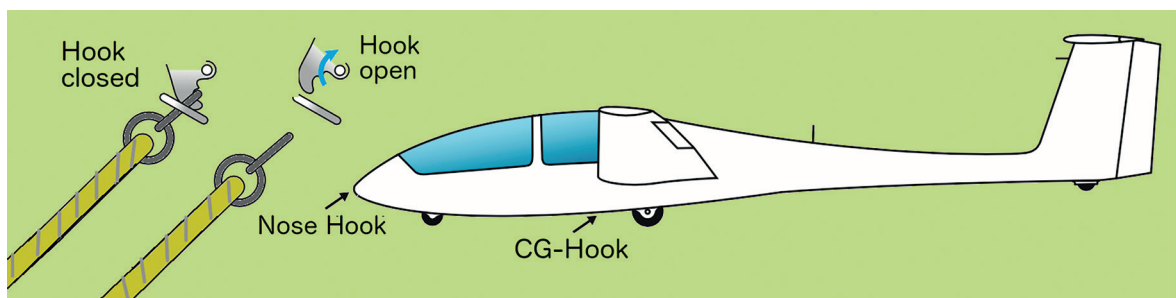
Figure 5: The location of the centre of gravity (CG) release hook. (Source: *Gliding, The basics in 35 lessons*, D. and R. Corporaal)

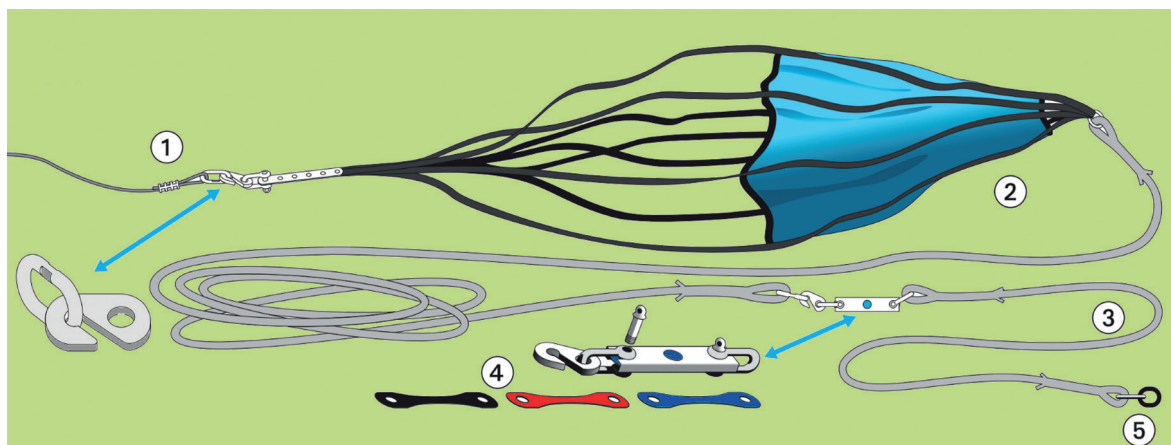
The pilot who experienced the second case (during the third flight of PH-1150 that day), at a height of approximately 200 metres, assumed that the weak link (see Figure 11) had broken and did not report it. He made a flight of 37 minutes. In the evening, when he heard from his wife that the weak link had not broken, he could hardly believe it. His wife, who is also a glider pilot, had contacted the winch operator after the second premature cable release, who told her the weak link was still intact.

Figure 11: Winch cable (1), the cable parachute (2), the shock absorber rope (3), the weak link (4) and the release rings (5). (Source: *Gliding, The basics in 35 lessons*, D. and R. Corporaal)
