AIRCRAFT ACCIDENT SHORT REPORT

CA18/2/3/9906: Right main gear collapsed during landing roll on Runway 35 at FAGC.

Aircraft registration : ZS-DVD

Aircraft manufacturer and model : Piper Aircraft Corporation, PA-30-160

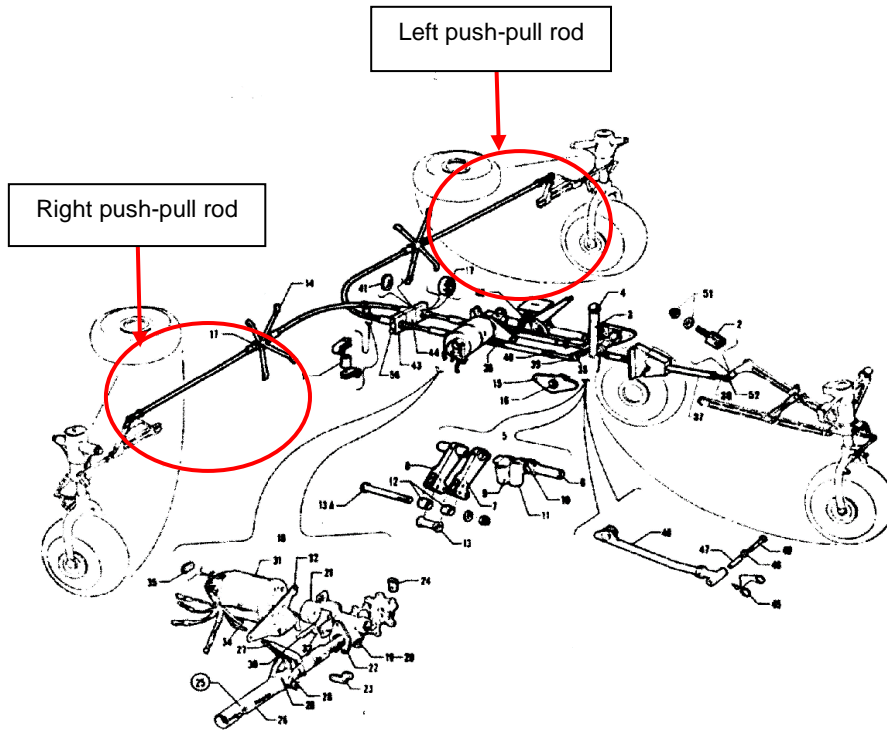
Retraction of the landing gear is accomplished through the use of an electric motor and gear train located under the floor boards, actuating push-pull cables to each of the main gears and a tube to the nose gear. The landing gear motor is activated by a selector switch located on the instrument panel. To guard against inadvertent movement of the landing gear selector on the ground, a mechanical guard is positioned just below the selector handle. The handle should also be pulled aft before moving it upward. The gear selector is in the shape of a wheel to differentiate it from the electric flap control knob, which has an airfoil shape. As an added safety feature, the warning horn is connected to the gear selector switch. The horn will then operate if the selector is moved to the “UP” position with the master switch on and the weight of the airplane on the landing gear. As a final safety factor to prevent gear retraction on the ground, an anti-retraction switch is installed on the left main gear. This prevents the electric circuit to the landing gear motor from being completed until the gear strut is extended.

Figure 7: The landing gear retraction system. (Source: Piper PA-30-160 POH, Section II)
