AIRCRAFT ACCIDENT REPORT AND EXECUTIVE SUMMARY

Reference:	CA18/2/3/9930	
Aircraft registration	ZS-CNM	Date of accident	6 November 2020		Time of accident	1352Z
Type of aircraft	Cirrus SR22T (Aeroplane)		Type of operation		Part 91 (Private)	
Pilot-in-command licence type		Commercial	Age	63	Licence valid	Yes
Pilot-in-command flying experience		Total flying hours	3 533.3		Hours on type	5.0
Last point of departure		Hazyview Aerodrome (FAHW), Mpumalanga Province				
Next point of intended landing		Nelspruit Aerodrome (FANS), Mpumalanga Province				
Damage to the Aircraft		Destroyed				
Location of the accident site with reference to easily defined geographical points (GPS readings if possible)						
Pecan nut orchard next to FANS (GPS position: 25°30'04.05" South 030°55'00.30" East), elevation 2792 feet						
Meteorological information		Surface wind: 329°/9kts gusting 17kts; Temperature: 32°C; Visibility: CAVOK				
Number of people on board	1 + 0	No. of people injured	0	No. of people killed	1

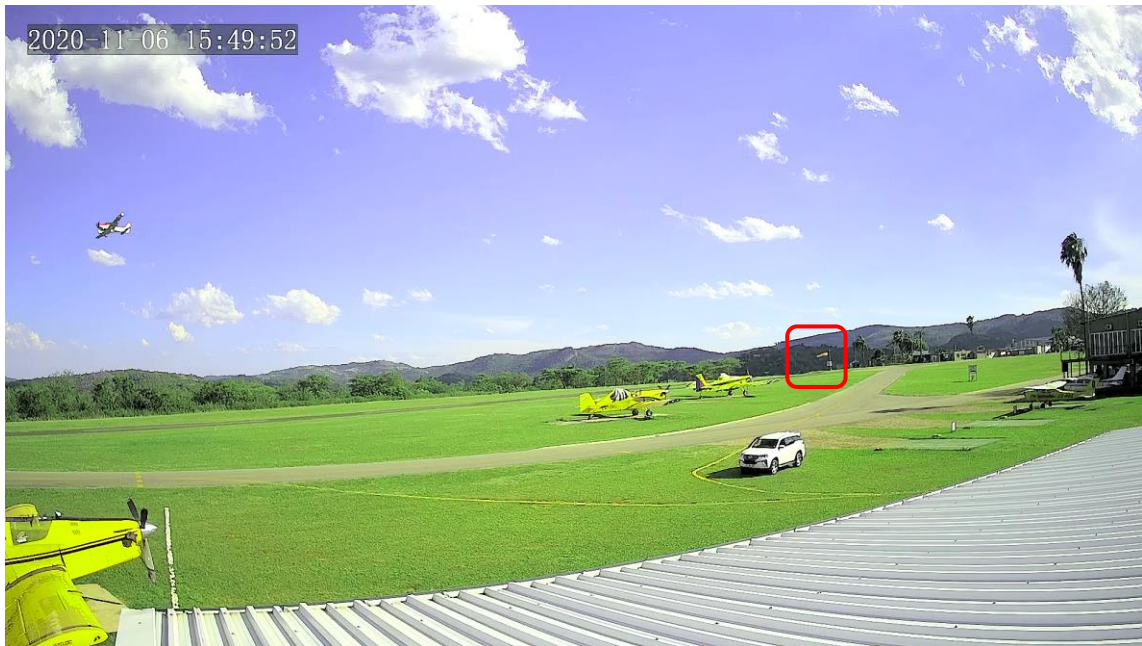
Figure 10: The Cirrus SR22, ZS-CNM joins overhead from the north-east.
Windsock in red window.

The windsock (see Figure 10) indicated the prevailing wind at the time to be from the north-west when the ZS-CNM aircraft was seen overhead Runway 22. According to the SAWS weather report, which received weather information from the automatic weather station at the aerodrome, the wind was 9 knots gusting 17 knots at 1355Z, which was 3 minutes after the accident occurred.

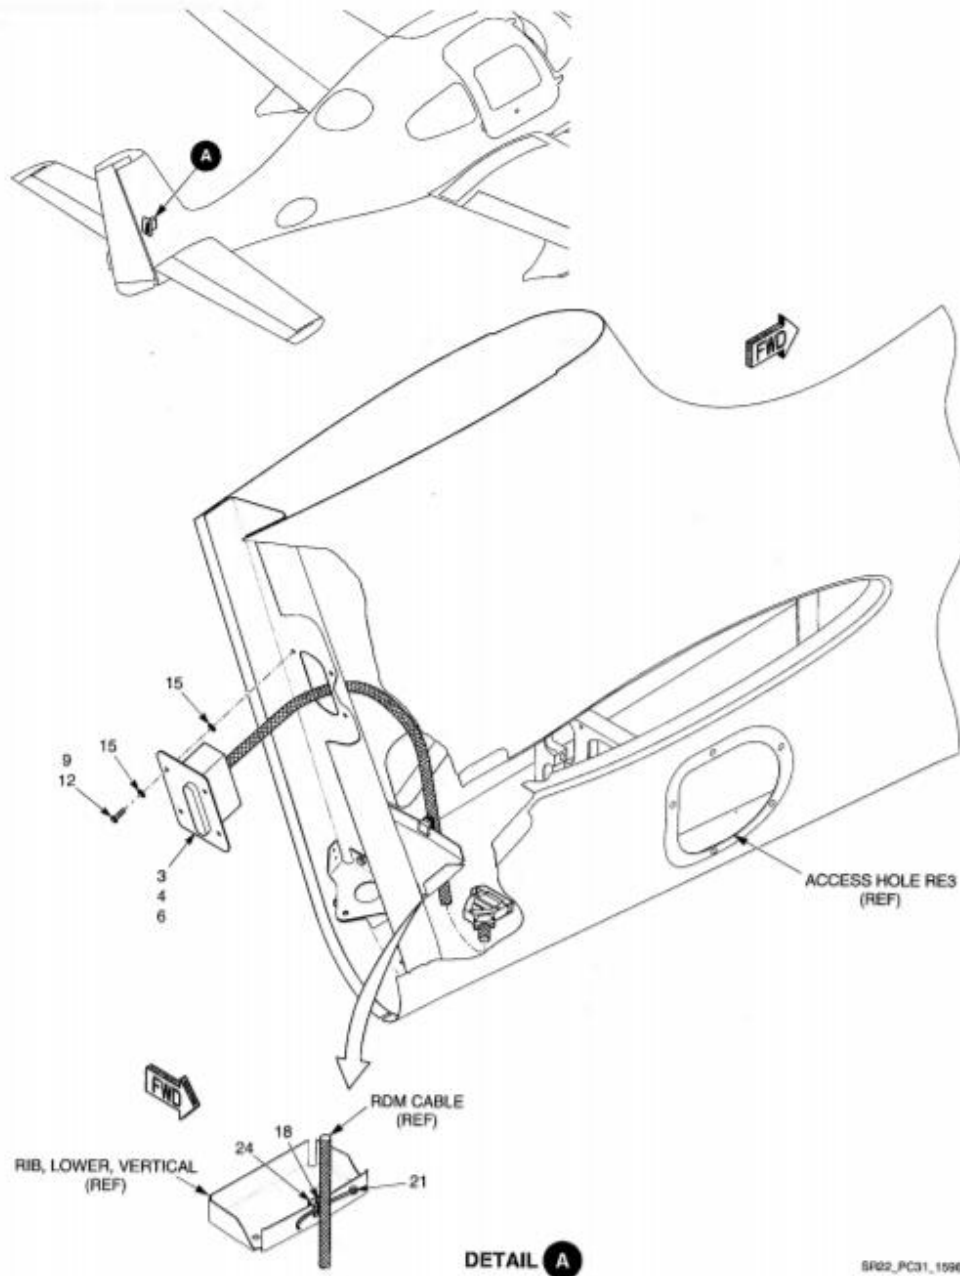
Figure 19: The position of the RDM on the aircraft structure.

The aircraft was fitted with a Recoverable Data Module (RDM) unit which is located within the vertical fin (see Figure 19). It is possible to extract flight data from this unit; however, in this accident, the unit was destroyed by post-impact fuel-fed fire that erupted as it is not a crash-/fire-resistant device.

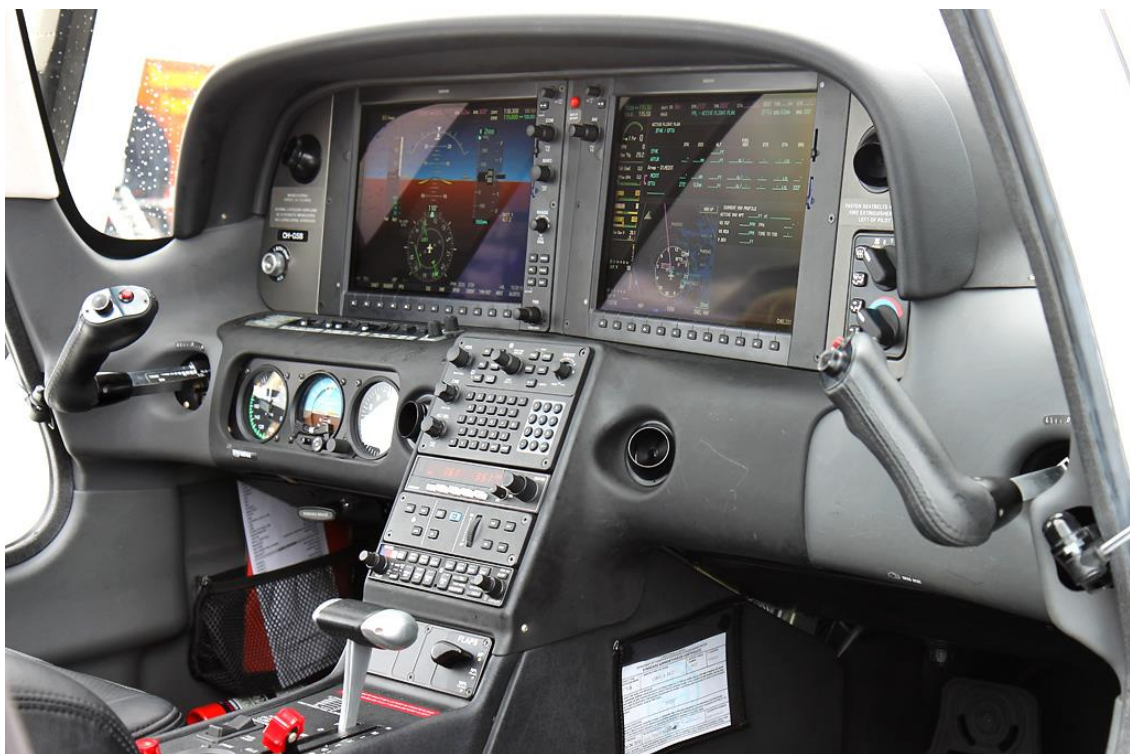
Figure 19: The cockpit layout of the Cirrus SR22 with the side yoke configuration.

What makes this aircraft different from most other aircraft that are below 2 250kg maximum take-off weight (MTOW) category and above on the market is the fact that this aircraft is designed with a unique side yoke (similar to Airbus aircraft) which is located on the left- and right-side of the cockpit (see Figure 19). With the PIC seated on the left seat, the side yoke configuration was positioned on his left-hand side. The pilot's control inputs are, therefore, within the range of his/her left-hand side. Only one hand is required to operate it; a two-hand operation is neither possible nor necessary, unlike flying an aircraft with a conventional control yoke fitted to most aircraft in this weight category and above. Even though the pilot had accumulated a substantial number of flying hours on other aircraft types, including the Pilatus PC12 (fitted with a Pratt & Whitney PT6 turboprop (turbine) engine (see cockpit displayed in Figure 20), the Cirrus SR22 cockpit layout was new to him and should be considered a significant contributory factor to this accident, based on his limited experience, as well as the fact that the accident flight was his second solo flight on this aircraft type.
