Final report RL 2021:10e

**Accident at Skövde Airport, Västra
Götaland County, on 19 December 2020
involving the aeroplane SE-MDN of the
model Cessna 172N, operated by Skövde
Aeroclub.**

File no. L-97/20

15 December 2021

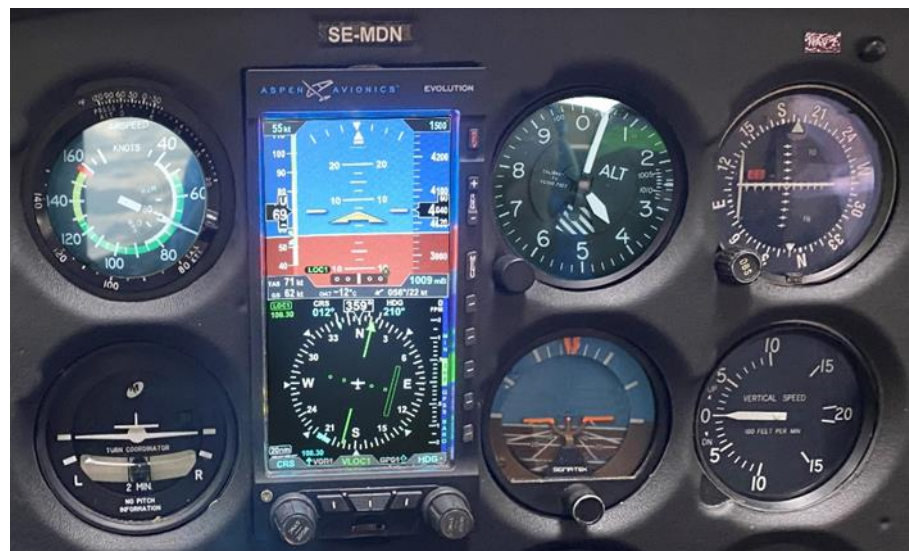
Figure 3. Instrumentation in SE-MDN with Aspen Avionics EFD 1000 as a complement to the primary flight instruments.

An airspeed indicator test was performed without remarks. It could be noted that the speed indication on the Aspen instrument had some lag compared to the analogue indicator. The same lag was observed during the reference flight.

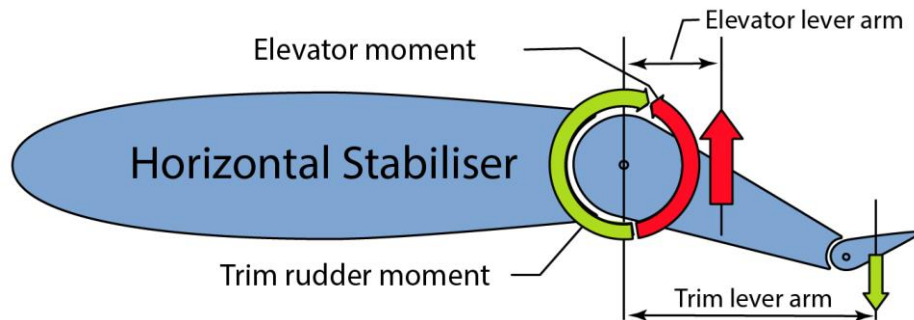
Figure 4. The trim moment arm gives authority over the rudder until equilibrium is reached.

According to the instructor, the student was manoeuvring the trim wheel more than normal before landing. The student experienced that the aircraft felt abnormal during the final approach and stopped trimming. It is therefore probable that the student overcompensated the trim towards nose down to compensate for the stick forces that the flap extension caused. This may explain the position of the trim.

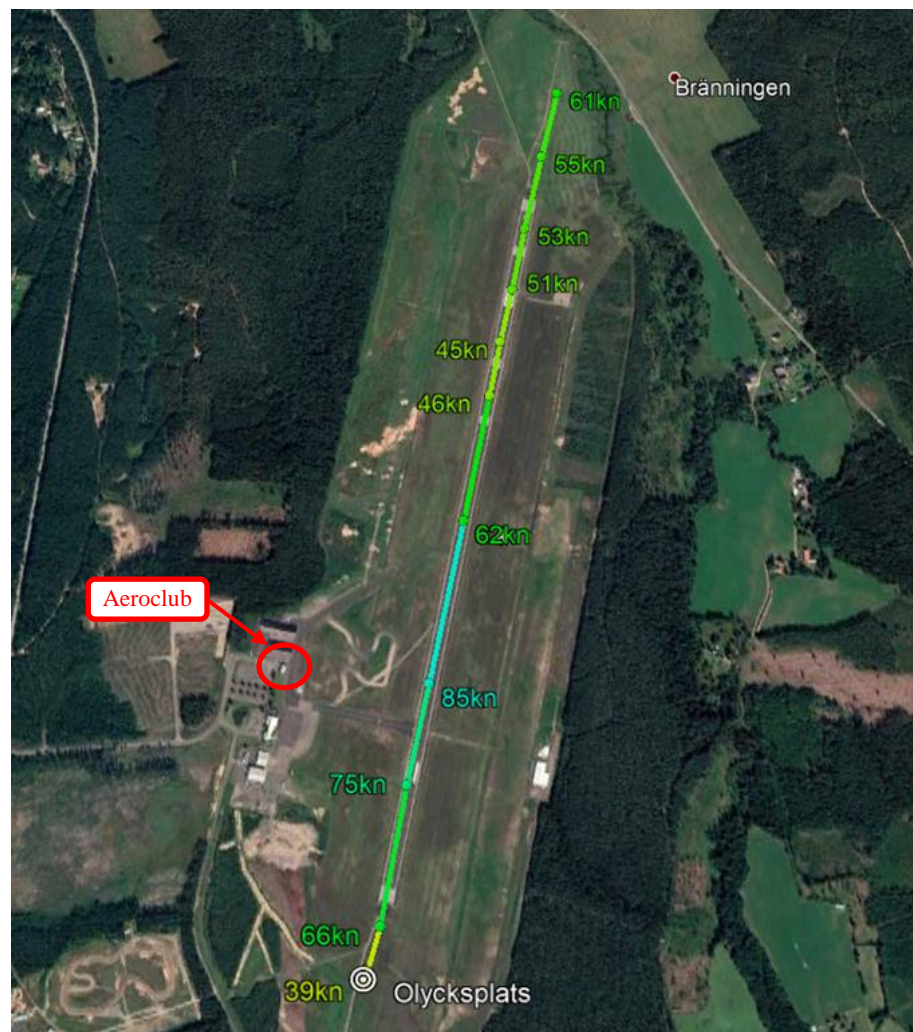
Figure 7. The aborted take-off. Each point represents the average speed (ground speed) calculated from the previous point. Image: Google Earth with markings inserted by SHK.

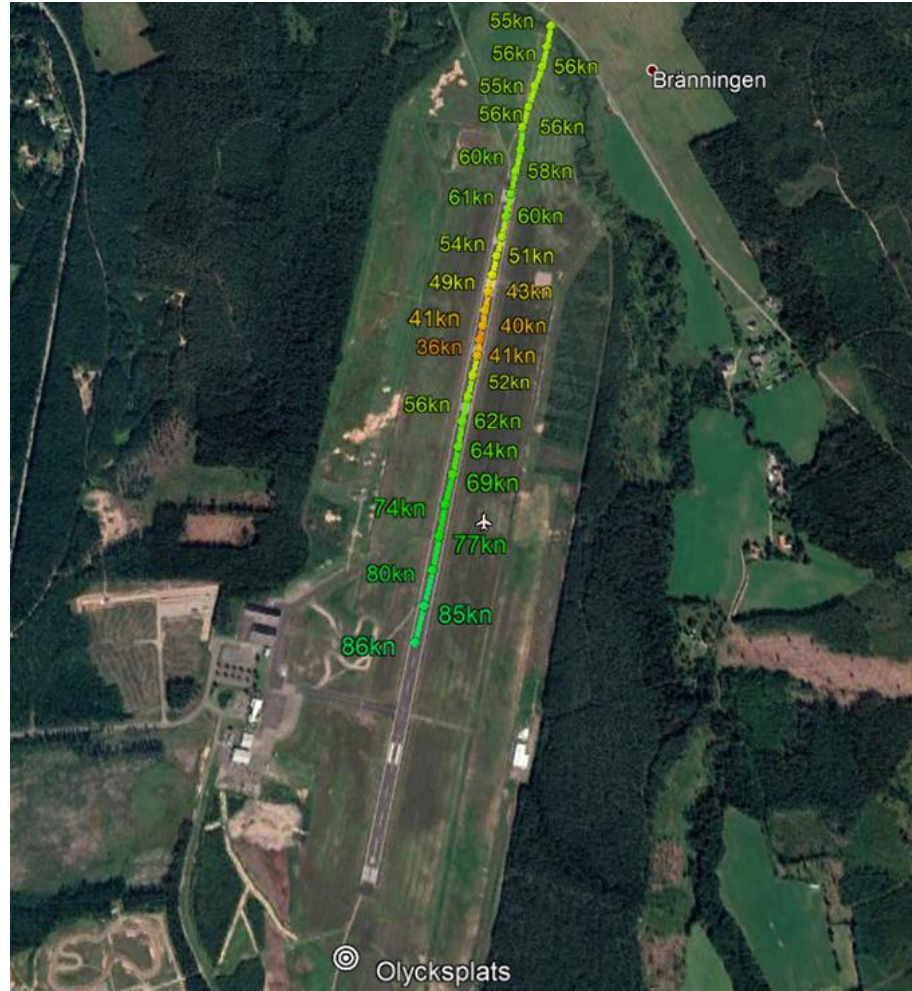
The Head of Training had a smartphone with built-in GPS that registered and recorded the flight with the Garmin Pilot application. The recordings were recorded at a frequency of half a hertz (once every two seconds). The recording started when the aircraft took off for the first time from runway 19 at 10.28.23 and stopped automatically at 11.55.18. When the recording ended, the aircraft had 587 metres left of runway 19.

Figure 8. The landing followed by the aborted take-off. Each point represents the ground speed at each reading. Markings inserted by SHK. Image: Google Earth.

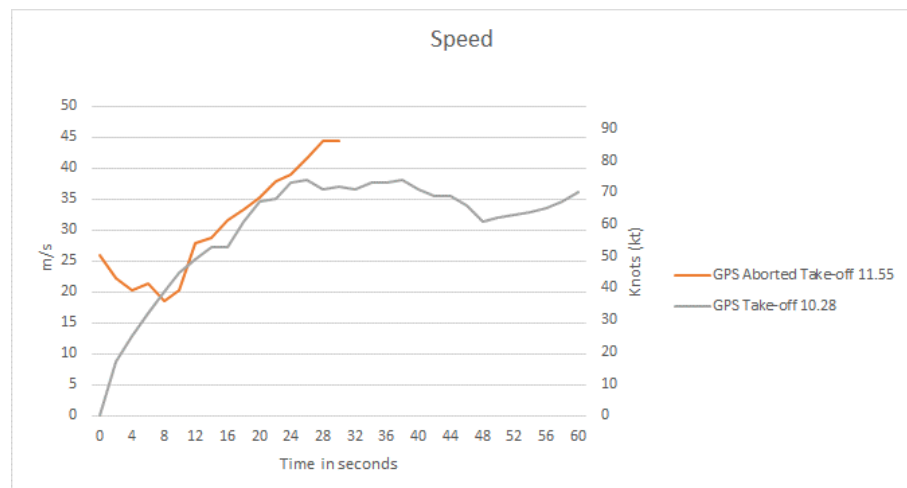
Figure 9. GPS data. The speed represents the speed above the ground at each reading. The gray line shows the first take-off. The orange line shows the aborted take-off.

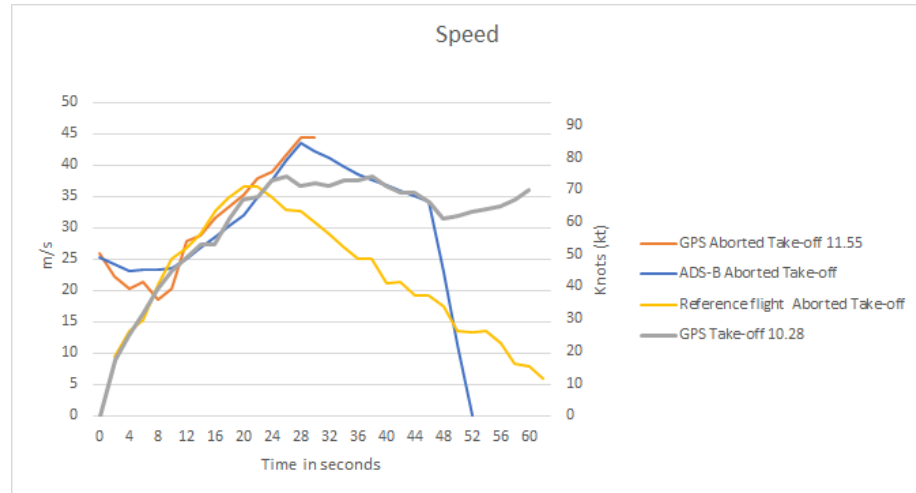
Figure 18. Merged data from Flightradar24, GPS data and the reference flight (GPS). Each point represents the average speed (ground speed) calculated from the previous point for data from Flightradar24. For GPS data and reference flight data, each point represents the ground speed at each reading.

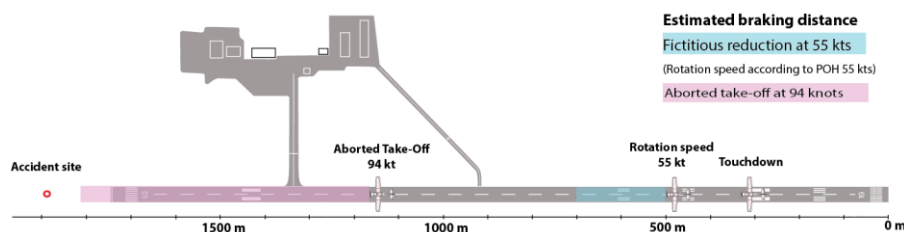
The figure below illustrates how the length of the braking distance was affected by the speed at the aborted take-off. The blue mark shows the braking distance at rotational speed 55 knots and the red mark shows the braking distance at 94 knots which the indicated speed has been estimated at when the take-off was aborted during the accident flight. The speeds are estimated on the basis of GPS data from the time of the accident, where the points represent the groundspeed. The speeds have then been adjusted with the reported headwind to represent the indicated airspeed.

Figure 21. The effect of braking distance at power reduction at different speeds. Aircraft symbols not to scale.

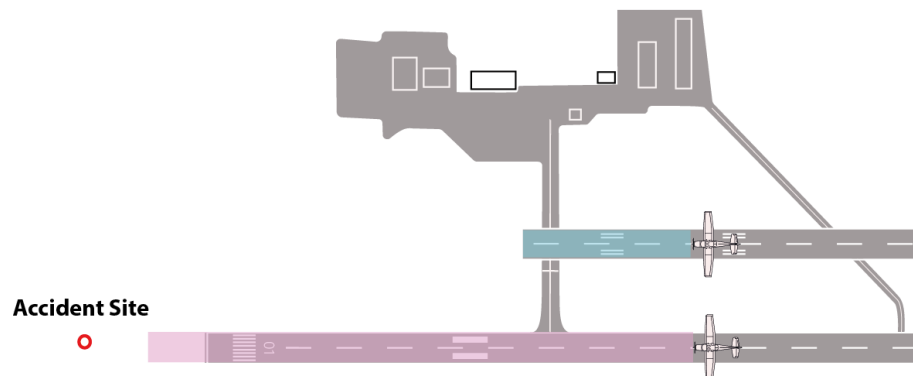
Figure 23 illustrates the braking distance required for an aborted take-off at different speeds at the approximate point where the instructor aborted the take-off. The blue marking is the calculated braking distance based on the flight manual's landing distance at landing speed. The red marking is the SHK:s calculation of the braking distance at the speed that the aircraft had when the take-off was aborted. If the instructor had an opinion similar to the blue marking, there was no reason for him to believe that the braking distance would not be sufficient in case of an aborted take-off.

Figure 23. Aborted take-off at the approximate point on the runway where the instructor aborted the take-off. Illustration of braking distance depending on the speed of the aircraft according to the paragraph above.
