HELICOPTER ACCIDENT REPORT AND EXECUTIVE SUMMARY

Reference:		CA18/2/3/9946	
Helicopter Registration	ZT-RRT	Date of Accident	21 January 2021		Time of Accident	1118Z	
Type of Helicopter	BELL 430		Type of Operation		Commercial (Part 138)		
Pilot-in-command Licence Type	CPL(H)		Age	40	Licence Valid	Yes	
Pilot-in-command Flying Experience	Total Flying Hours		2680.3		Hours on Type	561.7	
Last Point of Departure		Ultimate Heli, Midrand, Gauteng Province					
Next Point of Intended Landing		Hillcrest Hospital, Pietermaritzburg, KwaZulu-Natal Province					
Damage to Helicopter (Minor/Substantial/Destroyed)		Destroyed					
Location of the accident site with reference to easily defined geographical points (GPS readings if possible)							
8nm north-east of Winterton at GPS coordinates S28° 46' 52.66" E29° 40' 28.09";m Elevation at 3301 feet (ft)							
Meteorological Information	Surface wind 260° at 04kts; Temperature 29°C; Dew point 18°C; Visibility 9999m; Nil cloud; QNH 1020

Reference Number : CA18/2/3/9946
Name of Owner/Operator : National Airways Corporation (Pty) Ltd
Manufacturer : Bell Helicopter Textron
Model : Bell 430
Nationality : South African
Registration Marks : ZT-RRT
Place :

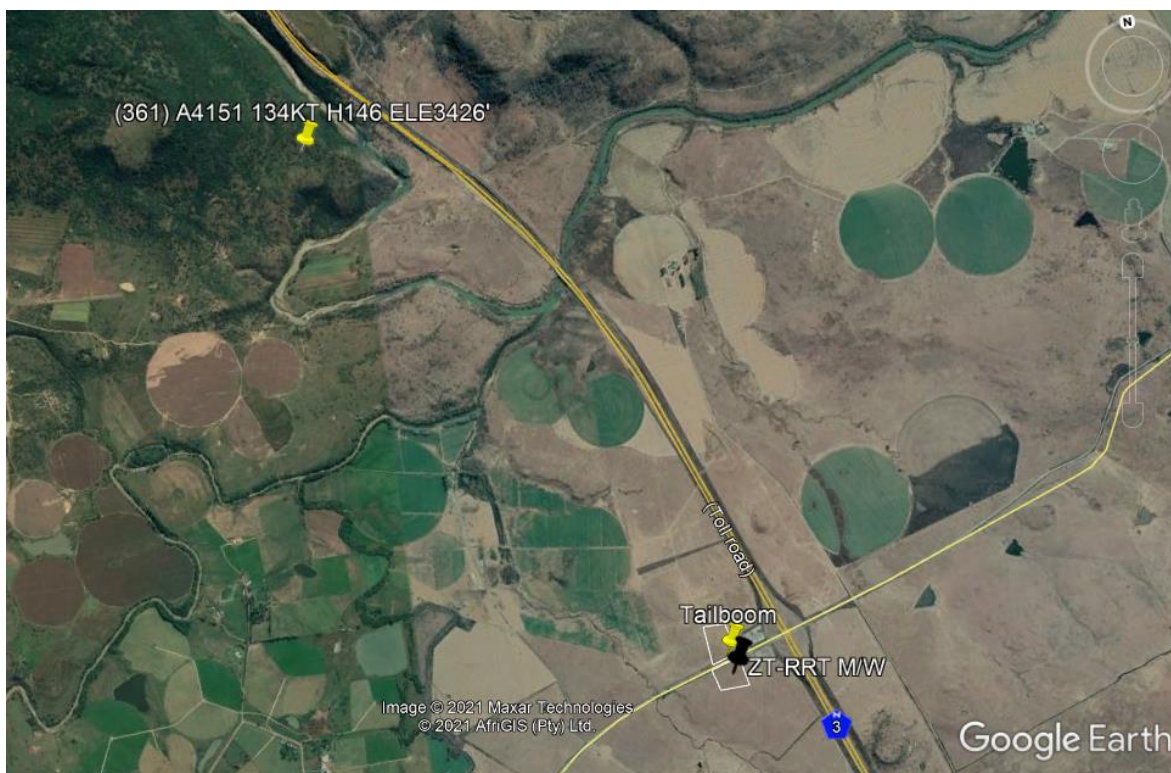
1.12.1 The helicopter's last known position from the Spidertracks device is 361 (Figure 4). The helicopter was cruising at 725ft AGL parallel to the N3 Highway in a south-easterly direction, 146°. The eyewitness (the farmer) stated that he saw a red and white helicopter spinning around with objects being flung out of the helicopter. The helicopter maintained a south-easterly direction but started to lose height rapidly. Loss of control continued until the helicopter impacted the ground and burst into flames after flying over the main road which crosses overhead the N3 Highway. The Okhahlamba Fire Department declared the accident site safe after extinguishing the fire.

Figure 4: Point 361 is the last downloaded position of the helicopter. It is 2.4nm away from the main wreckage. (Source: Google Earth)

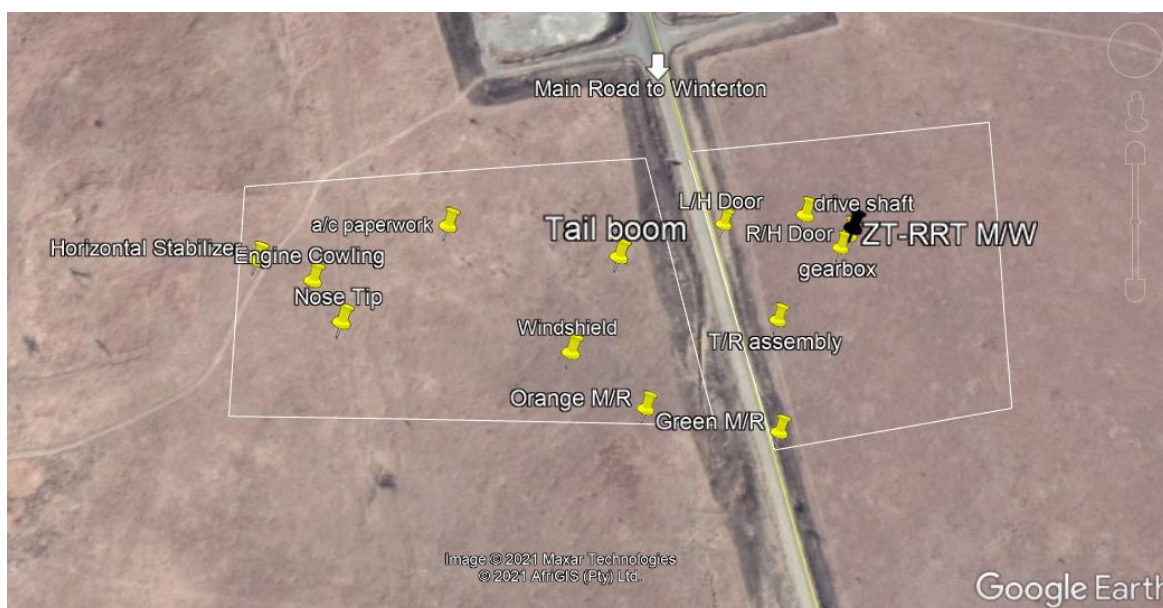
1.12.2 The objects that were flung out of the helicopter were some of its airframe parts that were severed by one or more of the helicopter's main rotor blades whilst spinning out of control, and some airframe parts that broke off because of the accident sequence. The accident site was divided into two sections; the first section was the tail boom site, and the second section was the main wreckage site. The accident site sections were separated by the main road leading to Winterton, south-west of the N3 Highway.

Figure 5: Schematic view of wreckage distribution. (Source: Google Earth)

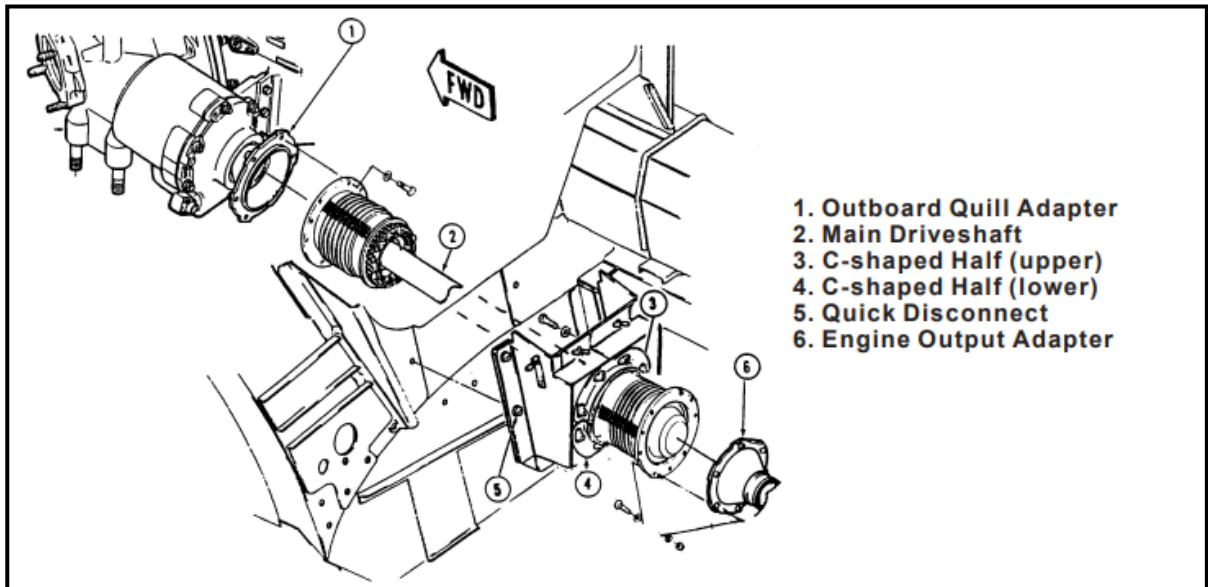
Diagram 2: Drive shaft connection between the engine and the transmission.

- *Both driveshafts got separated from the engine and transmission, and on examination they were found in good condition. On both ends of the two driveshafts, the inner spherical gears and outer gears were lined up perfectly, indicating no damage at all.*

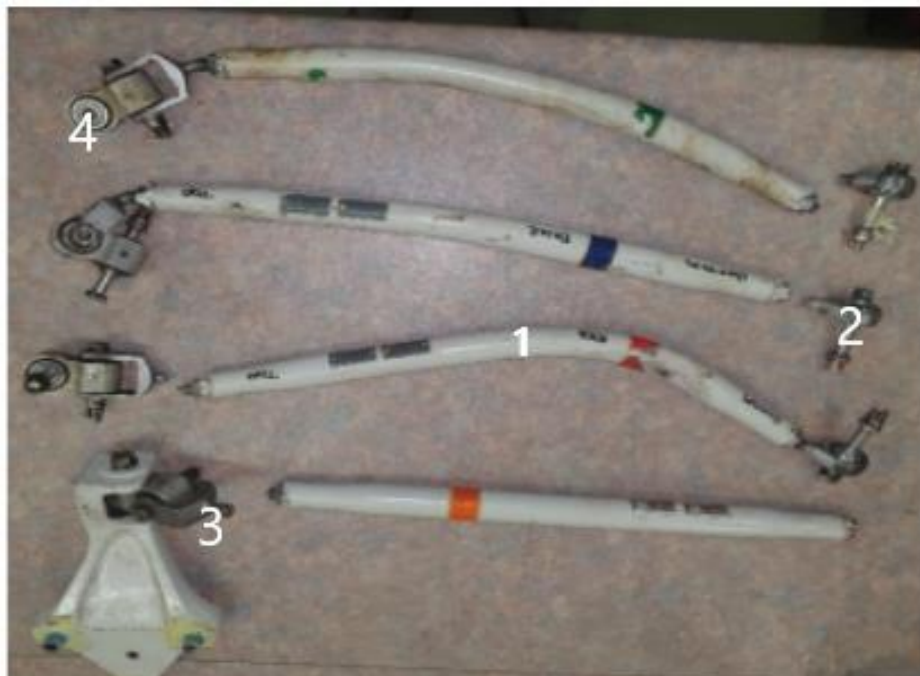
Figure 18: Components sent for analysis.

as they had failed before their respective scheduled removal hours as per the Bell historical service record manual Model 430. According to the Bell model 430 helicopter component replacement, all main rotor link assembly components (See Figure 18 (1) tube assembly, (2) rod end, (3) clevis and (4) universal bearing) had a life of 10 000 hours. Of all the M/R link assembly components that got replaced, the universal bearing was frequently changed. Hence, research of the failed components and the causes, thereof, was assigned to Laboratory for Microscopy and Microanalysis of the University of Pretoria. The second issue of the final report was released on 28 April 2021. The full report is attached as Annexure G.

The ORANGE and RED Clevises revealed fractures within the protruding threaded sections (Figure 22). The remaining BLUE and GREEN units revealed bending and impact damages only (Figure 23). The visual inspection of the ORANGE Clevis fracture surface revealed indications of a fatigue failure mode (Figure 24) suggesting it to be the primary failure initiating the accident sequence of events. The variation in impact damages between the ORANGE and the remainder of the M/R PCL Tubes (Figure 18) support this hypothesis. The RED Clevis as well as all the bottom PCL ends/bearings fractures and damages can be attributed to impact forces.

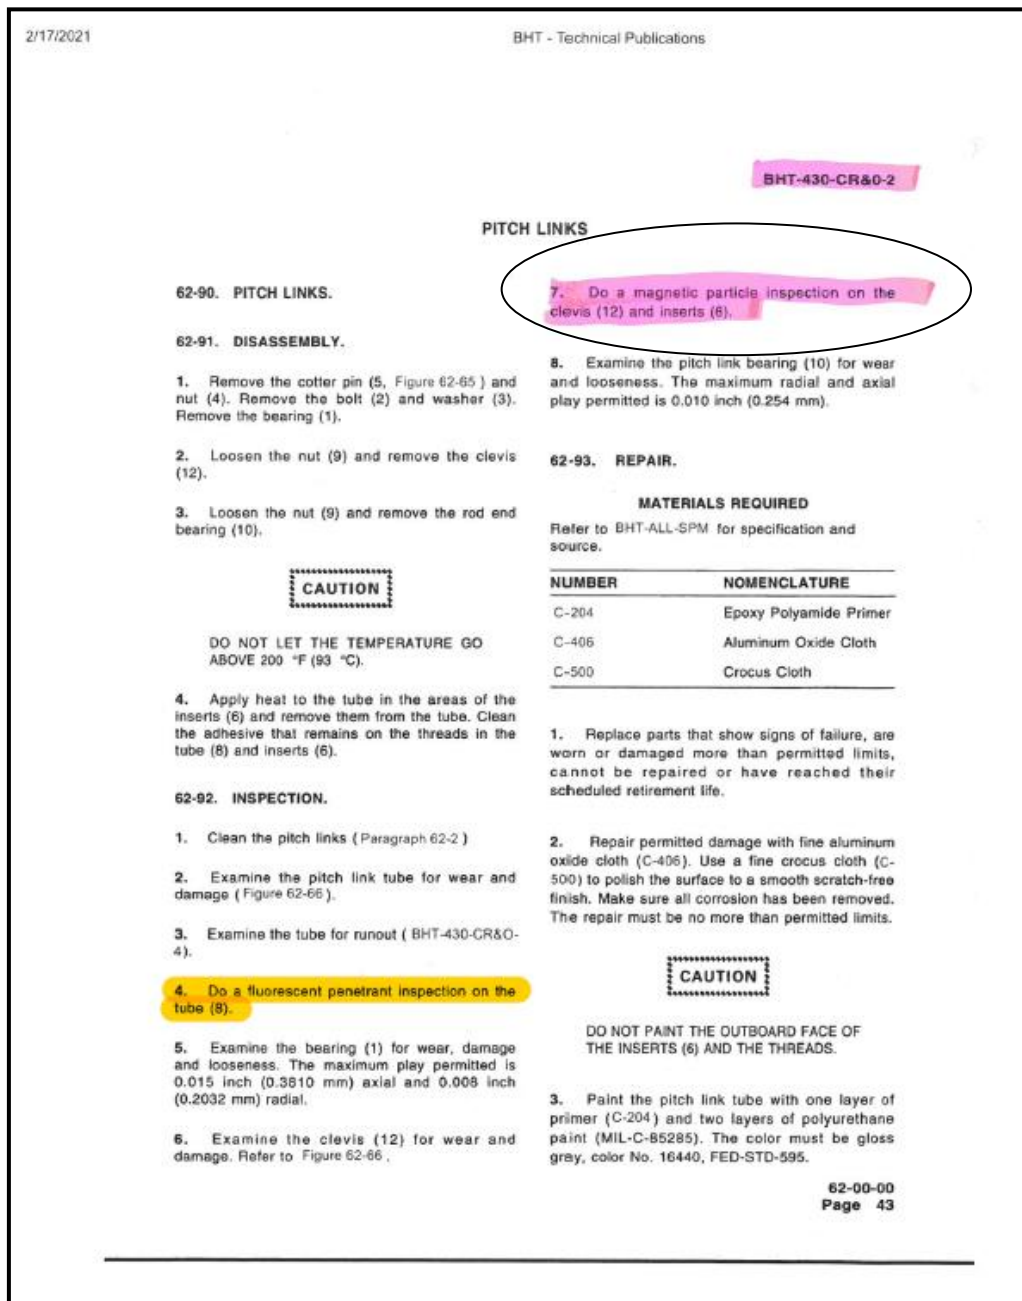
Failure to identify the fatigue crack on the threaded section of the clevis during a magnetic particle inspection as well as during the mandatory periodic inspection (MPI).

Figure 19: Bell 430 technical publication instructs that the clevis should be subjected to MPI testing.

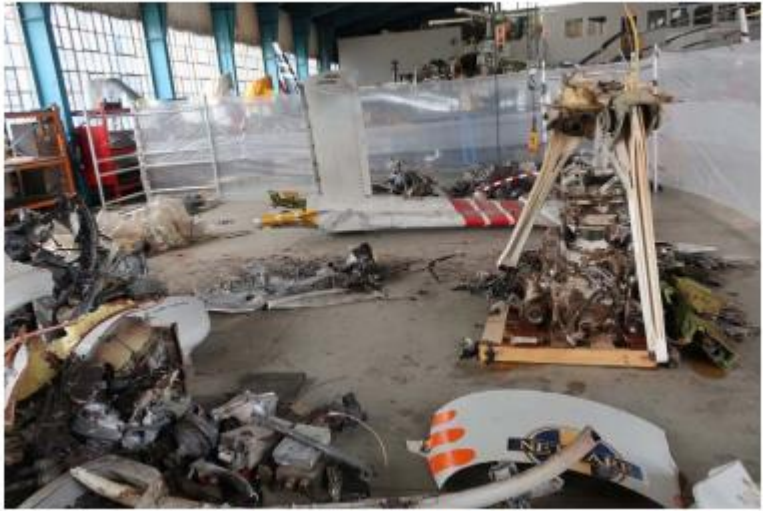
Aircraft after recovery to NAC Facility

Executive Summary: No abnormalities were observed during the engine exam which would affect engine operation during the event. The damage noted to both power turbine sections was consistent with a loss of load during the impact sequence and subsequent overspeed of the power turbine rotors. Multiple rotational and operational signatures were observed in both engines which was consistent with engine operation during the accident sequence.
