AIRCRAFT ACCIDENT REPORT AND EXECUTIVE SUMMARY

Reference:	CA18/2/3/9952	
Aircraft Registration	ZS-XAT	Date of Accident	4 February 2021		Time of Accident	0932Z
Type of Aircraft	Air Tractor AT-502B		Type of Operation		Private (Part 91)	
Pilot-in-command Licence Type	CPL	Age	67		Licence Valid	Yes
Pilot-in-command Flying Experience	Total Flying Hours	21 932.3		Hours on Type	8560.0	
Last Point of Departure	Lanseria International Airport (FALA), Gauteng Province, South Africa					
Next Point of Intended Landing	Hosea Kutako International Airport (FYWH), Namibia					
Location of the accident site with reference to easily defined geographical points (GPS readings if possible)						
Letsatsi Game Lodge, North West province (GPS position: 25°40'4.0" South, 026°53'7.8" East at an elevation of 4500ft)						
Damage to Aircraft	Destroyed					
Meteorological Information	Wind: 270° at 1kt; Temperature: 22°C; Dew Point: 20°C; Visibility: Unknown; Cloud: Broken at 2000-3000ft AGL; QNH: 1019 hPa

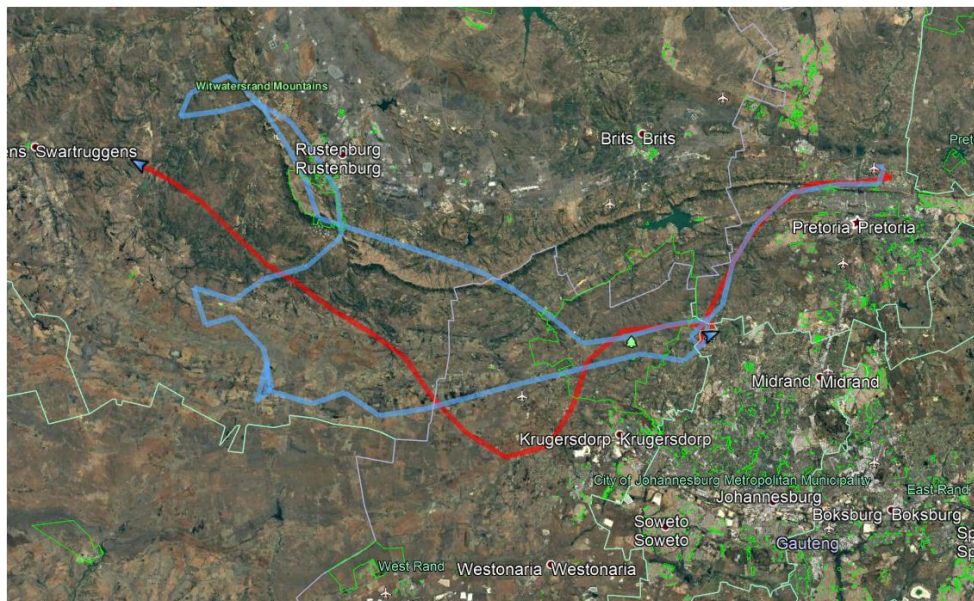
1.1.2 The pilot of ZS-XAS stated that he took off at 0858Z after ZS-XAT aircraft. The two pilots were communicating via very high frequency (VHF) radio during the flight. He (ZS-XAS pilot) then routed right (see Figure 1 blue line) of the planned flight path due to low-hanging clouds; and climbed to flight level 055 (FL055). He then contacted the ZS-XAT pilot, who responded and notified him that he was climbing to FL100 and was flying to the left (see Figure 1 red line) of the planned flight path. The pilot of the ZS-XAS flew towards north of Rustenburg and turned in a south-westerly direction due to deteriorating weather conditions. He then tried to contact the ZS-XAT pilot but to no avail. Thereafter, he contacted Johannesburg (JHB) Information to get an update on the weather conditions. JHB Information advised him that the weather conditions were becoming more unfavourable to fly; thereafter, the ZS-XAS pilot made the decision to fly back to FALA.

Figure 1: The flight paths of both aircraft — red line is ZS-XAT path, and blue line is ZS-XAS path.
(Source: Operator)

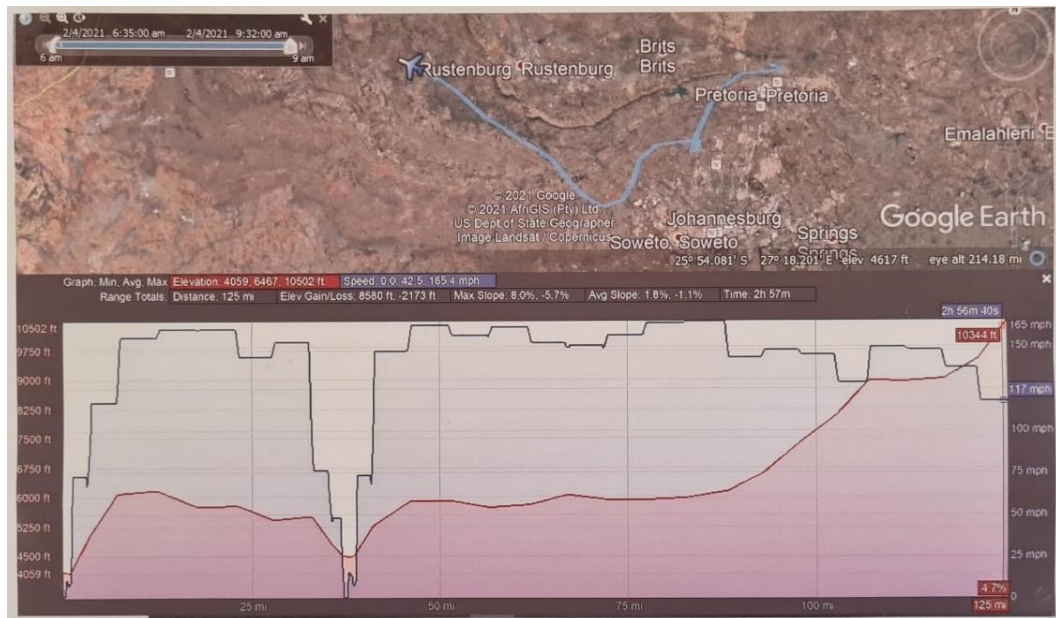
1.1.3.1 The red shaded area relates to the altitude of the accident aircraft (ZS-XAT). The aircraft took off from FAWB and made a descent to FALA where it landed without event. The purpose of landing at Lanseria was to clear immigration and customs before proceeding to Namibia. The aircraft then took off again routing to FYWH; it climbed to 6000 feet (ft) above mean sea level (AMSL) approximately 50 miles from FALA; it again climbed to an altitude of 10 344ft AMSL at 0932Z when it disappeared from the tracking device.

- 1.1.3.2 The blue shaded area (in Figure 2) relates to the speed of the aircraft (ZS-XAT). The aircraft took off from FAWB and made a descent to FALA where it landed without event. It then took off again and climbed, reaching a speed of 165 miles per hour (mph) or 143 knots (kts) approximately 50 miles from FALA. Thereafter, the speed started to decrease until 117mph (101kts) at 0930Z before the aircraft disappeared from the tracking device.
- 1.1.3.3 The point where the aircraft disappeared from the operator's tracking device and radar control of JHB Information was determined to be 1 nautical mile (nm) north-east of Morningside Airfield (FAMS).

Figure 2: The flight path of the ZS-XAT aircraft. (Source: Operator)

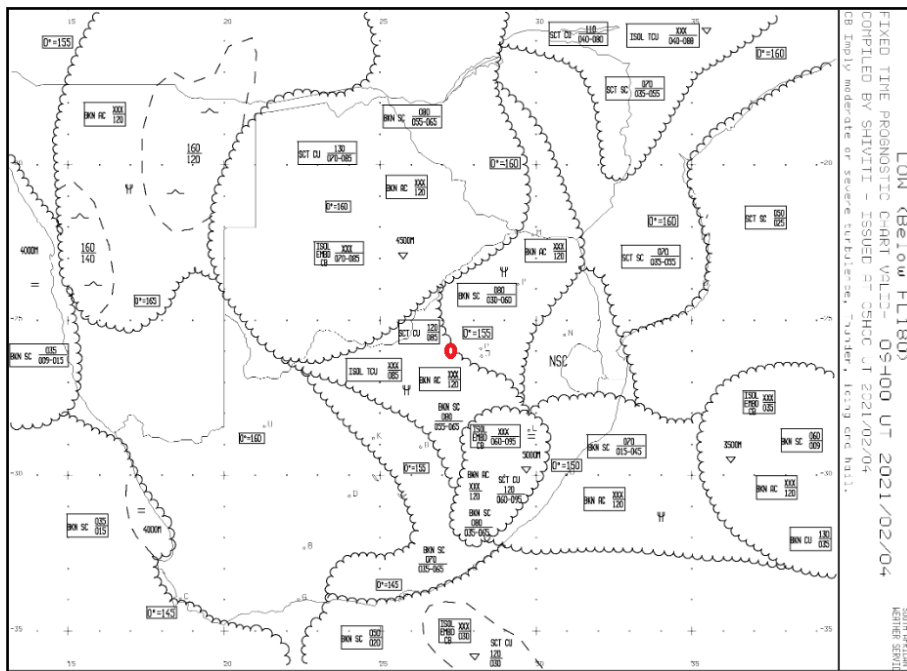
Red area is roughly the accident site.

It shows generally cloudy area with low level stratocumulus and cumulus clouds ranging from 1500-3000ft above ground with tops up to 12000ft and also towering cumulus clouds which could have some light showery rain.

Figure 4: The cloud bases and tops at the time of the accident.

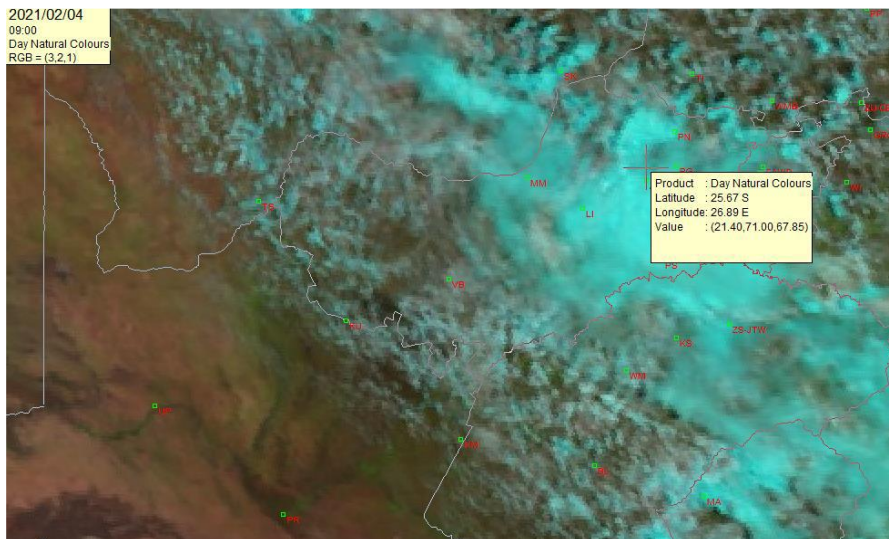
1.7.3 The weather report of 4 February 2021 shows that the weather stations along the planned route — FALA, Hartbeespoort, Buffelspoort, FARG and FAMM recorded broken cumulus at 2000-4000ft above ground level (AGL) with cumulonimbus clouds, towering cumulus at 4500ft AGL, and overcast at 6000ft AGL. The grey cross in Figure 5 represents the accident site.

Figure 5: The cloud cover at the time of accident.
