Final report RL 2022:02e

**Accident at Skeberg, Dalarna County, on
16 March 2021 involving the helicopter
SE-JVF of the model Robinson R44,
operated by a private individual**

File no. L-15/21

6 May 2022

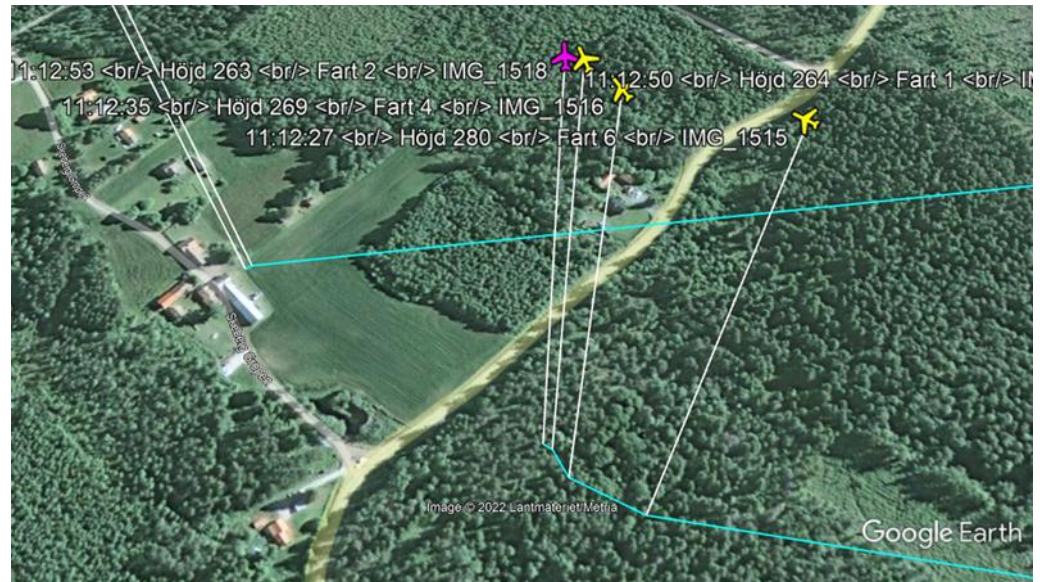
Figure 1. Last part of the flight. Source: Mobile phone data, Google Earth and © Lantmäteriet.

The image positions are marked with airplane symbols. The green line connects the positions and does not show the exact flight path. The text in white in figure 1 shows the current speed and altitude at the time when the picture was taken. (Ground speed in km/h and altitude in metres above mean sea level.) The ground level at the accident site is about 225 metres above mean sea level and the trees are around 18 metres high.

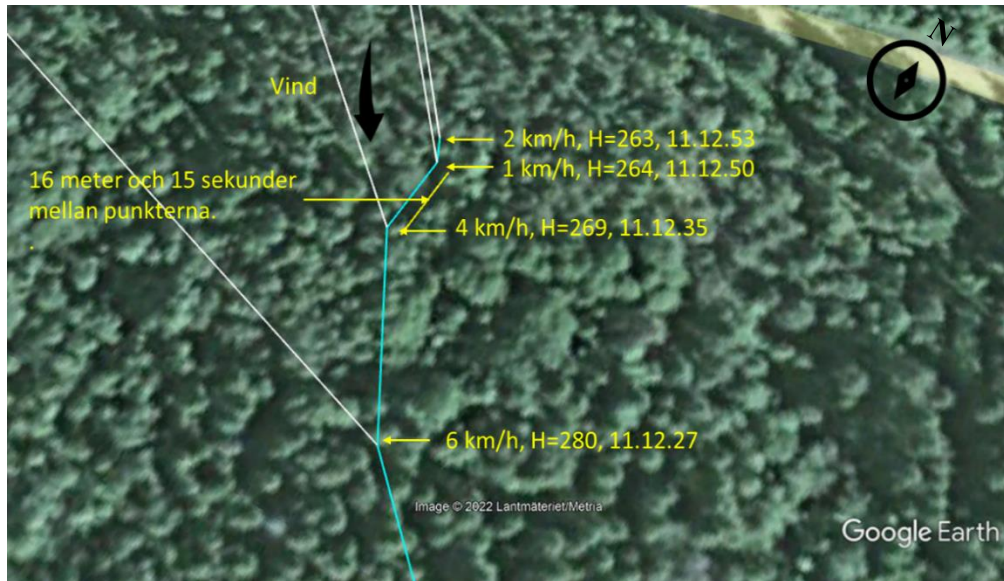
Figure 2 shows the image positions directly from above in yellow text and the estimated wind direction.

Figure 2. Time, speeds and altitudes during the last part of the flight. Source: Mobile phone data, Google Earth and © Lantmäteriet.

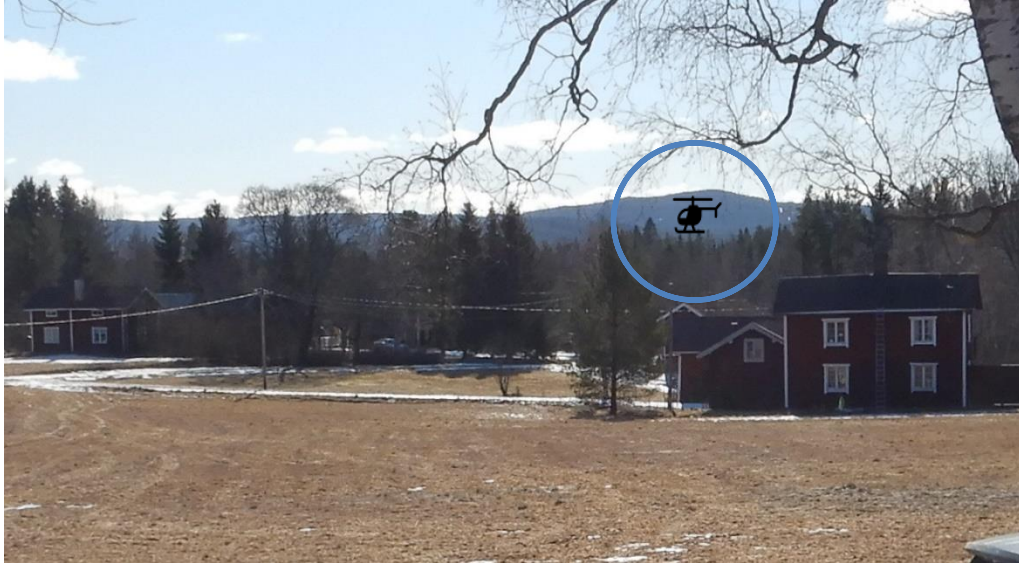
One witness saw the helicopter head-on at a distance of around 600 metres. The witness has stated that the helicopter looked like it was standing still above the forest and that it was turning a little in one direction before then turning in the other direction in an accelerating rotation. The helicopter then disappeared from view.

Figure 4. The witnesses' view towards the helicopter at the time of the accident. The helicopter silhouette shows the approximate location of the helicopter during the rotation prior to the crash, as perceived by the witness.

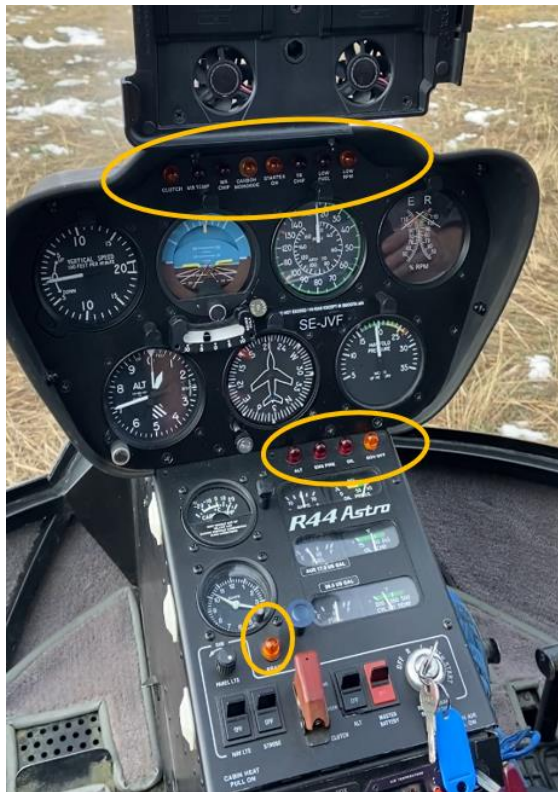
There are a number of warning lights on the instrument panels in the cockpit (see Figure 23). All the warning lights have been examined.

Figure 23. The location of the warning light on the instrument panels. Picture from the start of the flight. Markings by SHK. Photo: Private.

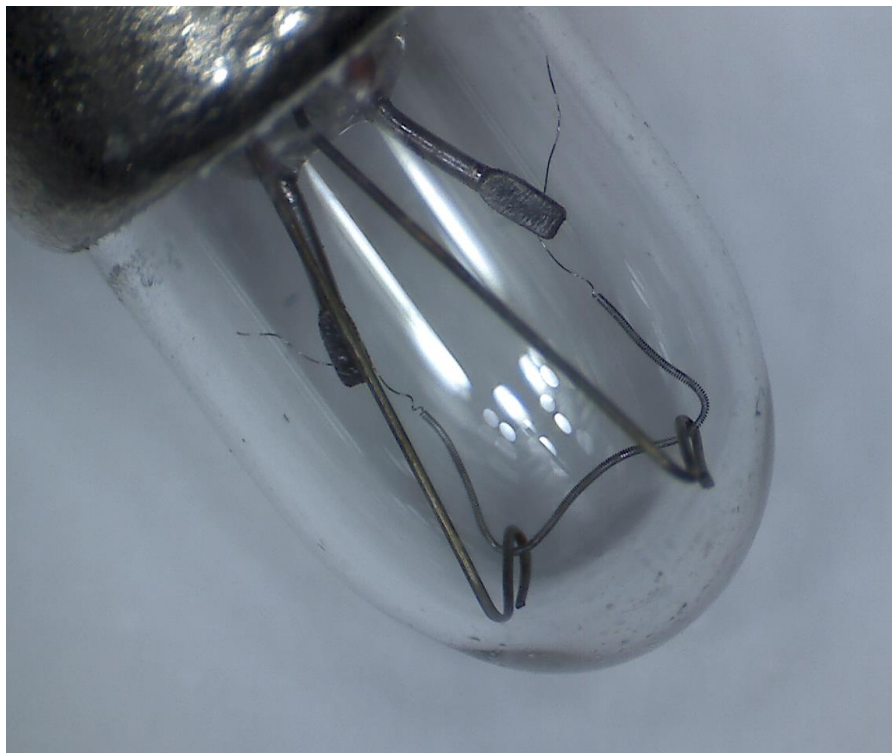
When a lit light bulb is subjected to g-forces, as is the case during a crash, the glowing filament is stretched. Inspection of the filaments from the warning lights under a microscope shows that it is highly probable that the warning light for low voltage from the alternator was illuminated (see Figure 24). This indicates that the engine had either stalled or had low RPM before the impact with the ground.

Figure 25. Filament with a normal appearance for comparison. In this case, the warning light for low engine oil pressure.

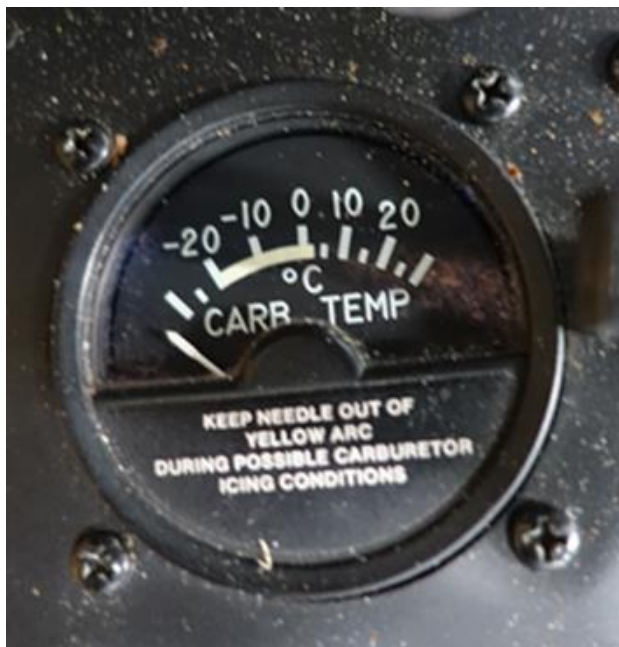
There was an instrument in the cockpit that shows the temperature in the carburetor. The temperature has to be kept outside of the marked area (see Figure 26).

Figure 26. Instrument showing the temperature in the carburetor (Carb Temp).

An analysis of pictures and videos taken during the flight showed carburetor temperatures between +10°C and +20°C on the instrument. These values indicate that the carburetor heat was working during the flight and probably prevented any problems with carburetor icing.

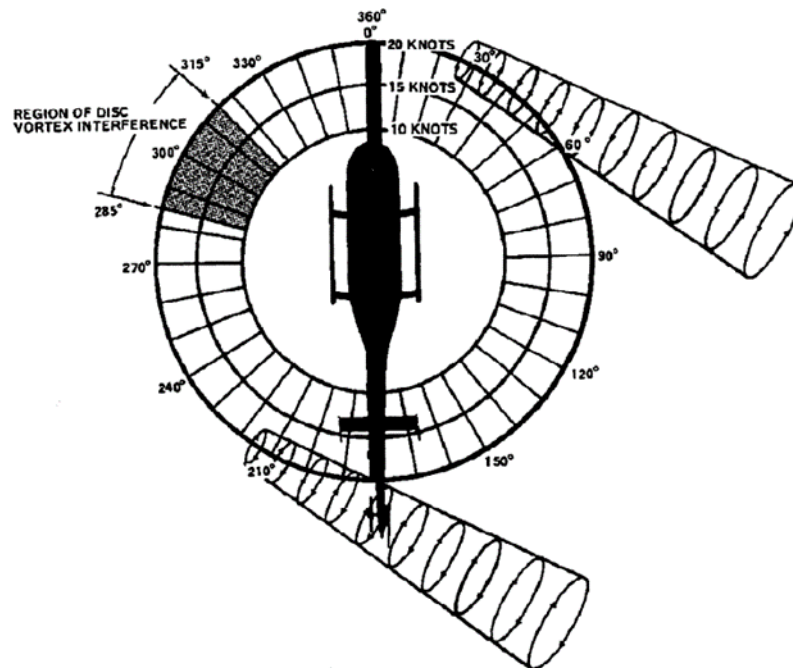
FIGURE 1. MAIN ROTOR DISC VORTEX INTERFERENCE

The type certificate holder Robinson Helicopters Inc. has published a safety document in which they point out the risk of unanticipated yaw in, for example, wind from the left or low rotor RPM (*Robinson SN-42 Unanticipated yaw, 2017*).

Figure 29. Shows how the downwash from the main rotor can interfere with the function of the tail rotor. Source: FAA AC 12/26/95.
