**LIMITED OCCURRENCE INVESTIGATION REPORT**

<b>Reference Number</b>	CA18/2/3/9992						
<b>Classification</b>	Accident	<b>Date</b>	3 May 2021	<b>Time</b>	1148Z		
<b>Type of Operation</b>	Training (Part 141)						
<b>Location</b>							
<b>Place of Departure</b>	Virginia Airport (FAVG)			<b>Place of Intended Landing</b>	FAVG		
Place	Umngeni River, Durban, KwaZulu-Natal						
<b>GPS Co-ordinates</b>	Latitude	S29° 46' 15"	Longitude	E031°03'37"	Elevation	1732ft	
<b>Aircraft Information</b>							
Registration	ZS-HBR						
Model/Make	Robinson R22, Beta II						
Damage to Aircraft	Destroyed		Total Aircraft Hours	3230.4			
<b>Pilot-in-command</b>							
Licence Type	Commercial Pilot Licence		Gender	Male	Age	24	
Licence Valid	Yes						
Total Hours on Type	170.7		Total Flying Hours	533.1			
People On-board	1 + 1	Injuries	0	Fatalities	2	Other (on Ground)	0
<b>What Happened</b>							
<p>On Monday morning 3 May 2021 at about 1148Z, a Robinson R22 Beta II helicopter with registration ZS-HBR was conducting a local training flight at Virginia Aerodrome (FAVG), north-east of Durban in KwaZulu-Natal province, when the accident occurred. On-board the helicopter were the student pilot and a Grade I

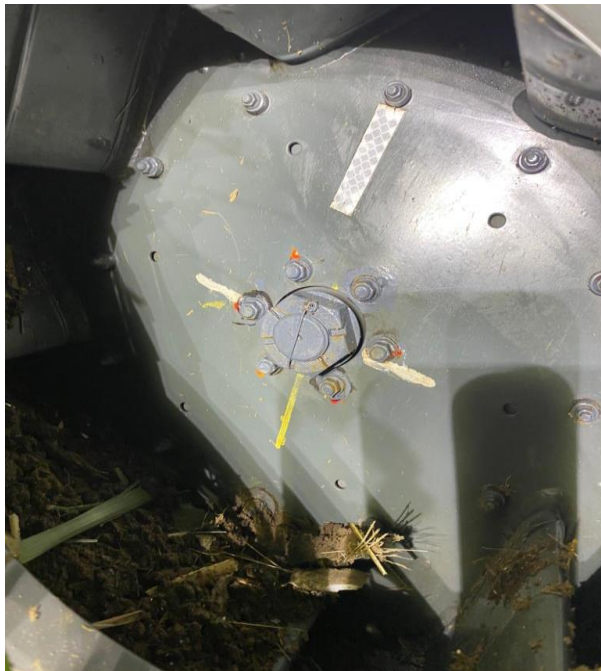
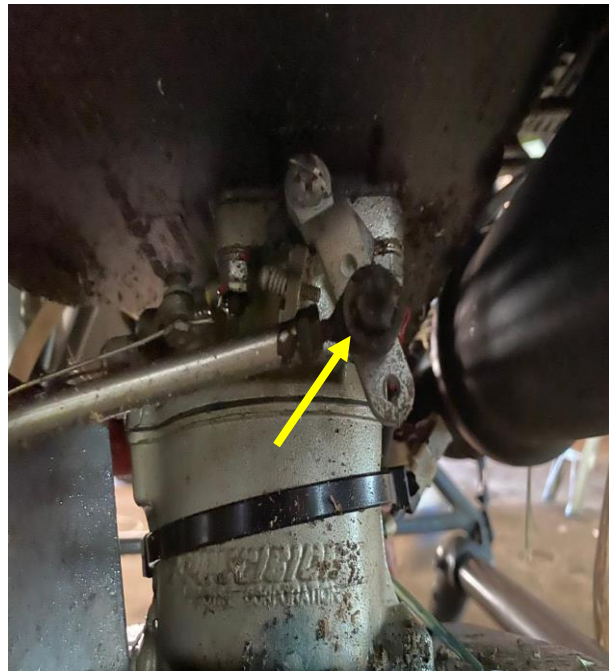
Upon examining the wreckage while focusing on the tail rotor, bird feathers were noted on one of the blades, as well as blood stains on the tail cone area. The investigators also noted several signs that indicated that the engine was running at the time of accident. The twist-grip throttle control rod attached to the engine carburettor was found at maximum power and the engine cooling fan displaying scoring around the perimeter and on the inlet cone surface indicated that it was turning at the time of accident. Witness marks on the tail rotor teetering hinge were an indication of a bird strike during normal rotation. Records indicated that the helicopter was certified, equipped and maintained in accordance with (IAW) the existing regulations and approved procedures. The helicopter had no known deficiencies before the flight and was being operated within its weight and centre of gravity limits.

**Figures 4 & 5:** Left picture shows witness marks left on the tail rotor teetering hinge after a bird strike. Right picture shows bird feathers on the tail rotor blade.
