DUTCH
SAFETY BOARD

Loss of engine power after takeoff

The Hague, April 2023

Identification number:	2021062
Classification:	Accident
Date, time of occurrence:	25 June 2021, 09.33 hours ¹
Location of occurrence:	West of International Airport Teuge (EHTE)
Operator:	Skydive Teuge
Registration:	PH-FST
Aircraft type:	Cessna 208B Supervan
Aircraft category:	Fixed wing, single engine turboprop
Engine type	Honeywell TPE331-12JR
Type of flight:	Parachute drop
Phase of operation:	Initial climb
Damage to aircraft:	Substantial
Flight crew:	One
Passengers:	Seventeen
Injuries:	One passenger minor
Light conditions:	Daylight

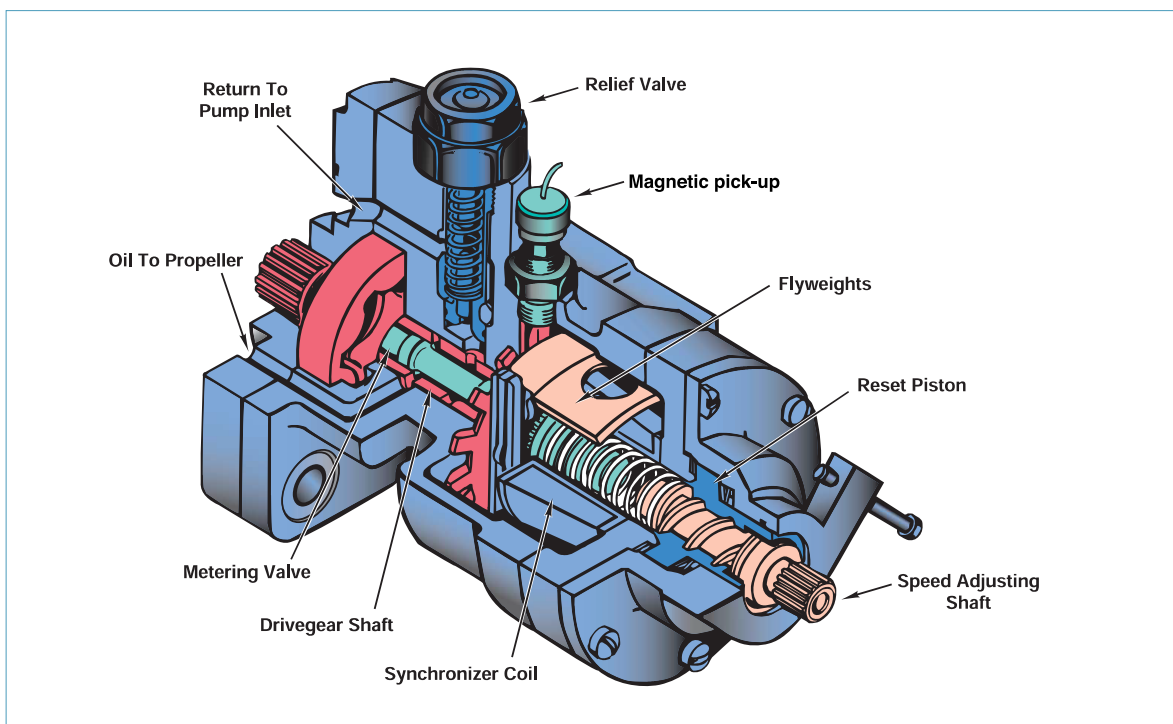
Figure 2: Simplified drawing of propeller governor. (Source: Honeywell TPE331 Line Maintenance Training Manual)

The propeller governor assembly is composed of a sliding metering valve, speeder spring and a ball head assembly, which includes a toothed gear and flyweights, see Figure 2. When RPM changes, the flyweights, a component of the ball head assembly, change position and move the sliding metering valve. This leads to either releasing oil from or applying pressurised oil to the propeller dome, changing the propeller pitch and load.

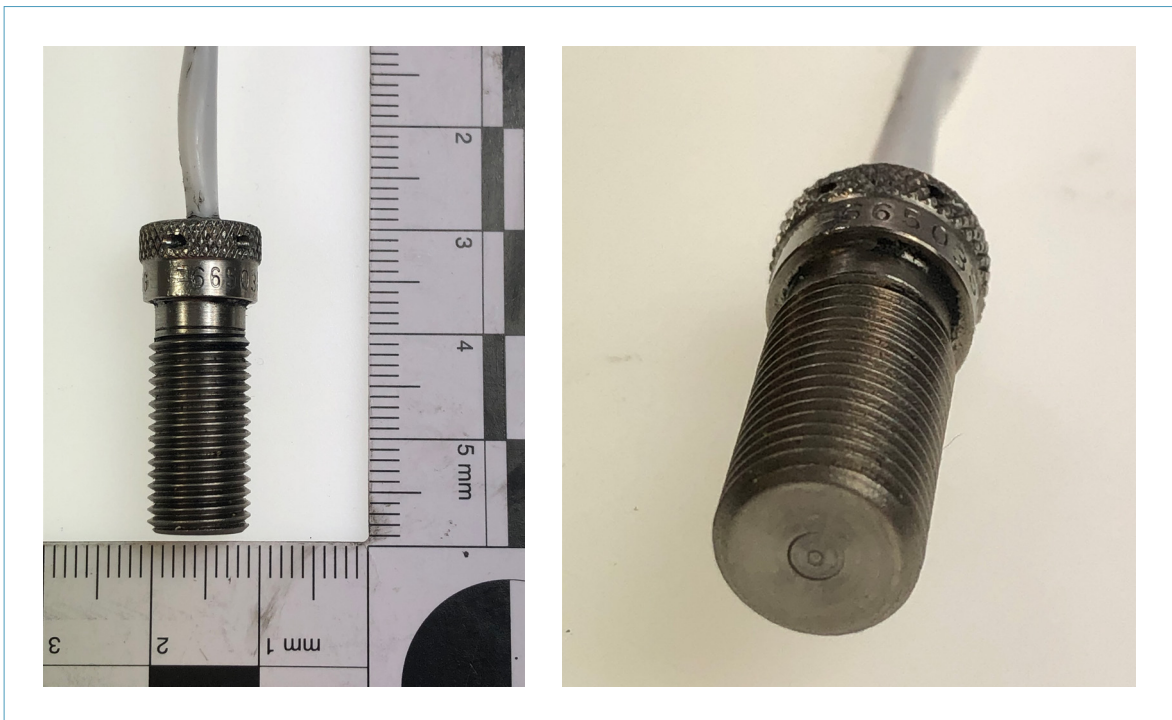
Figure 3a and 3b: Magnetic pick-up in its original state. (Source: Dutch Safety Board)

The magnetic pick-up is a threaded part and installed in the propeller governor by turning the part in the assembly and tightening it with a locknut. The magnetic pole is in the centre of the sensor housing, see Figure 3a and 3b. The brazing material used for the core is silver.

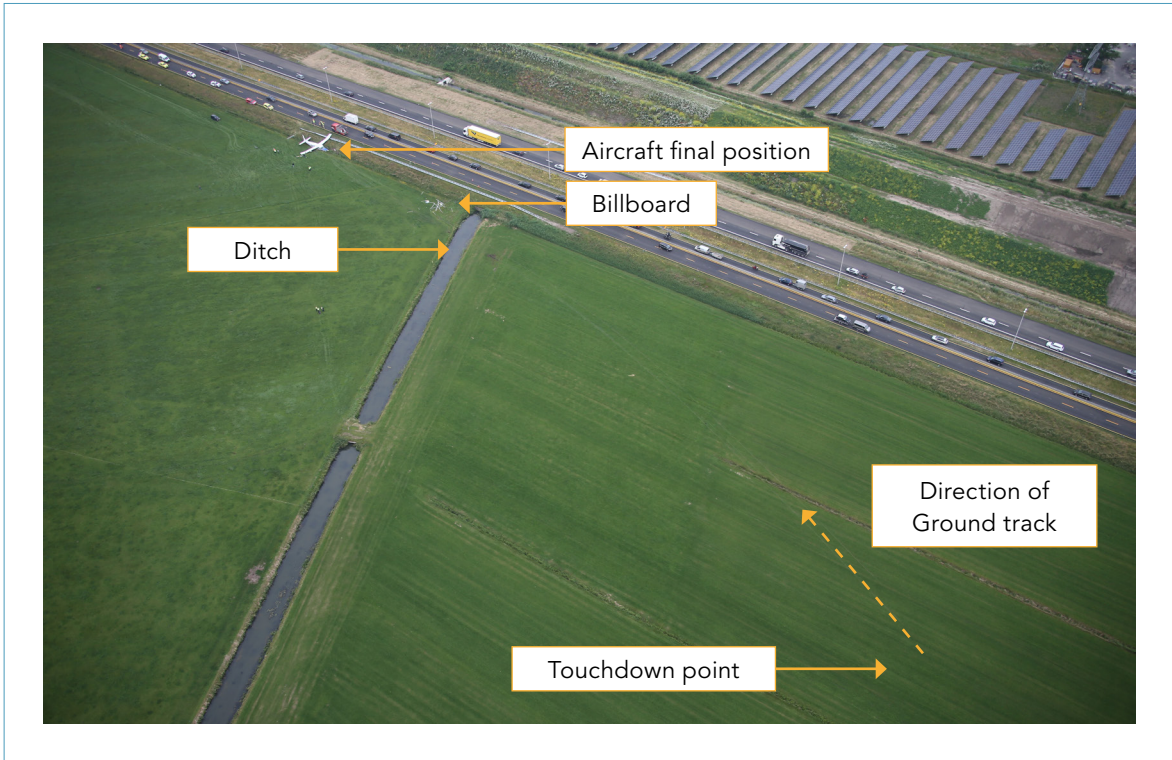
Figure 4: Ground track of the aircraft. (Source photo: Dutch Aviation Police)

The track of the emergency landing in the field is shown in Figure 4. During the ground roll, the aircraft collided with a billboard with the right wing. The aircraft came to rest in a ditch.

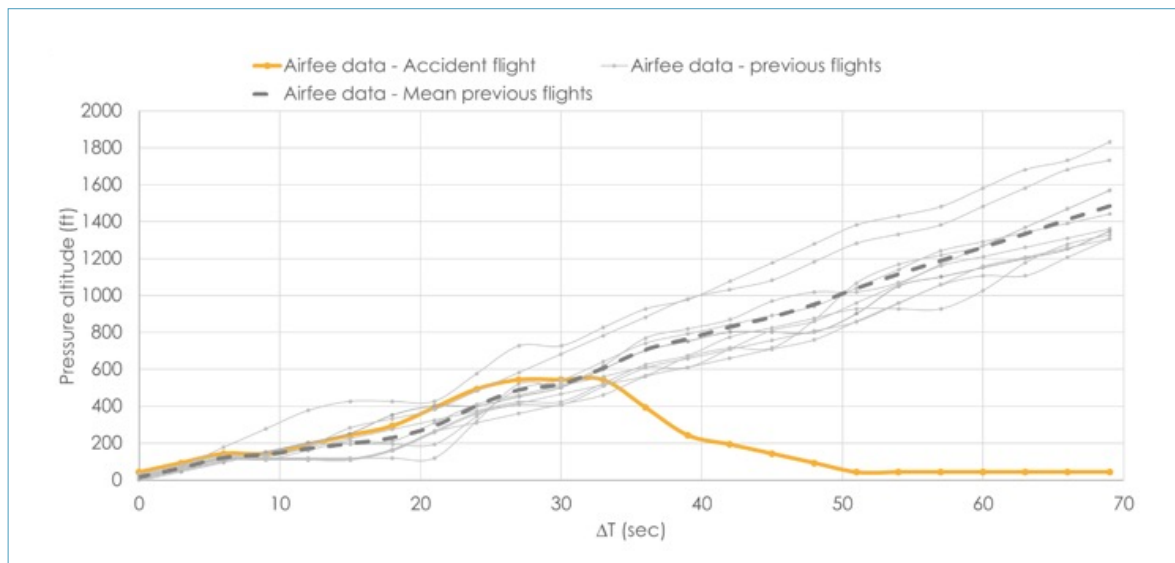
Figure 6: The pressure altitude of the aircraft during the accident flight as indicated by AirFee data compared to previous flights including the mean value as a reference.

In addition to the Garmin data, use was made of data extracted from AirFee, an automated movement registration system used by the aerodrome. AirFee data was collected for the accident flight and previous flights of PH-FST, during the seven days leading up to the accident. Figure 6 shows the pressure altitude (1013 mbar reference) of the aircraft during the accident flight in comparison to the mean altitude (climb) profile of previous flights. This data provides a rough indication of the climb profile of the accident flight.⁸ The data shows that the climb profile of the first part of the flight (up to the point of the engine failure) coincides with the mean altitude profile of previous flights.

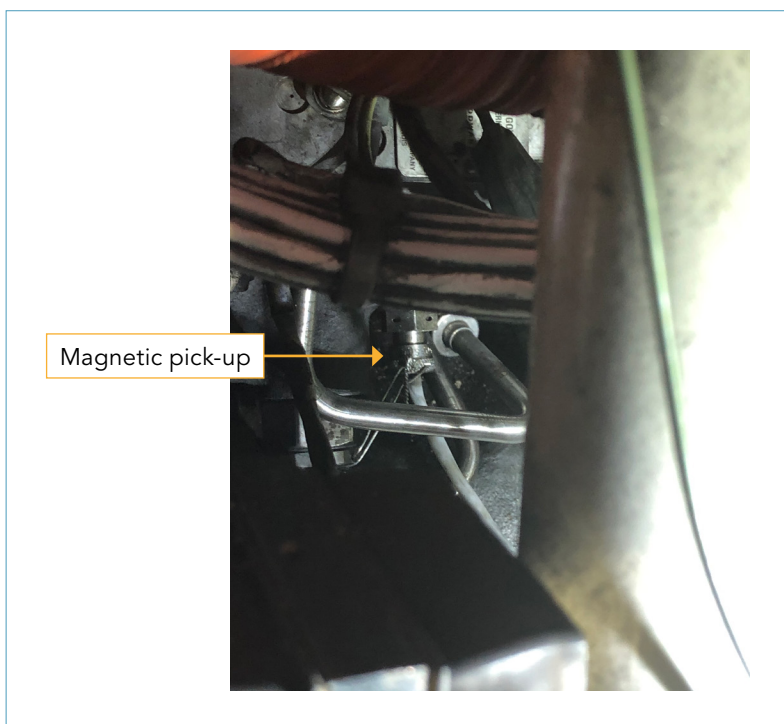
Figure 17: Location of magnetic pick-up in the engine. (Source: Dutch Safety Board)

On this engine, the magnetic pick-up is located on the underside of the propeller governor, see Figure 17.

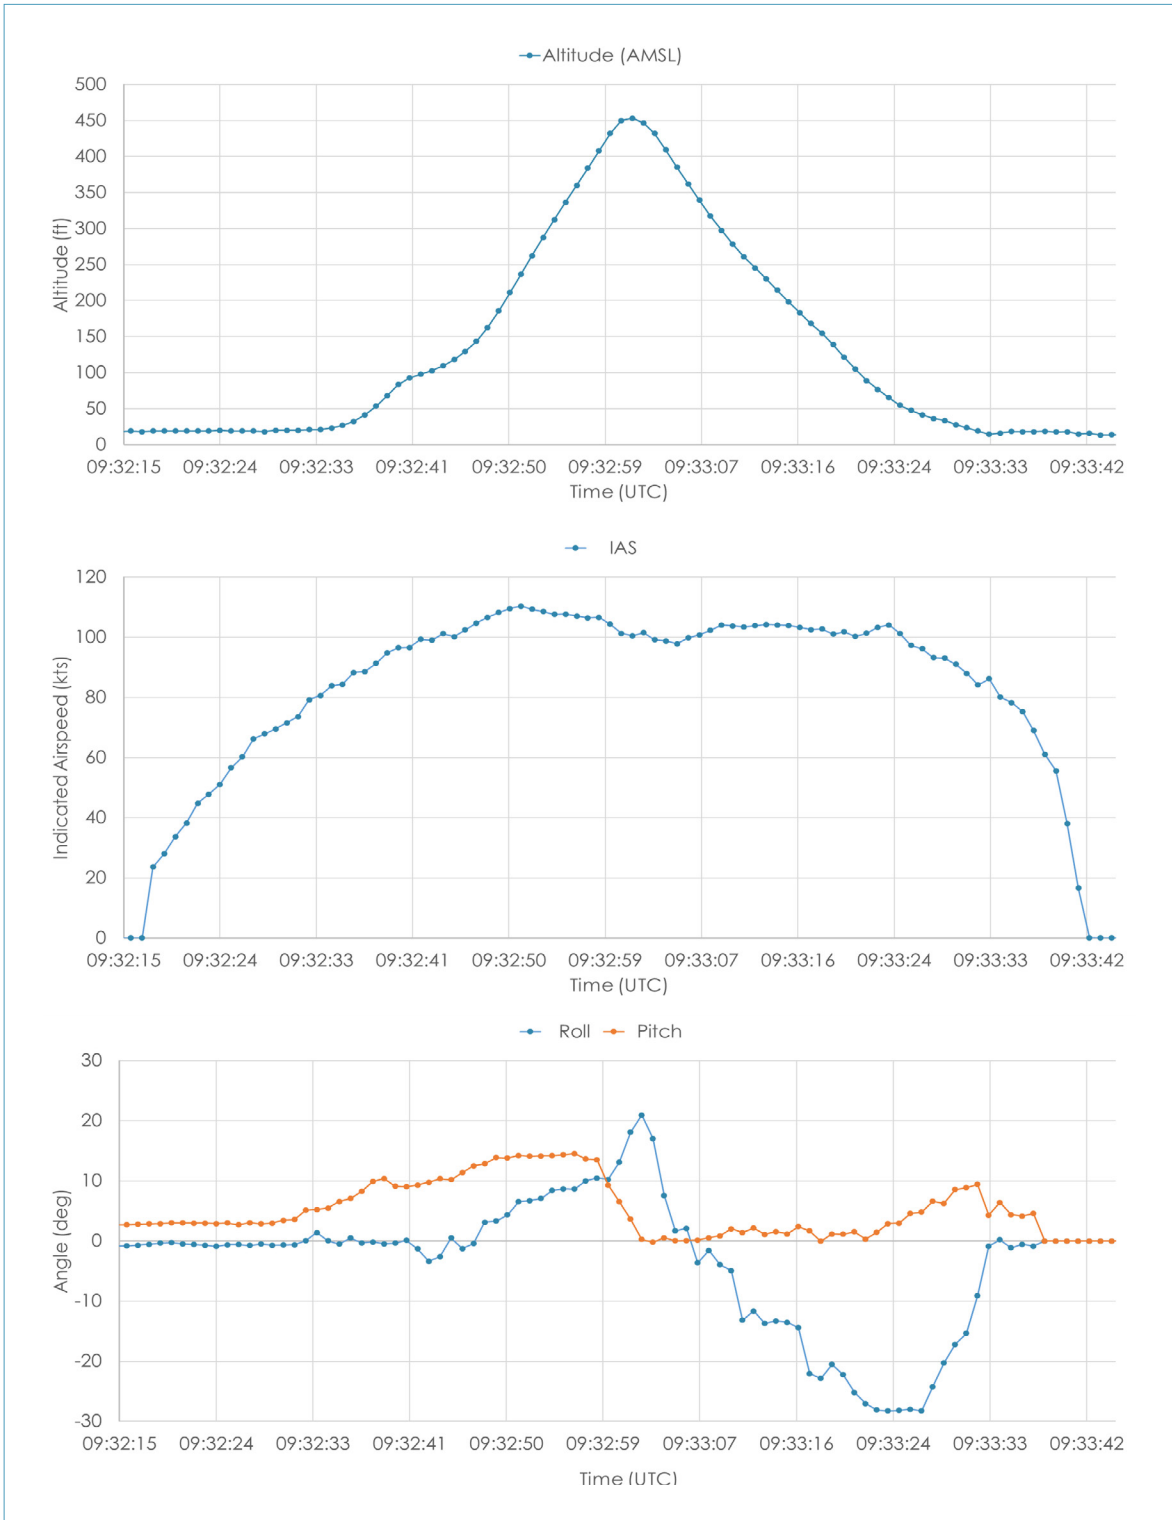
Figure 19: The altitude and speed profile and roll and pitch attitude of the aircraft during the accident flight, based on data from the Garmin G600 device.

The memory card of the Garmin G600 avionics device in the aircraft was retrieved and contained data logs of the accident flight and previous flights. The parameters that were recorded on the device included, amongst others, the device time, GPS position data (longitude, latitude), altitude and barometric settings, outside air temperature, indicated airspeed (IAS), ground speed, linear accelerations (lateral and normal) and aircraft attitude (roll and pitch). A selection of parameters are depicted in Figure 19.

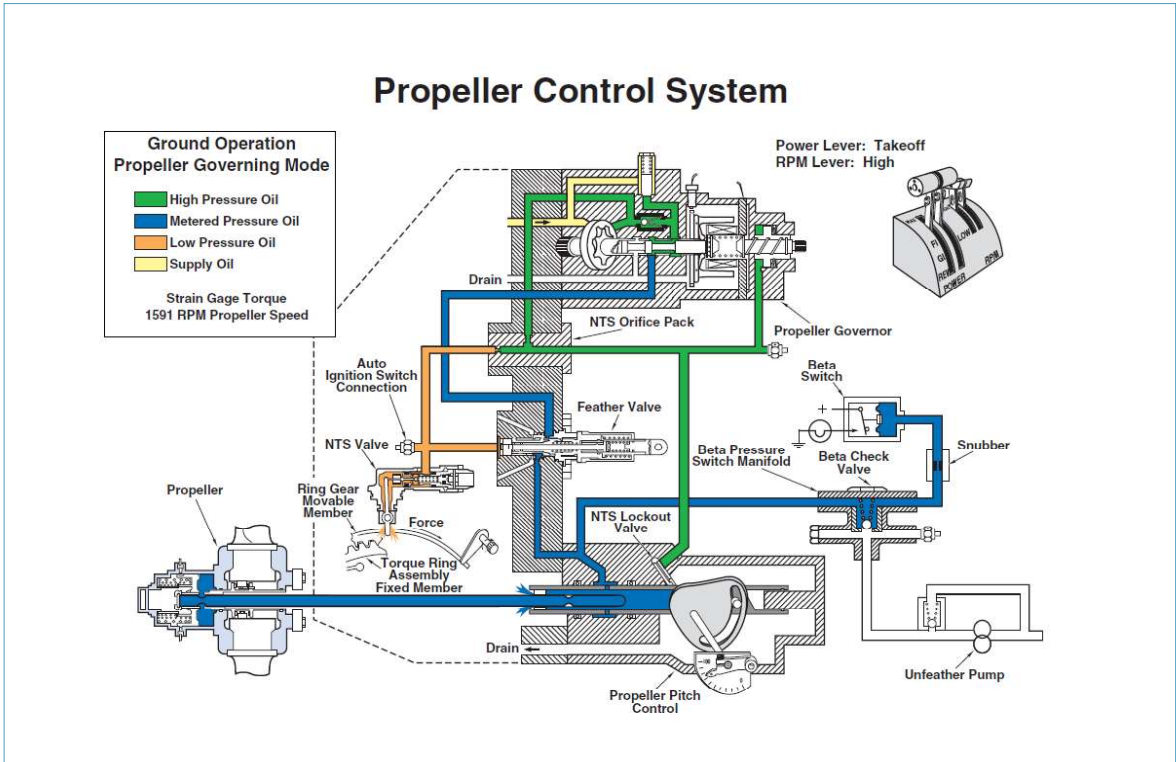
Figure 20: Propeller governing mode at Takeoff.

Figure 20 below illustrates the oil flow path during propeller governing mode at takeoff. Figure 21 illustrates the oil flow path with the displaced ballhead assembly and pilot metering valve. [Source: Honeywell Aerospace]
