Final report RL 2022:06e

**Accident at Åsäng, Västernorrland
County on 16 November 2021 involving
the helicopter LN-OYH of the model AS
350 B3, operated by Heliscan**

File no. L-84/21

7 November 2022

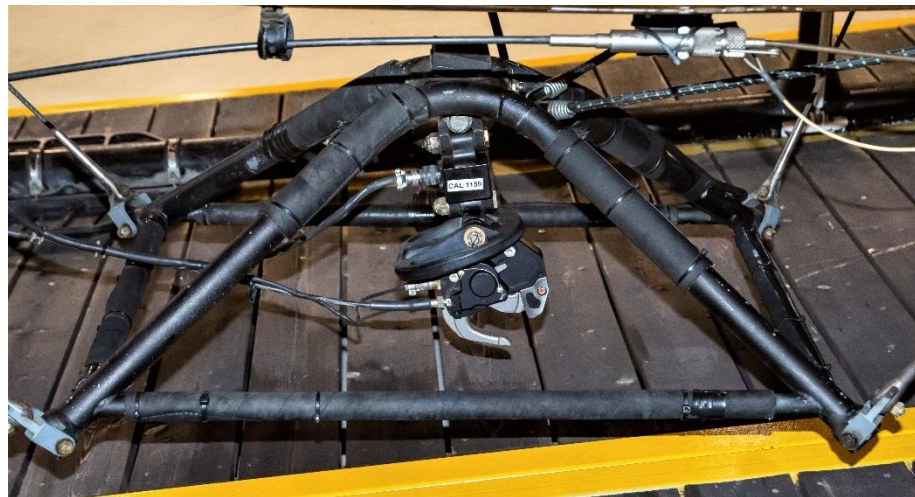
The helicopter was equipped with sling load equipment, with a cargo hook under the helicopter that had been installed by Airbus. The cargo hook can be opened in two ways, electrically or mechanically. Electric opening is done by pressing the upper button on the cyclic control. Mechanical opening is done by pressing a handle on the underside of the collective control that is linked to a release wire. According to the aircraft flight manual, the cargo hook has to be inspected with regard to electrical and mechanical opening before each flight with a sling load. Such an inspection was conducted in the morning before the first take-off with a sling load.

Figure 2. Sling load equipment with a cargo hook.

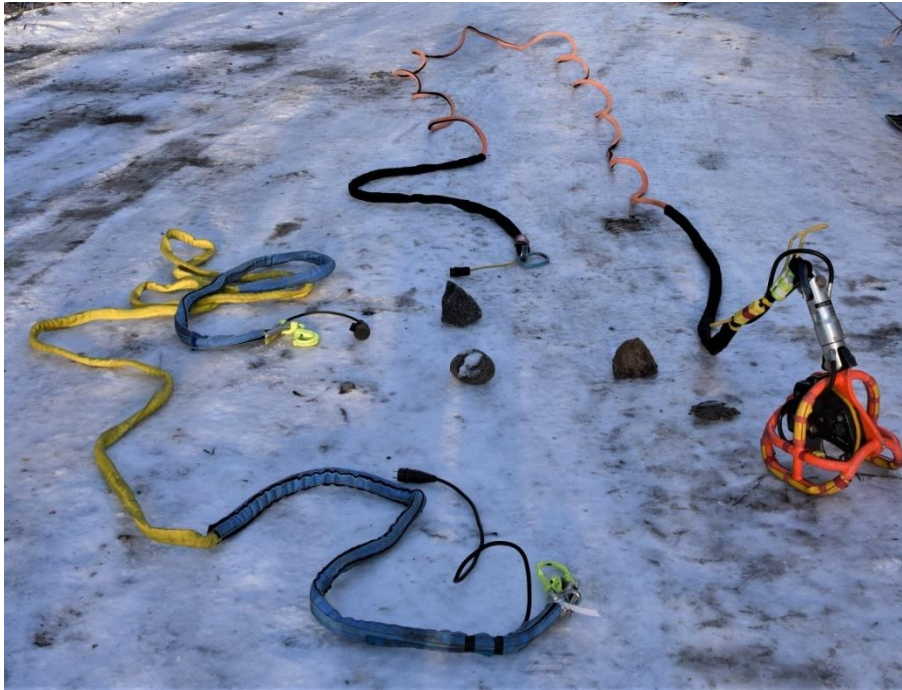
A sling with a lower hook was attached to the cargo hook on the helicopter. The load that was to be transported was attached to the lower hook. The sling contained an electrical connection to the lower hook, which meant that the pilot was able to open it in order to release the cargo. During the flight in question, a sling that was 15 metres long was being used, to which was also attached a 10-metre-long extension sling. These slings had the same construction.

Figure 3. The sling with a lower hook (on the right) and the 10-metre-long extension sling.

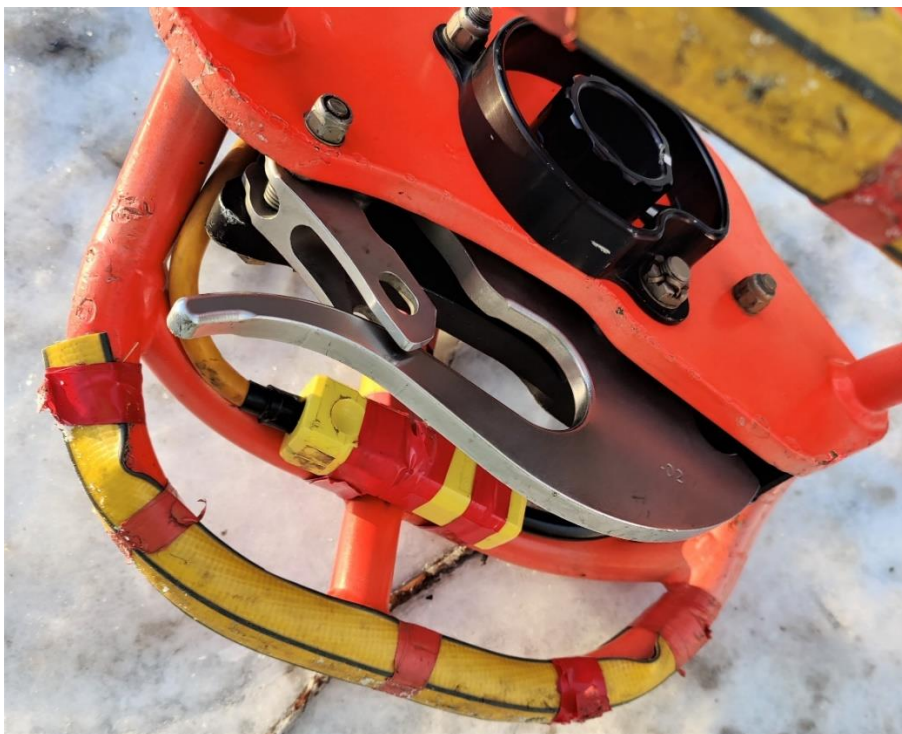
Figure 4. Close-up image of the lower hook.

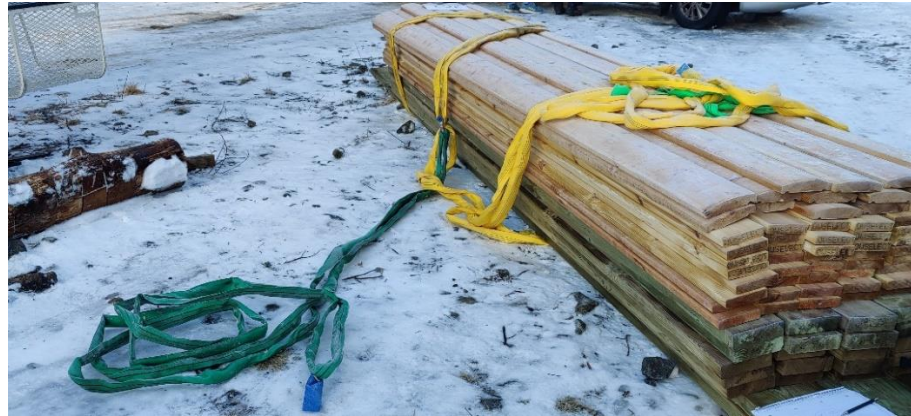
Each load of timber was lashed down with cargo straps that were attached to the lower hook on the sling. Some loads were equipped with an extra strap that also formed an extra extension to the entire line under the helicopter. This extra strap was six metres long and was attached to the other straps by a shackle.

Figure 5. The cargo straps in yellow and the extension strap, which is coloured green.

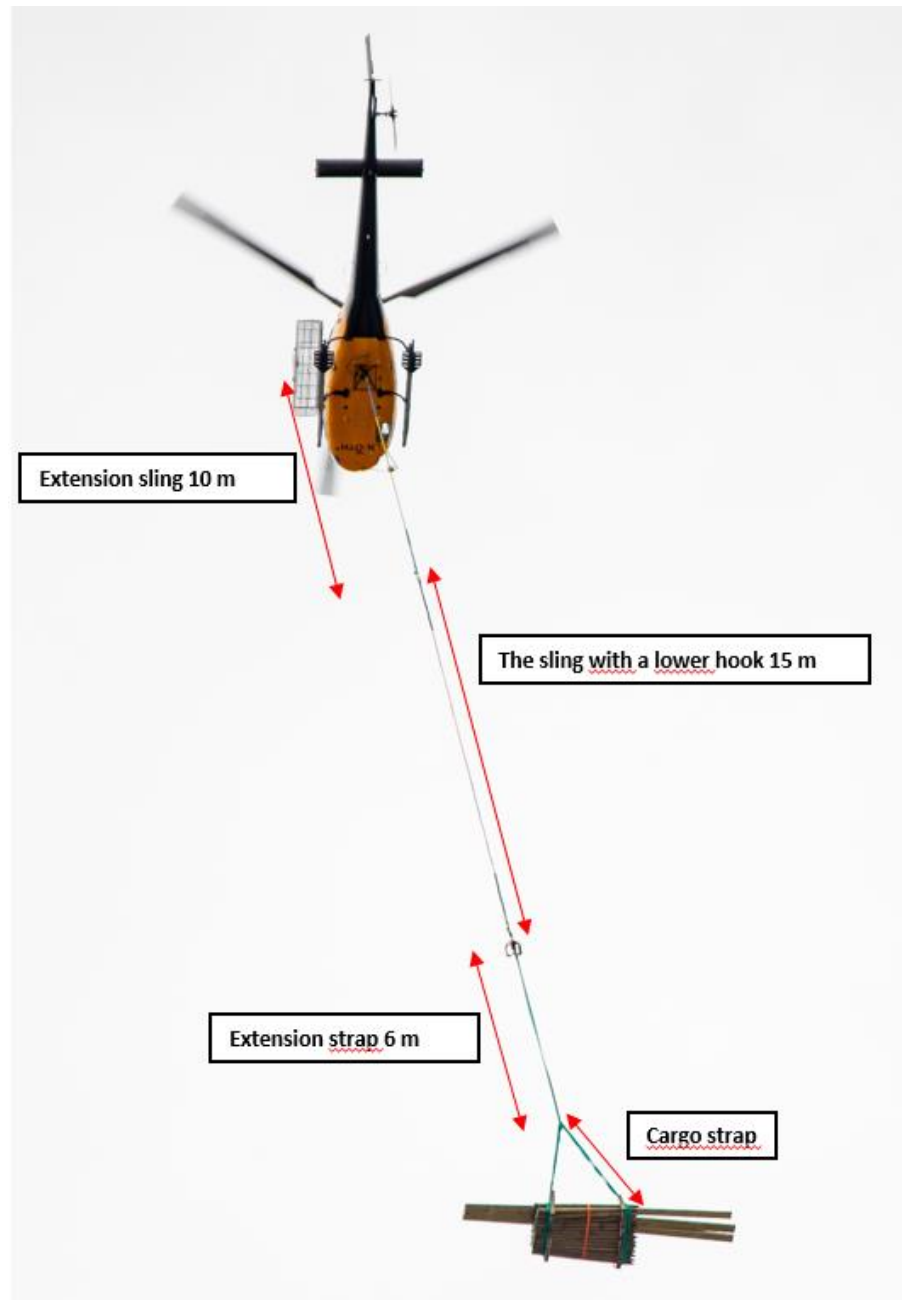
Figure 6. Picture showing the sling load and clearly indicating the constituent parts of the sling and straps. Markings made by SHK. Photo: Erik Engelo, Västernorrland County Administrative Board.

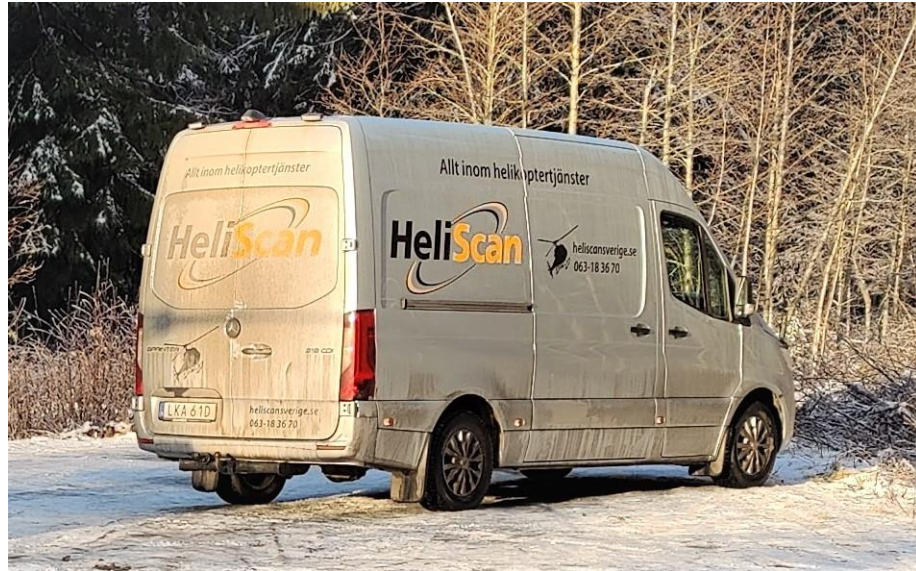
The refueller drove and was responsible for the refuelling vehicle that Heliscan had on site. The refuelling vehicle was a van and the cargo space contained a tank of fuel for the helicopter. While the work was taking place, the refuelling vehicle was parked close to the loading site (see Figure 10) in order to be as close as possible to the helicopter during refuelling.

Figure 8. The refuelling vehicle.
