FINAL REPORT

OCCURRENCE NO – 2022/2231

AIRCRAFT – Gyroplane AutoGyro Cavalon, OK-AWC98

DATE AND PLACE OF OCCURRENCE – 13 May 2022, Brzeziny

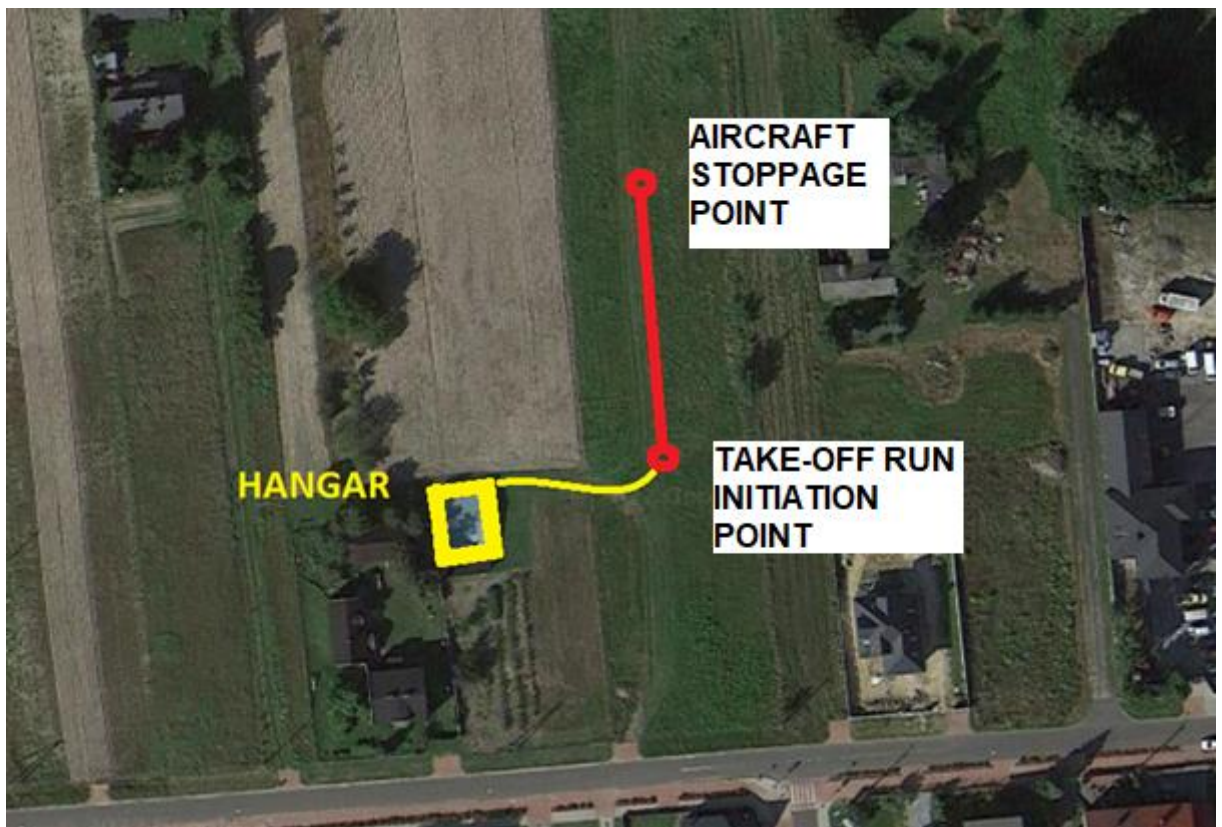
Fig. 4. Satellite view of the accident site. Yellow line - the taxi route of the gyroplane from the hangar to the take-off point. Red line - the take-off run of the gyroplane that ended in the accident [Source: google.pl/maps]

Pilot's error consisting in starting the take-off run with braked wheels of the main landing gear, which resulted in the creation of destructive forces at the landing gear attachment points resulting in the landing gear damage during take-off run.
