DUTCH
SAFETY BOARD

Fatal accident Dyn'Aéro MCR01

5 June 2022

The Hague, 8 November 2023

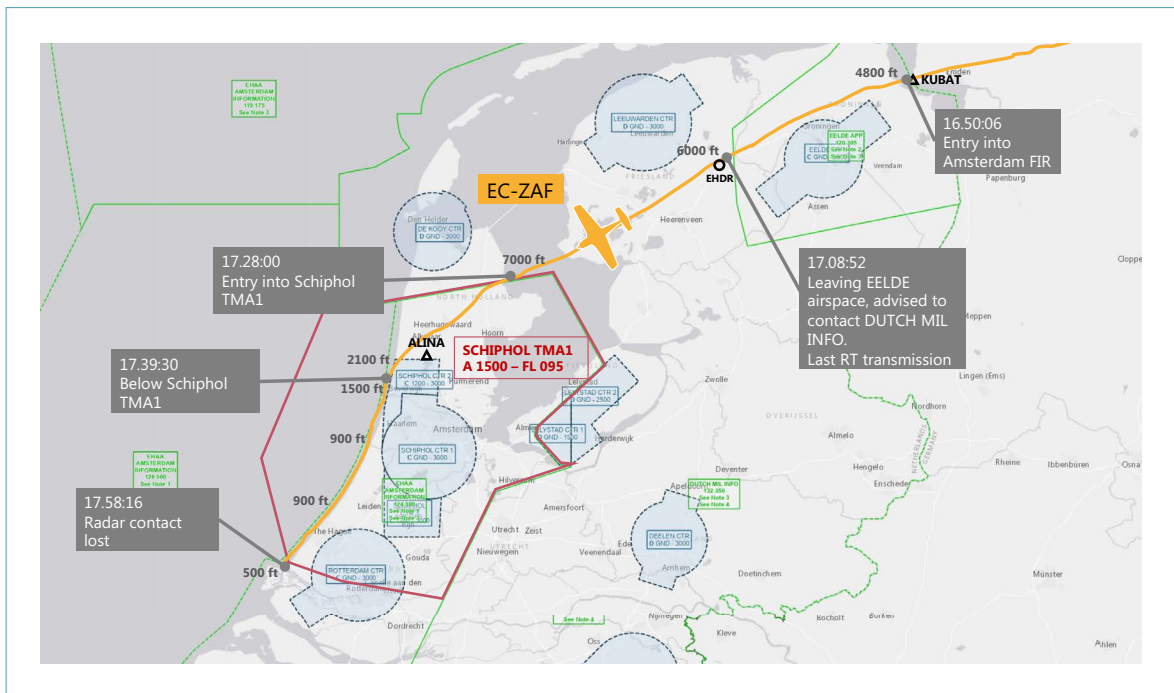
The flight continued and after leaving the Eelde TMA, entered Dutch MIL airspace, passed over the town of Drachten, crossed the IJsselmeer and then changed course to a more southerly direction. The aircraft entered the Schiphol TMA 1 (class A airspace¹¹) at 17.28 hours at around 7,000 feet¹². The supervisor of Schiphol Approach made several calls using the standard emergency frequency in an attempt to contact the pilot, but without any response. The supervisor of Schiphol Tower called the Dutch Aviation Police to ask if they had a helicopter available to intercept the unknown VFR flight crossing the Schiphol TMA 1. A police helicopter took off from Amsterdam Airport Schiphol (hereafter, Schiphol) with the intention to intercept the aircraft at approximately 17.45 hours.

Figure 1: Trajectory of the aircraft. (Source radar data: LVNL)

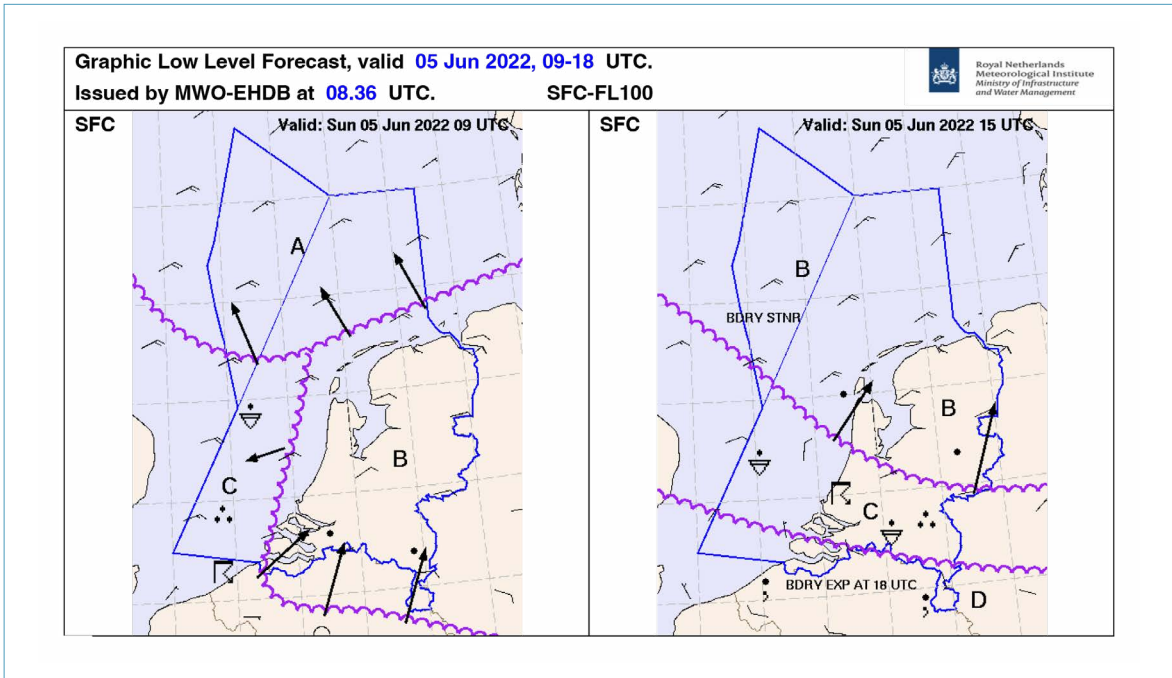
Figure 8: Graphic low level forecast for 09.00 UTC (left) and 15.00 UTC (right). (Source: KNMI)

The relevant meteorological areas for the accident flight are areas B and C. The forecast indicated for area B alto cumulus clouds at 7,000 feet or higher with a visibility of more than 10 km and some local light rain. The forecast for area C showed significant weather: temporary rain, occasional isolated showers of rain and thunderstorms, visibility more than 10 km, in precipitation 5,000 to 8,000 metres and local 3,000 to 5,000 metres. During thunderstorms with rain, a visibility of 3,000 to 1,500 metres was forecasted with a risk of visibility below 1,500 metres. Broken clouds (BKN)¹⁹ stratus cumulus were forecasted between 3,000 and 5,000 feet. Mainly over land, east and south, the forecast indicated an increasing risk to encounter BKN stratus between 500 and 1,000 feet. In showers few (FEW) and/or scattered (SCT) cumulonimbus were possible with a cloud base between 4,000 and 6,000 feet and with cloud tops above flight level 100.

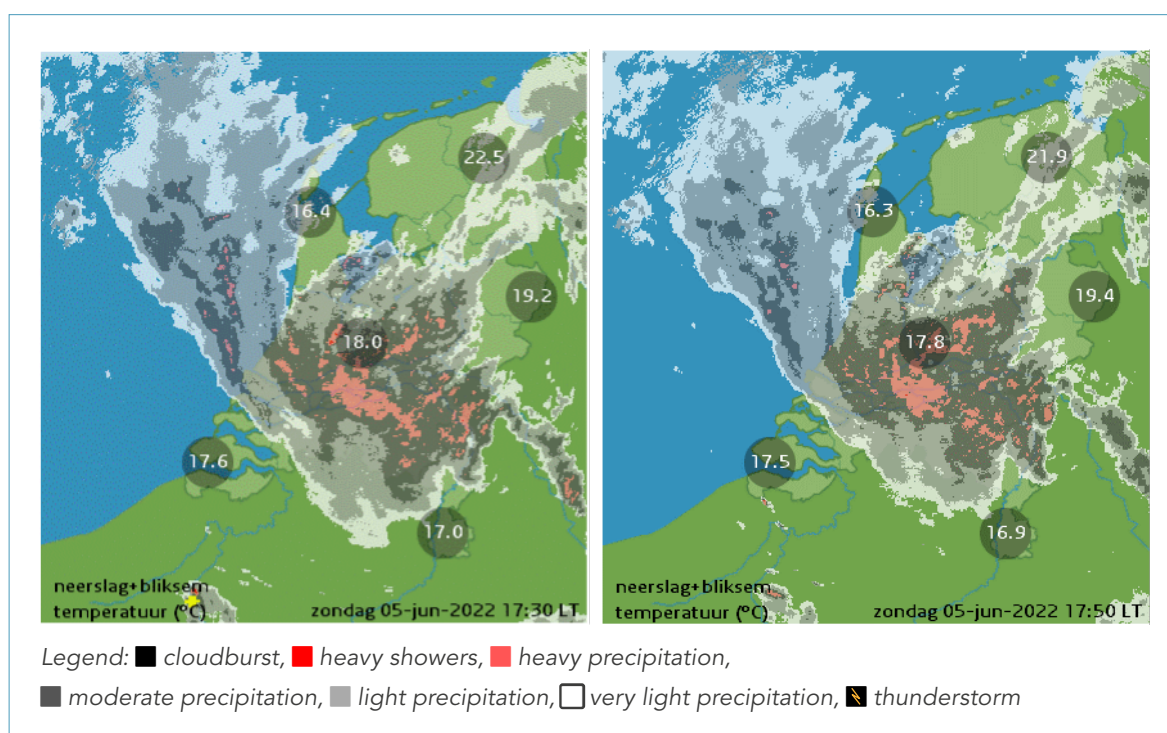
Along the route, conditions were initially quite good. In general, there was a visibility of more than 10 km, a light eastern wind and a cloud base between 3,000 and 5,000 feet. When the aircraft flew along the coastline in southern direction, the weather conditions were deteriorating: the cloud base was descending to 2,000 to 3,000 feet with visibility of 3,000 to 5,000 metres. It cannot be ruled out that in the last part of the trajectory there were also FEW/SCT clouds between 1,000 and 1,500 feet and a visibility reduction to 1,500 to 2,000 metres occurred. Radar images show that on the route along the coastline (between 17.44 and 17.58 hours) light, possibly temporarily moderate rain fell (see Figure 9). The cloud cover consisted of various layers. The chance of hidden cumulonimbus (CBs) on the route was very small (unlike the inland, where various embedded CBs were present). The Meteorological Aerodrome Reports (METARs) of Schiphol and Rotterdam The Hague airport are presented in Appendix C.

Figure 9: Radar images showing precipitation, lightning (yellow) and temperature. (Source: KNMI)

The Dutch Safety Board notes that the weather observations made by the police helicopter crew and the METARs of Schiphol and Rotterdam The Hague airport were not representative of the weather conditions encountered by the aircraft. Both the flight track of the police helicopter and the location of the two aerodromes is more land inwards. As also visible on the radar images of the precipitation in Figure 9, the weather conditions over land were different from the conditions near the coastline.

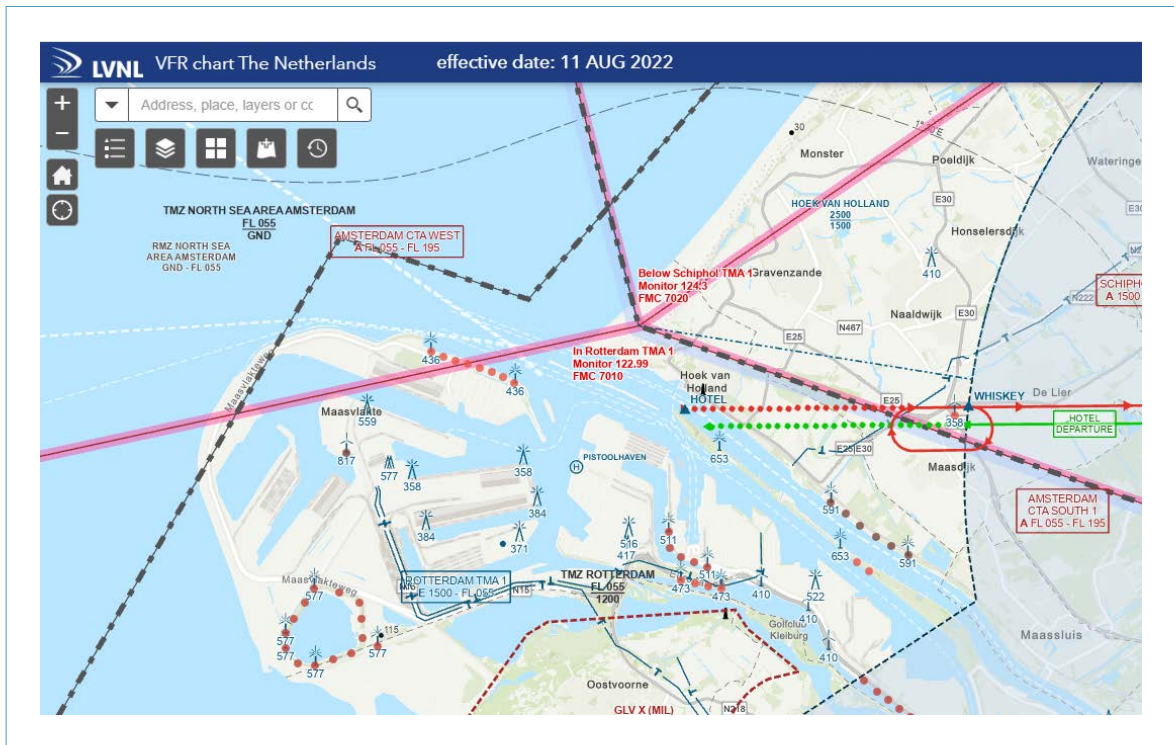
There are several wind turbines, chimneys and cranes on the Maasvlakte, the area where EC-ZAF crashed. They are listed in the AIP The Netherlands and depicted in Figure 11. The heights of the obstacles vary: lines of moveable harbour cranes of 358-384 feet

AMSL, two chimneys of 577 feet AMSL, two flare stacks of 371 and 550 feet AMSL and several lines of wind turbines (8 of 436 feet AMSL, 5 of 511 feet AMSL, 14 of 577 AMSL, one of 817 feet AMSL).

The AIP contains a warning for the Maasvlakte area regarding a gas venting site and an accompanying advisory measure to avoid flying below 1,000 feet above ground level and in close vicinity of this site.

Figure 11: VFR chart with obstacles at Maasvlakte. (Source: VFR chart The Netherlands, LVNL, consulted on 11 August 2022)

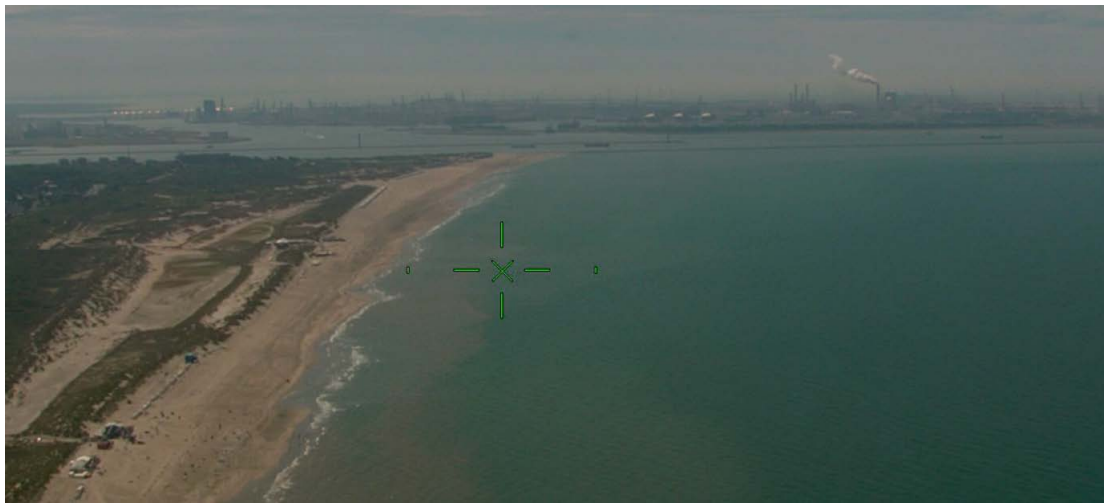
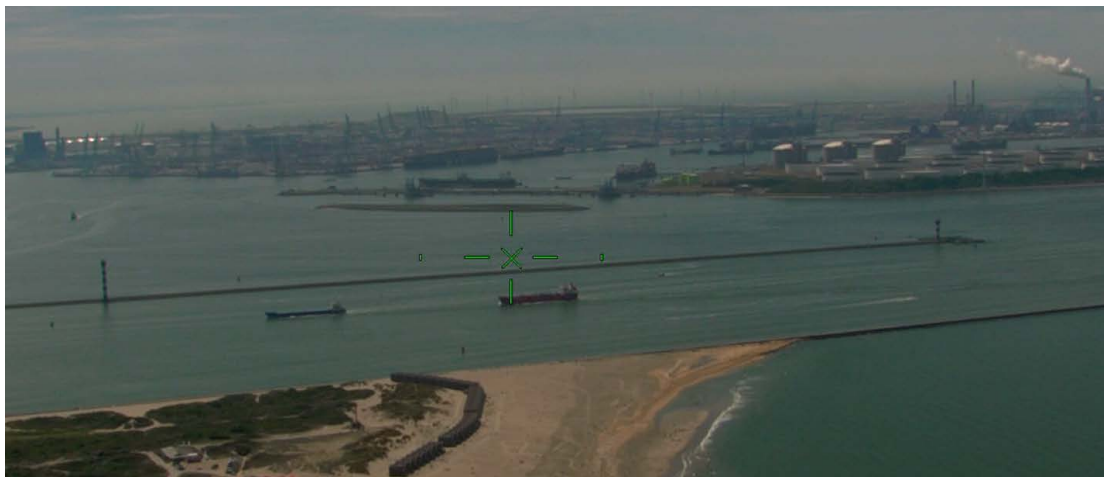
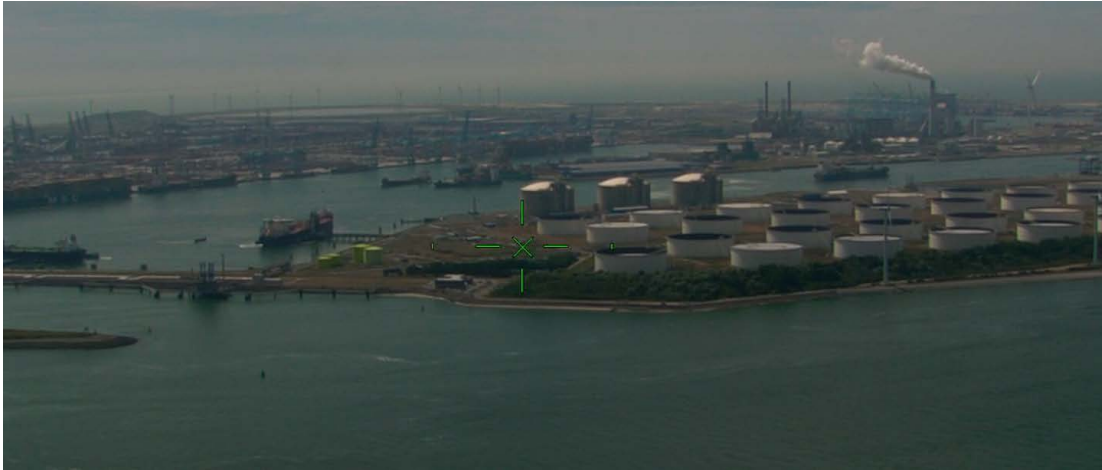
The final twenty minutes of the flight, the aircraft followed the Dutch coastline. As indicated in Section 3.1.3, the weather conditions deteriorated along the route. When approaching the Maasvlakte, the distinct shoreline ends into a land section with different obstacles. Figure 14 presents three screenshots taken from a video recording of a helicopter flight performed by the Dutch Aviation Police one month after the accident.

These screenshots give an impression of the visual environment the pilot encountered. It is to be noted, however, that this specific helicopter flight was performed in far more favourable weather conditions in comparison to the accident flight. Directly on the right of the flight path, there was a line of eight tall wind turbines. Ahead were lines of moveable harbour cranes, chimneys and more wind turbines.

When reaching the Maasvlakte, the flight track shows a change of heading towards the south, but also a drop in altitude, followed by altitude variations. Although it cannot be determined with certainty, the end of the distinct coastline and appearance of the Maasvlakte and obstacles may have triggered a reaction by the pilot to avoid the obstacles by changing direction. As the cloud base was around 1,000 to 1,500 feet, there was only limited opportunity to climb.

Figure 14: View towards Maasvlakte from altitude of 776-772 feet on 13 July 2022. (Source: Dutch Aviation police)
