## *Final report* *SHK 2023:12e*

**Seaplane accident at Lake Siljan, Dalarna County on 18 July 2022 involving the aeroplane N747HJ of the model UC-1 Twin Bee**

File no. L-70/22

23 October 2023

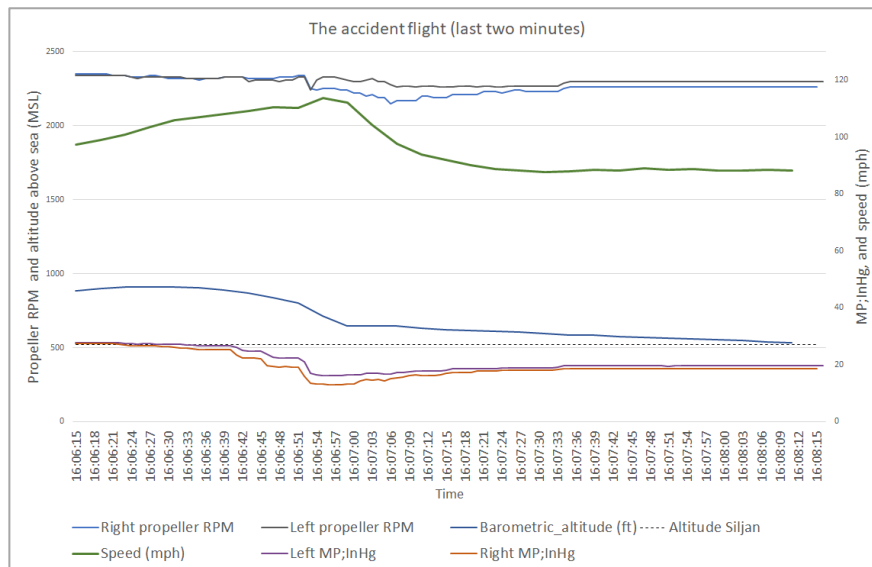
In Figure 14 a compilation of the registrations from FLARM and engine data during the last two minutes of the accident flight is presented. The compilation shows that the approach was stable in the final phase of the flight in terms of speed and rate of descent. Engine data did not show any major engine power changes. The right and left engine manifold pressure were relatively constant at 19 and 20 inches during the last 40 seconds the flight.

Figure 14. Recordings from FLARM and engine data.

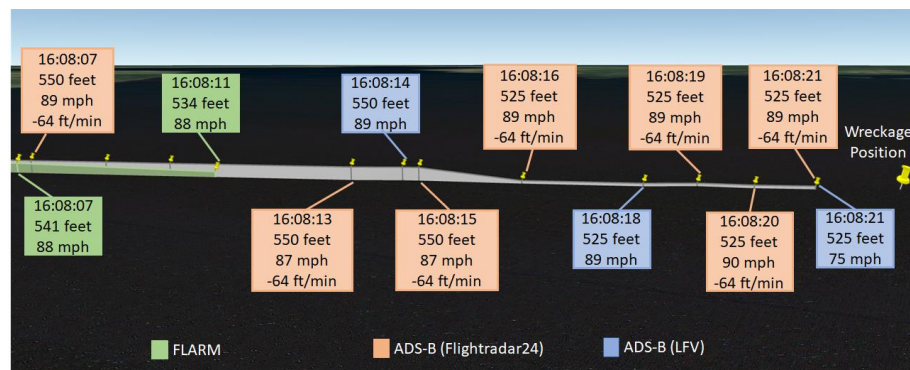
Figure 16 shows a compilation of data from FLARM (time, altitude and speed) and ADS-B (time, altitude, speed and vertical descent rate) during the last seconds of the flight. From the ADS-B data and FLARM data, it can be concluded that there were no significant changes in altitude and that the speed and the vertical rate of descent have been constant until the last registration.

Figure 16. Registrations from FLARM and ADS-B from the last seconds of the accident flight. Altitudes are adjusted for atmospheric pressure reduced to mean sea level (QNH). Image: Google Earth with tracks added by SHK.

At the last time stamps at 16:08:21 there are two registrations, one from LFV and one from Flightradar24. However, the registration from Flightradar24 is somewhat delayed in relation to the actual time when the information was registered in the aircraft (see section 1.11.1) and thus refers to a time slightly before the registration according to LFV's data.

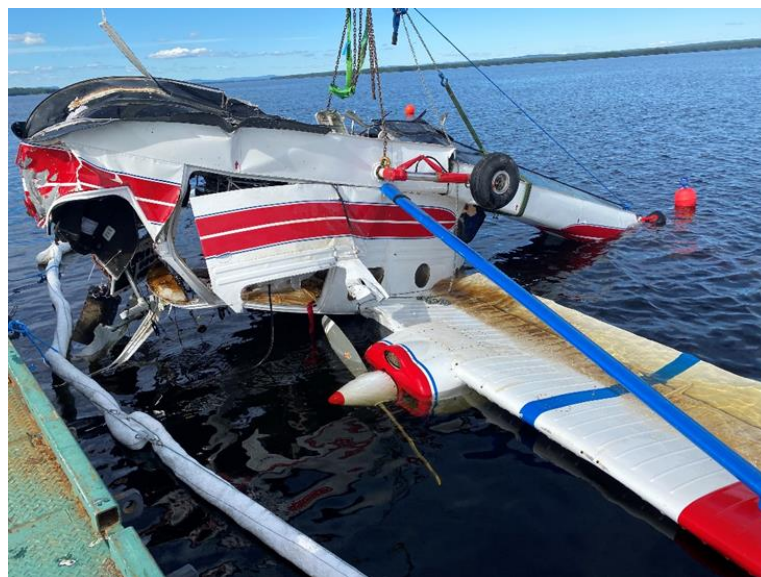
The aircraft was transported to shore where an initial technical examination was carried out. Before transportation for further examination at SHK's premises the wings were removed and the tail boom was sawed off approximately one meter behind the step.

Figure 22. The aircraft during the salvage on the Lake Siljan.

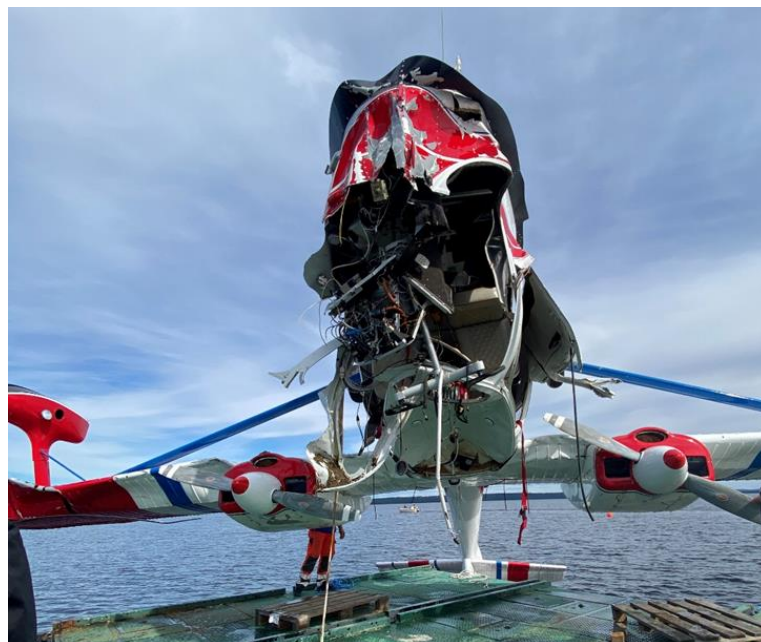
Figure 23. The aircraft during the salvage on the Lake Siljan.

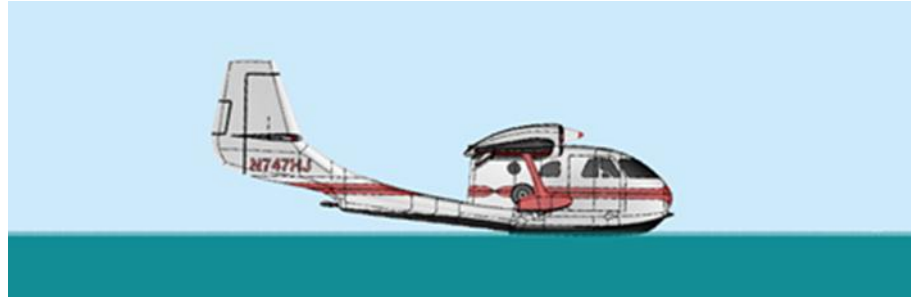
Assuming that the hull of the aircraft contacts the water surface without the step breaking the water surface, the water will be carried upwards along the hull. The reaction force from the water acting upwards will pull the aircraft downward and deeper into the water. This in turn means that the contact area with the water increases, which increases friction, i.e. the braking force against the water becomes greater, (see Figure 29).

Figure 29. The hull of the aircraft contacts the water surface without the step breaking the water surface.

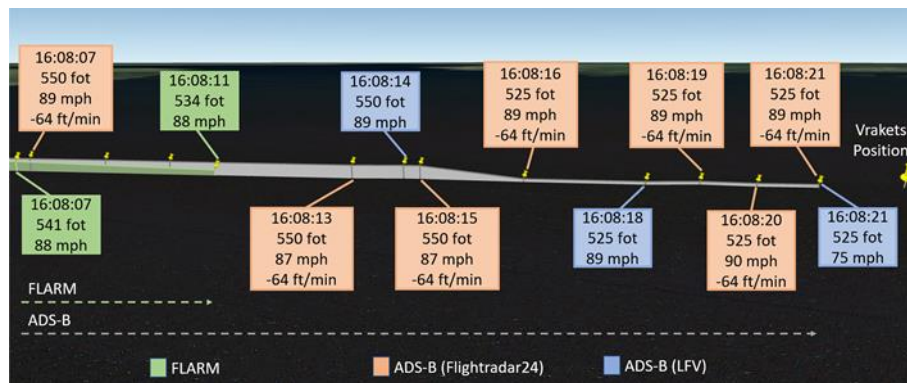
In order to be able to more precisely determine the time of the accident, a closer analysis of the ADS-B data has been carried out, (see Figure 31). At the last registrations (16:08:21) the distance between the positions is one metre and the decrease in speed is 14 mph. The rapid decrease in speed between these positions indicates that this is when the accident sequence begins.

Figure 31. Information from FLARM ends at 16:08:11 and then ADS-B information is presented until the last registration at 16:08:21.

Calculations of the aircraft's descent angle based on sensor data from FLARM show that with a constant vertical speed, the aircraft could have contacted the water surface before 16:08:21. An explanation for this could be that the aircraft bounced on the first water contact before the accident sequence begins. Another possibility is that the aircraft's vertical speed changed slightly at the end of the approach and thus changed the descent angle.
