Report RL 2000:12e

**Accident involving helicopter SE-JES,
03 April 1999, in the vicinity of Lake
Kamasjaure, 25 km. northeast of
Torneräsk, BD county, Sweden**

The Swedish Board of Accident Investigation (Statens haverikommission, SHK) has investigated a helicopter accident, aircraft registration SE-JES, which occurred on 3 April 1999, by Lake Kamasjaure, approximately 25 km. northeast of Torneträsk, BD county, Sweden.

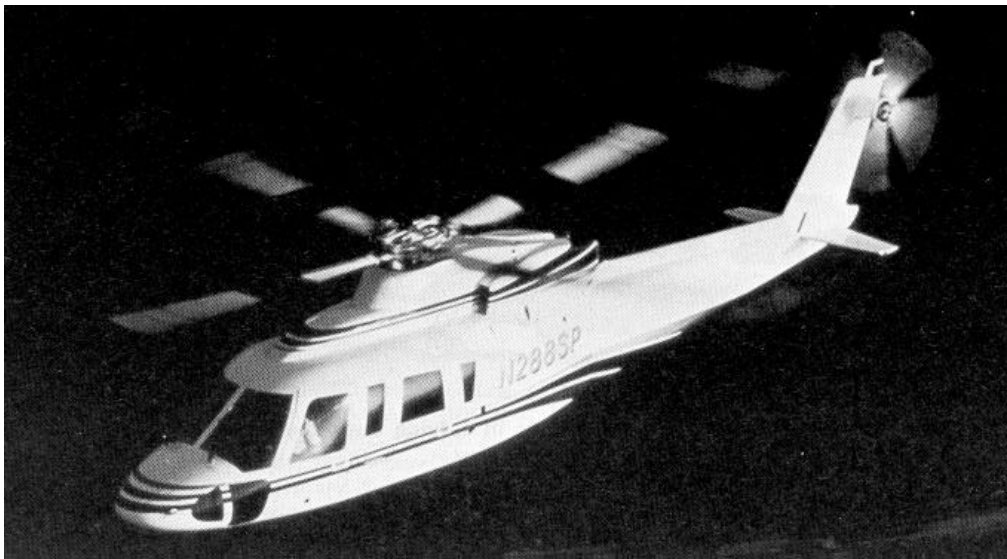
The S-76A helicopter is equipped with retractable undercarriage and is used for both the transport of personnel and for special purpose missions. In the standard version it carries two pilots and 12 passengers. The actual aircraft was IFR-equipped including a SAS II autopilot. It was also modified for use as air ambulance. In the cabin there was room for a removable stretcher, three separate seats and advanced medical equipment.
