AIRCRAFT ACCIDENT REPORT AND EXECUTIVE SUMMARY

Reference:	CA18/2/3/8849	
Aircraft Registration	ZU-BWU	Date of Accident	12 October 2010		Time of Accident	1545Z
Type of Aircraft	Windlass Aquilla		Type of Operation		Private	
Pilot-in-command Licence Type	Private		Age	29	Licence Valid	Yes
Pilot-in-command Flying Experience	Total Flying Hours	56.3		Hours on Type	56.3	
Last point of departure	Brits Aerodrome FABS North-West Province					
Next point of intended landing	Brits Aerodrome FABS North-West Province					
Location of the accident site with reference to easily defined geographical points (GPS readings if possible)						
Open field on farm, approximately 5nm North-West of Brits Aerodrome North-West Province.						
Meteorological Information	Surface wind; Calm, Temperature; 30°C, Visibility; + 10 km.					
Number of people on board	1 + 0	No. of people injured	0	No. of people killed	0	
Synopsis						
<p>On 12 October 2010 at approximately 1715Z, the pilot, who was the sole occupant on-board the aircraft, departed Brits Aerodrome on a private local flight with 30 litres of fuel available in the fuel tank. After flying for approximately 20 minutes at 4600' AMSL, he suddenly experienced

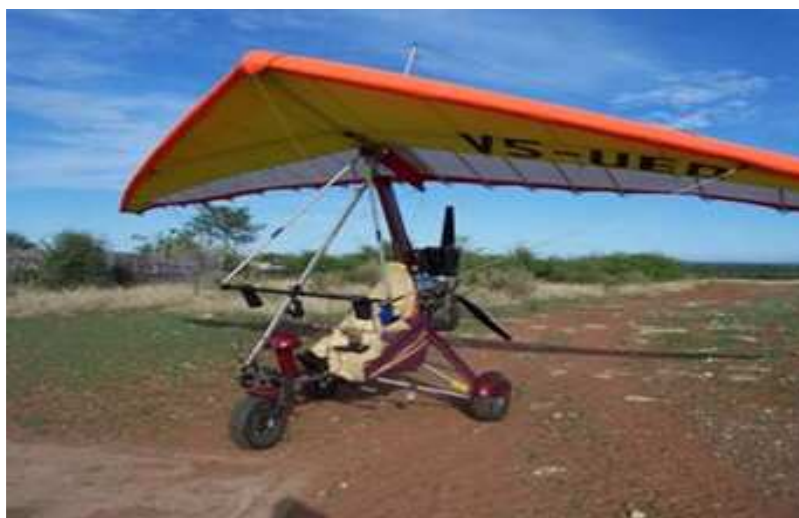
Figure 1: View of similar Type Microlight Aquilla.

1.3.1 The aircraft sustained substantial damage to the wings, spreader bar and propeller during the accident sequence.
