## AIRCRAFT ACCIDENT REPORT AND EXECUTIVE SUMMARY

Reference:	CA18/2/3/8998	
<b>Aircraft Registration</b>	ZU-DDO	<b>Date of Accident</b>	06 January 2012		<b>Time of Accident</b>	1600Z
<b>Type of Aircraft</b>	Bantam B22J		<b>Type of Operation</b>		Private	
<b>Pilot-in-command Licence Type</b>		Microlight	<b>Age</b>	33	<b>Licence Valid</b>	Yes
<b>Pilot-in-command Flying Experience</b>		Total Flying Hours	35,4		Hours on Type	35,4
<b>Last point of departure</b>		Roodedam farm, Thabazimbi, North West Province				
<b>Next point of intended landing</b>		Roodedam farm, Thabazimbi, North West				
<b>Location of the accident site with reference to easily defined geographical points (GPS readings if possible)</b>						
Open field on Roodedam farm, Thabazimbi, North West						
<b>Meteorological Information</b>		Surface wind: 120° / 3 kt; Visibility: CAVOK; Temperature: 24°C				
<b>Number of people on board</b>	1 + 0	<b>No. of people injured</b>	1	<b>No. of people killed</b>	0

## AIRCRAFT ACCIDENT REPORT

**Name of Owner/Operator** : Naude and Nel Partnership  
**Manufacturer** : Micro Aviation, New Zealand  
**Model** : Bantam B22J  
**Nationality** : South African  
**Registration Marks** :

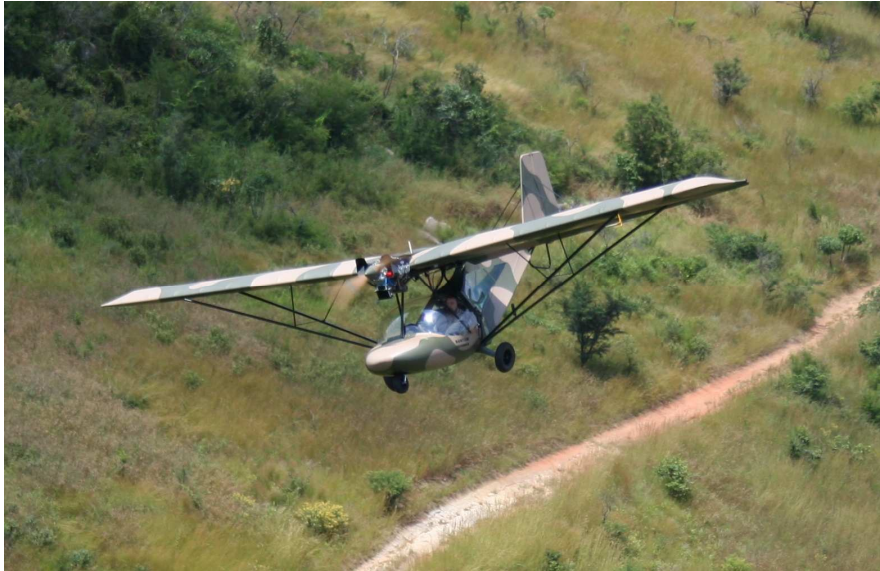
PICTURE1: SHOWING SIMILAR BANTAM B22J DURING FLIGHT

- 1.6.1 Although classified as a microlight, the Bantam B22J is not a kit-built aircraft but a factory-built and tested machine. It is also more like a conventional light aircraft in its design, being a three-axis, high-wing monoplane with side-by-side seating. It has a fuel capacity of 50 l. The undercarriage is a fixed tricycle-type.
- 1.6.2 The aircraft is fitted with a Jabiru 85 hp engine that runs on avgas and operates at between 2 600 rpm and 2 800 rpm, producing a cruise speed of 60 knots to 65 knots. Fuel burn is 14 to 17 l/hr.
- 1.6.3 The engine is fitted with a two-blade, laminated wood, fixed pitch propeller.
- 1.6.4 According to the pilot's Operating handbook (POH), the stall speed with power off and no flaps (flaperons) is 35 kt indicated air speed (IAS). With power on and full flaps, the stall speed is 34 kt IAS.
