Subj: ACTION OF THE FINAL REVIEWING AUTHORITY CONCERNING A
CLASS ALPHA AVIATION MISHAP INVOLVING AN MQ-8B FIRE
SCOUT, BUNO 167988, OPERATING FROM USS ROBERT G.
BRADLEY (FFG 49), WHICH OCCURRED ON 13 DECEMBER 2012

2. Summary. At 1140Z on 13 December 2012, an MQ-8B FIRE SCOUT (BUNO 167988/N12) launched from USS ROBERT G. BRADLEY (FFG-49) to conduct an Intelligence, Surveillance and Reconnaissance mission in support of Special Operations forces. After 27 minutes of flight, the mishap aircraft received an icing alert and was directed to return to the ship by the Air Vehicle Operator. While recovering aboard ship, the aircraft lost control, crashed into the sea, and was destroyed. Several pieces of the airframe were recovered, including tail rotor components, the air intake filter, and various pieces of the fuselage. Post-flight engineering analysis revealed out of balance and flapping conditions in the tail assembly, caused by rapid descent and ice loading.

3. The cause of the mishap was inadvertent flight into icing conditions, and subsequent loss of aircraft control.

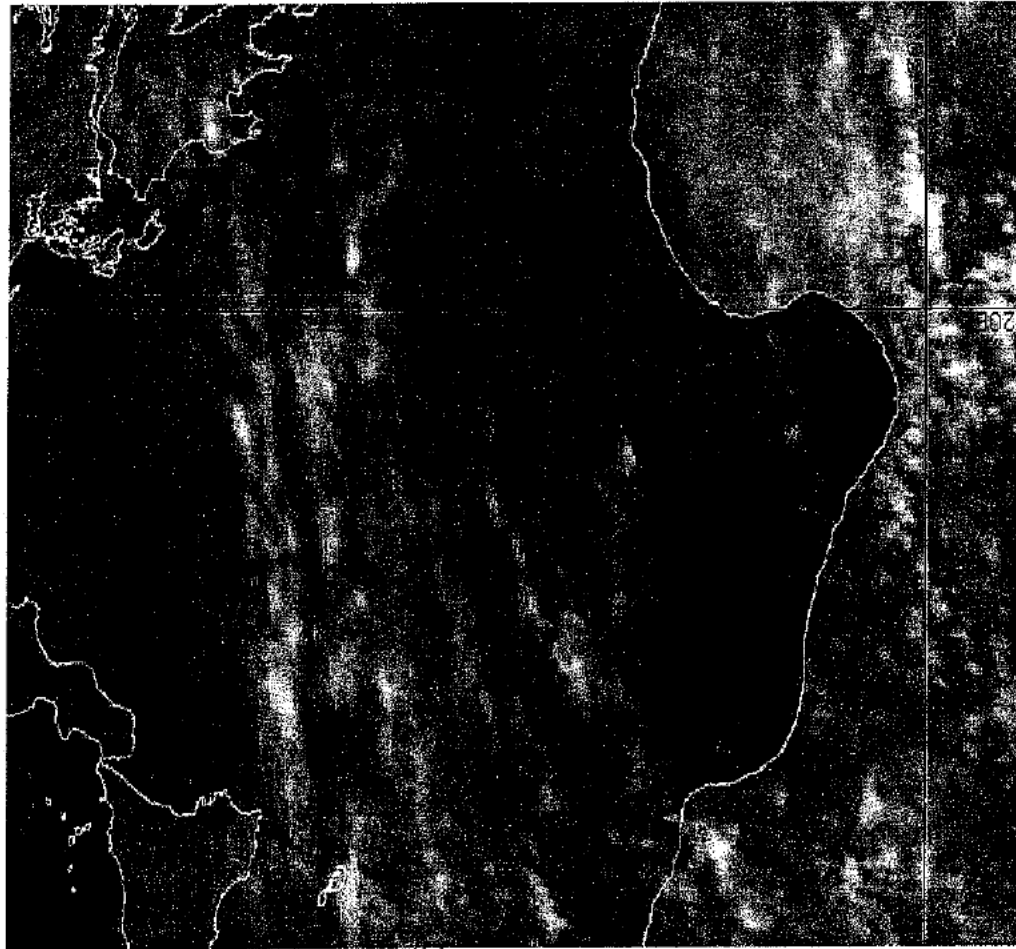
FIRE SCOUT AVIATION WEATHER

VIS SAT VT 11 DEC: 1030Z

* ICING AND TURB ARE ASSUMED W/ THUNDERSTORMS

10. The maritime weather brief compiled by (b) (6), (b) (7)(C) indicated few clouds at 1,000-2,000 feet, scattered clouds at 3,000-4,000 feet, a mostly broken layer at 5,000-7,000 feet, an overcast layer at 8,000-10,000 feet. [Encl 16, 17]
