# Air Accident Investigation Sector

- Summary Report -

AAIS Case N° AIFN/0010/2015

## Failure of the Integrated Primary Computer

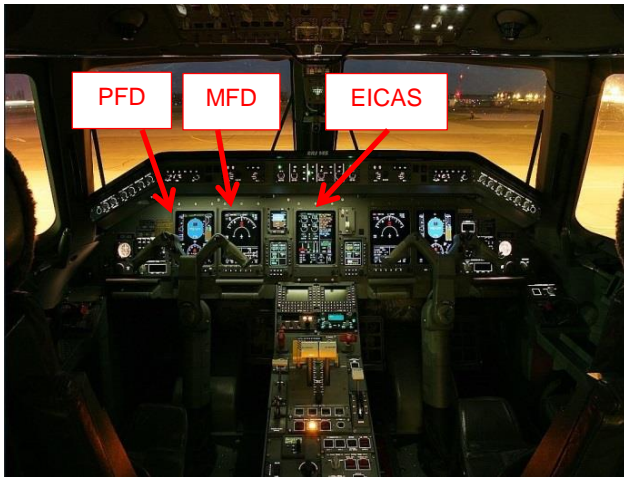
Figure 1. Front panel view

The PFD (figure 1) presents the primary information to the pilots in digital form and in analogue form for some parameters. In case of PFD failure, information may be presented on the MFD by setting the MFD selector knob on the reversionary panel. The radio management unit (RMU) is also able to present some PFD indications.

In normal operation, PFD1 and MFD1 (left side) and EICAS are provided by the No.1 IC-600, whereas the No.2 IC-600 provides images to PFD 2 and MFD 2 (right side). Both IC-600 interact to send output to the aural warning unit.
