Fly-away after loss of control, DJI Matrice 210 V2, PH-6RJ

Amsterdam, 26 July 2022

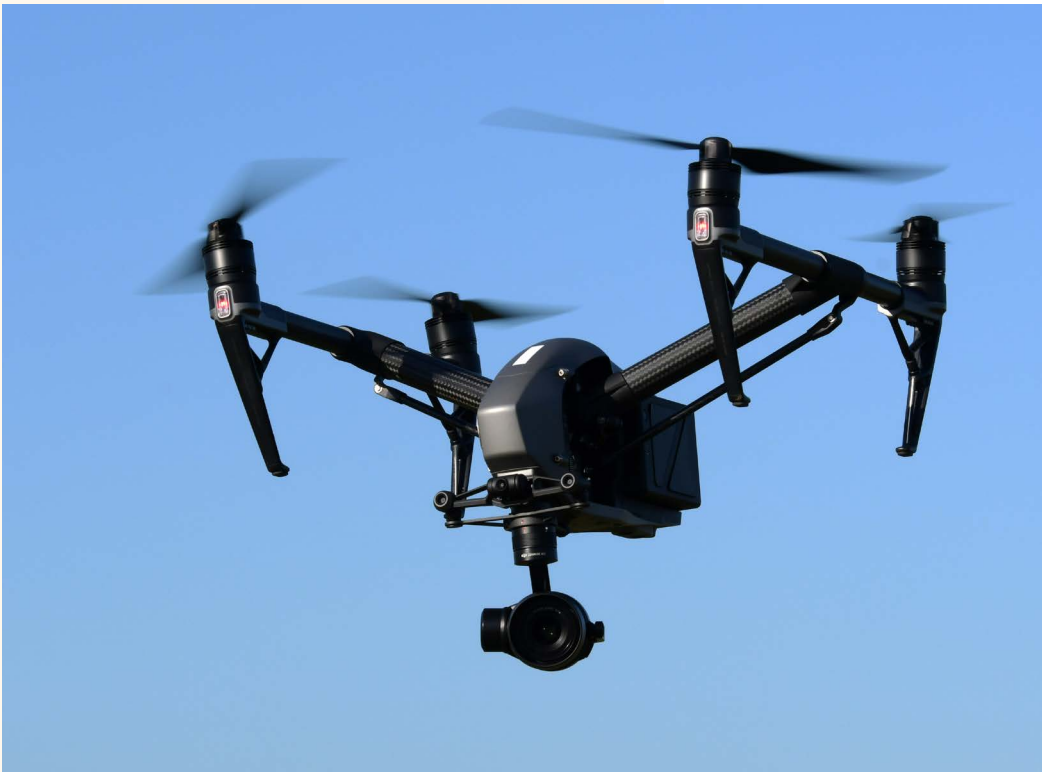
▼ *Archieffoto DJI Matrice 210 V2.*

The operator used the DJI Matrice 210 (M210) unmanned aircraft system (UAS) in the city of Amsterdam. The M210 has four propellers, each powered by its own motor.
